Havarikommissionen
Accident Investigation Board Denmark

BULLETIN

ELA 07 R-100 C

OY-1027

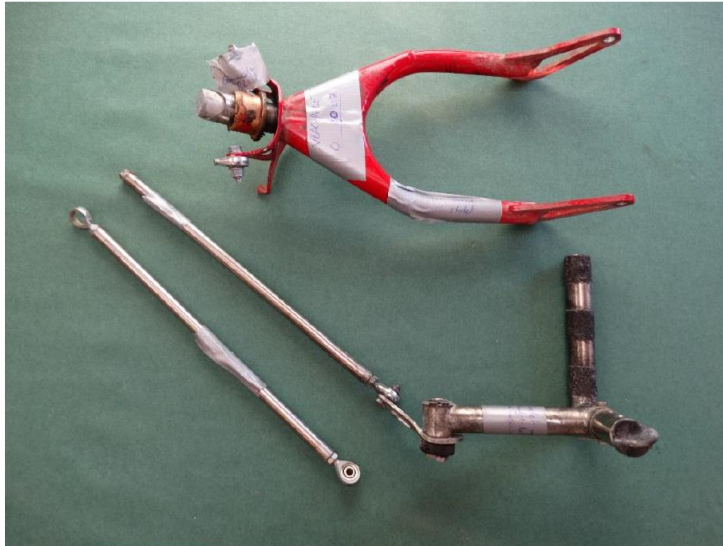
At your request, FORCE Technology has examined the supplied components, as seen in Figure 1, from an Ela Aviacion gyrocopter, with registration number OY-1027, to determine the causes of failure in selected positions.

Figure 1 Components as received by FORCE Technology for examination.

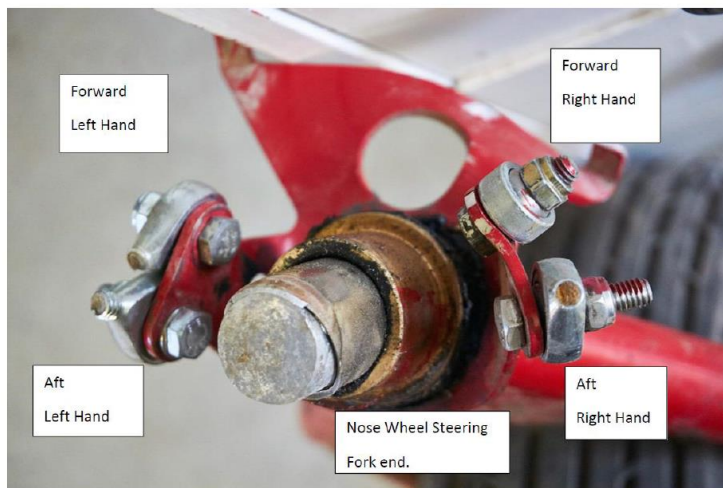
For ease of reference, Figure 2 illustrates the positions of the abovementioned components to be examined.

Figure 2 Illustration of component positions to be examined.
