**REDEGØRELSE**

| <i>HCLJ 510-2011-17</i> | | Registrering: | OY-NLA |
| Luftfartøj: | Cessna Citation 650 | Flyvning: | Taxaflyvning, IFR |
| Sted: | Københavns lufthavn, EKCH | | |

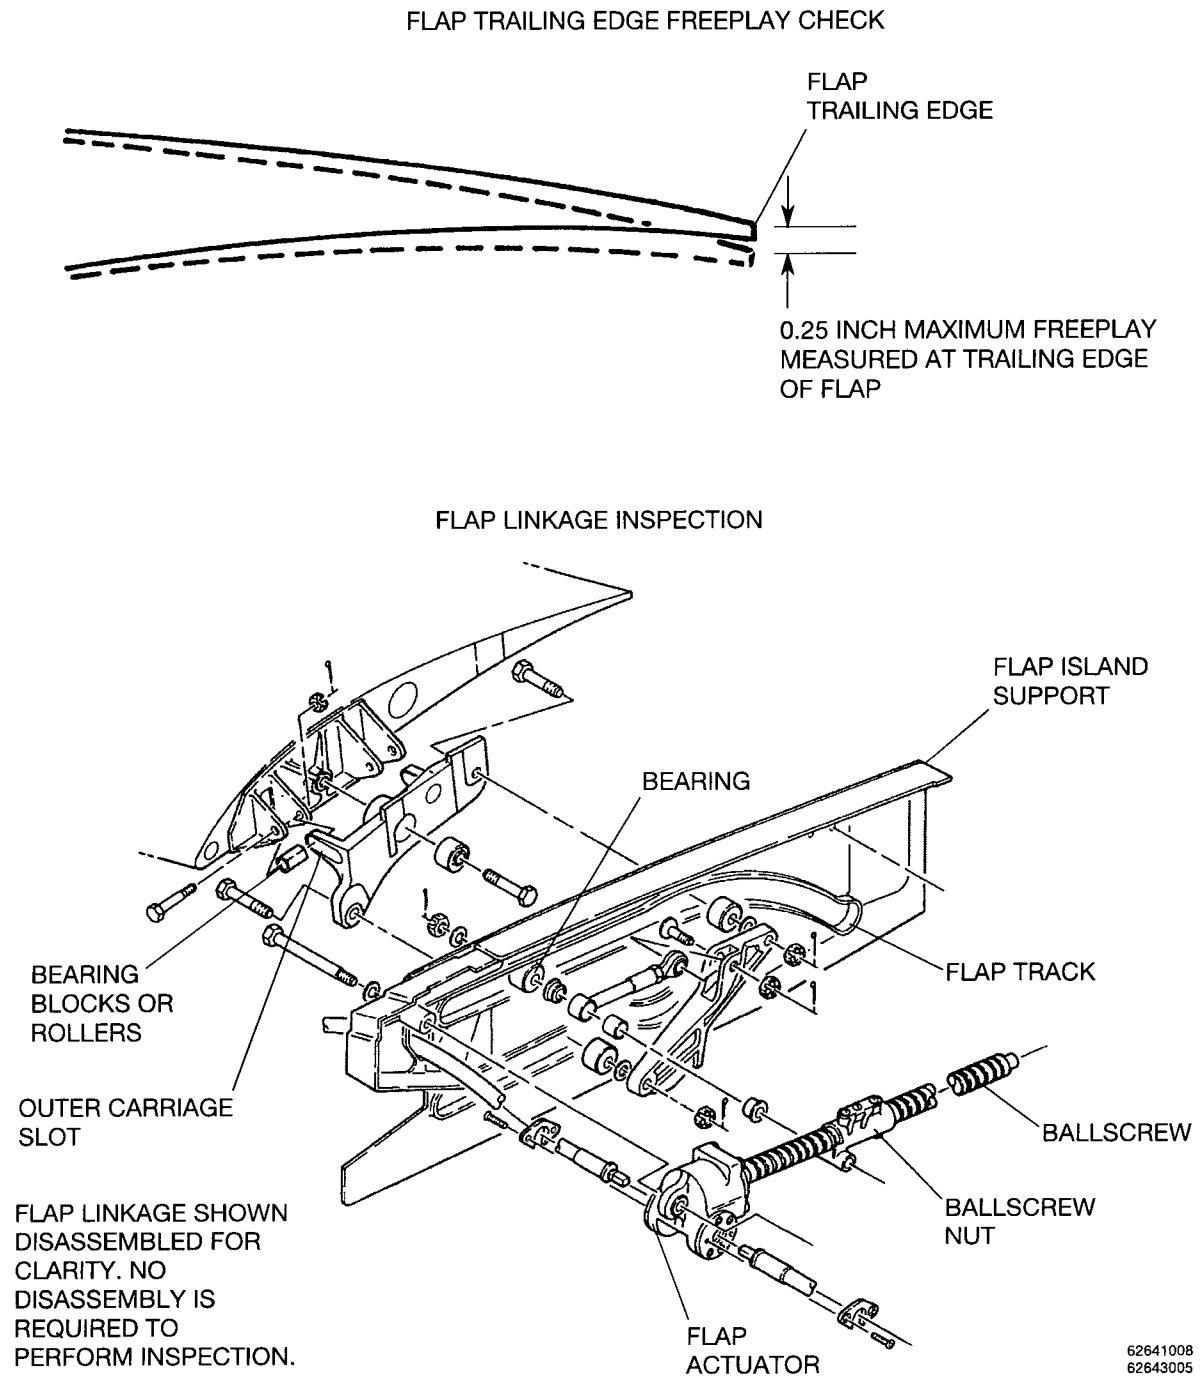
**Figure 601. Flap Trailing Edge Freeplay Check and Flap Linkage Inspection.**

- (1) Complete the flap trailing edge freeplay check as follows:
  - (a) Place the flaps in the 7-degree position.
  - (b) Apply approximately 20 pounds of force up and down at the trailing edge of each flap, with the force applied perpendicular to the flap surface. Refer to Figure 601. Measure the amount of total movement at the trailing edge. Use a rigid stand or a device temporarily mounted to the flap island or wing as a reference point for the measurement. Maximum amount of free play is 0.25 inches (6.35 mm). If the amount of free play is 0.25 inches (6.35 mm), then the flap linkage must be inspected to determine the cause of excessive free play.

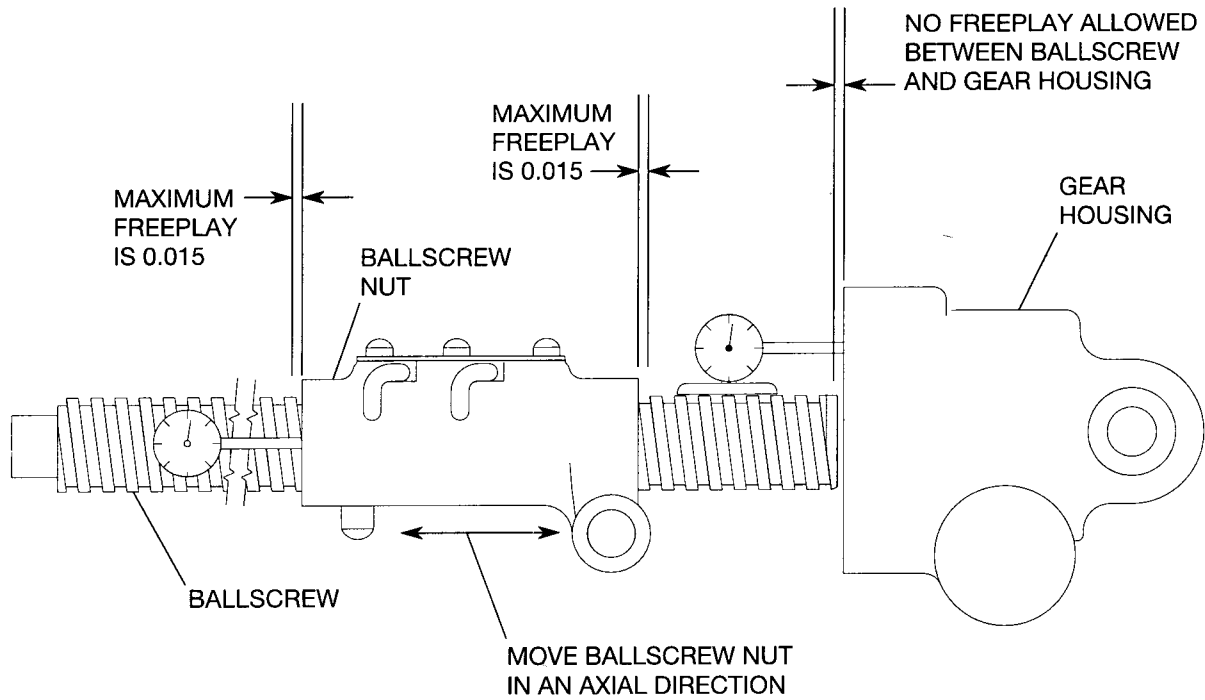
**Figure 602. Actuator Freeplay Check**

- (b) Upon discovery of worn items, replacement is required. If the visual inspection does not reveal any worn items, the applicable actuator(s) must be removed and examined for excessive ballscrew nut freeplay as follows (refer to Figure 602).

**NOTE 2:** RADIAL MOVEMENT OF BALLSCREW NUT IS ACCEPTABLE IF AXIAL FREEPLAY IS WITHIN LIMITS.
