Air Accident Investigation Sector - Final Incident Report -

AAIS Case File 14/2011

Tire Burst during Landing

Boeing 777-300

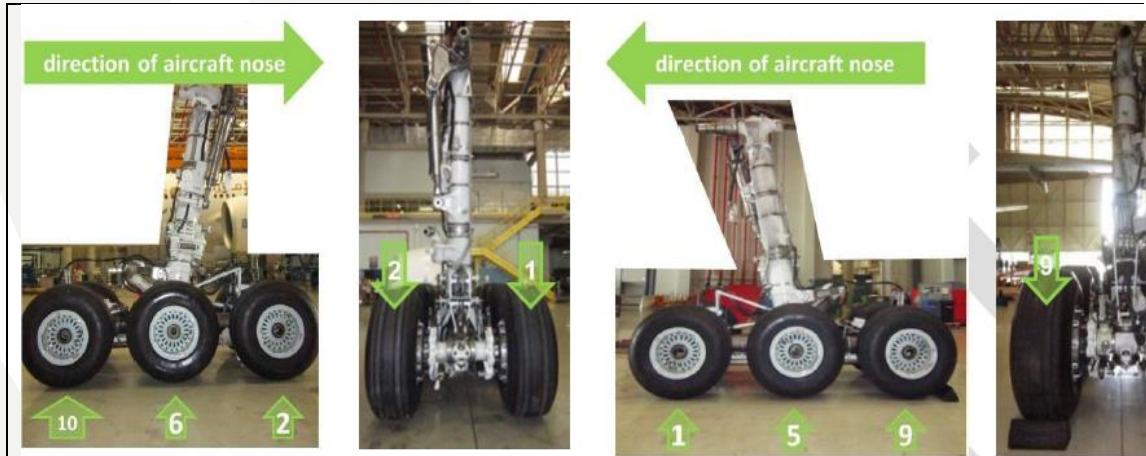
Figure 2. B777 (left) landing gear

For orientation, the tire numbering and position on the B777 can be seen in figure 2. As reported by the ground crew, the left hand (LH) Main Landing Gear (MLG) positions 1 and 2 tires had separated from their hubs, tire position 5 was damaged but still on the hub and both forward (fwd) junction box, J501, and aft

junction box, J503, were missing. All missing parts were later retrieved from the runway.

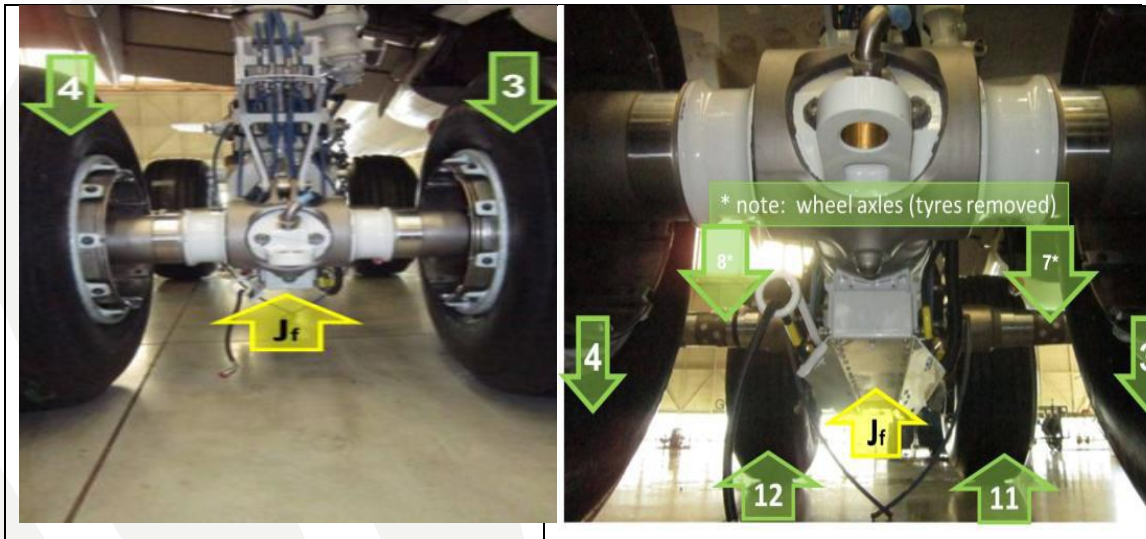
Figure 3. B777 landing gear junction box.

Attached to the underside of the B777 landing gear are two metal containers usually referred to as 'Junction Boxes'. Among the functions of the 'junction boxes' is the control of various aspects of the wheel braking. Junction boxes are attached to the landing gear bogie by a series of metal straps (see figures 3 &4).

Loss or significant damage to the 'junction boxes' can lead to loss or degradation in braking including anti-skid control. The loss of anti-skid control can lead to tire skidding and associated frictional heating.

The manufacturer undertook an examination of all 6 band clamps from the 2 departed J-Boxes. See figure 3 for a photo of the recovered junction boxes. All of the failures were ductile failures, not attributable to fatigue. The failures were consistent with a failure mechanism of excessive standing water on the runway being splashed against the side of the junction boxes and likely overloading the band clamps (particularly the forward- and aft-most clamps).

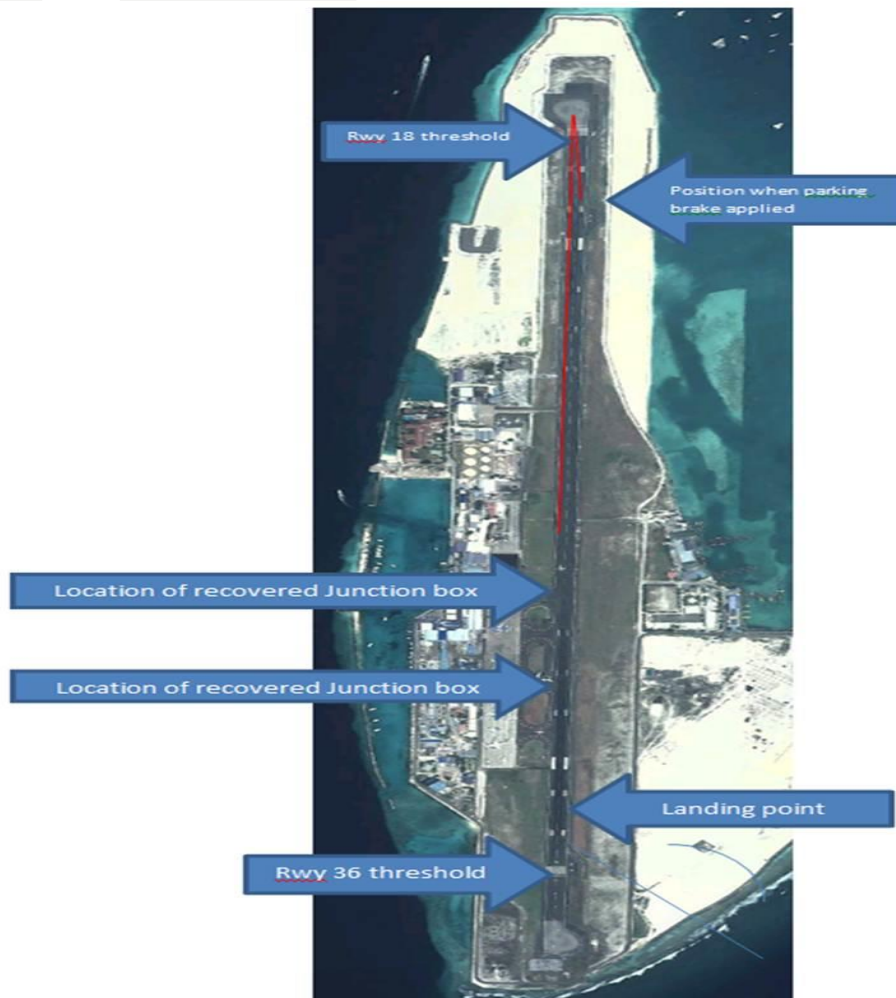
Figure 7. Google Earth image with approximate position of the recovered junction boxes, runway damage and the landing point.

Figure 7 shows the approximate positions of runway damage, the recovered junction boxes and the landing point.
