# **NATIONAL TRANSPORTATION SAFETY BOARD**

## **AIRCRAFT INCIDENT REPORT**

**AEROMEXICO  
DC-10-30, XA-DUH  
OVER LUXEMBOURG, EUROPE  
NOVEMBER 11, 1979**

**NTSB-AAR-80-10**

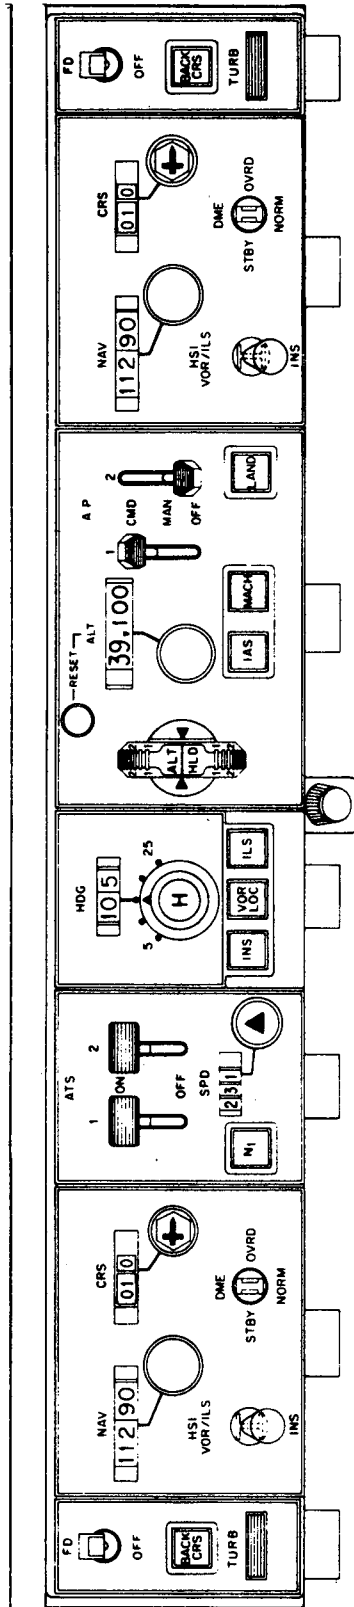
Figure 3.--Flight guidance and control system panel.

The manufacturer recommends that the autopilot "Indicated Airspeed Hold" (IAS Hold) and "Mach Hold" (MACH) modes be used primarily to climb or to descend. The IAS and MACH pushbutton switches are seen on the flight guidance and control panel below the autopilot levers in figure 3. With the autopilot in "CMD," pressing one of these switches commands the autopilot to adjust the pitch of the aircraft to maintain the airspeed or Mach existing when the switch was pressed. The pitch mode window annunciates IAS Hold or Mach Hold depending on which switch is depressed.

The vertical speed selector on the left side of the autopilot levers on the Flight Guidance and Control Panel, figure 3, is synchronized to the aircraft's vertical speed at all times except when the "Vertical Speed" (VERT SPD) or the "Altitude Hold" (ALT HOLD) mode is engaged. When the vertical speed selector is manually rotated to the altitude hold detent, the flight director pitch command bars will move correspondingly and the pitch annunciator will display "ALT HOLD." The vertical speed selector wheel functions as an indicator or as a control. If the altitude hold mode has been engaged, the vertical speed selector wheel will remain in the altitude hold detent and will command "ALT HOLD." If the vertical speed mode has been engaged (either a climb or a descent), the vertical speed selector wheel will remain in the selected position and will command a climb or a descent at the selected rate. When the "IAS Hold" or "Mach Hold" is engaged, the vertical speed selector wheel will automatically synchronize to the velocity of the aircraft.

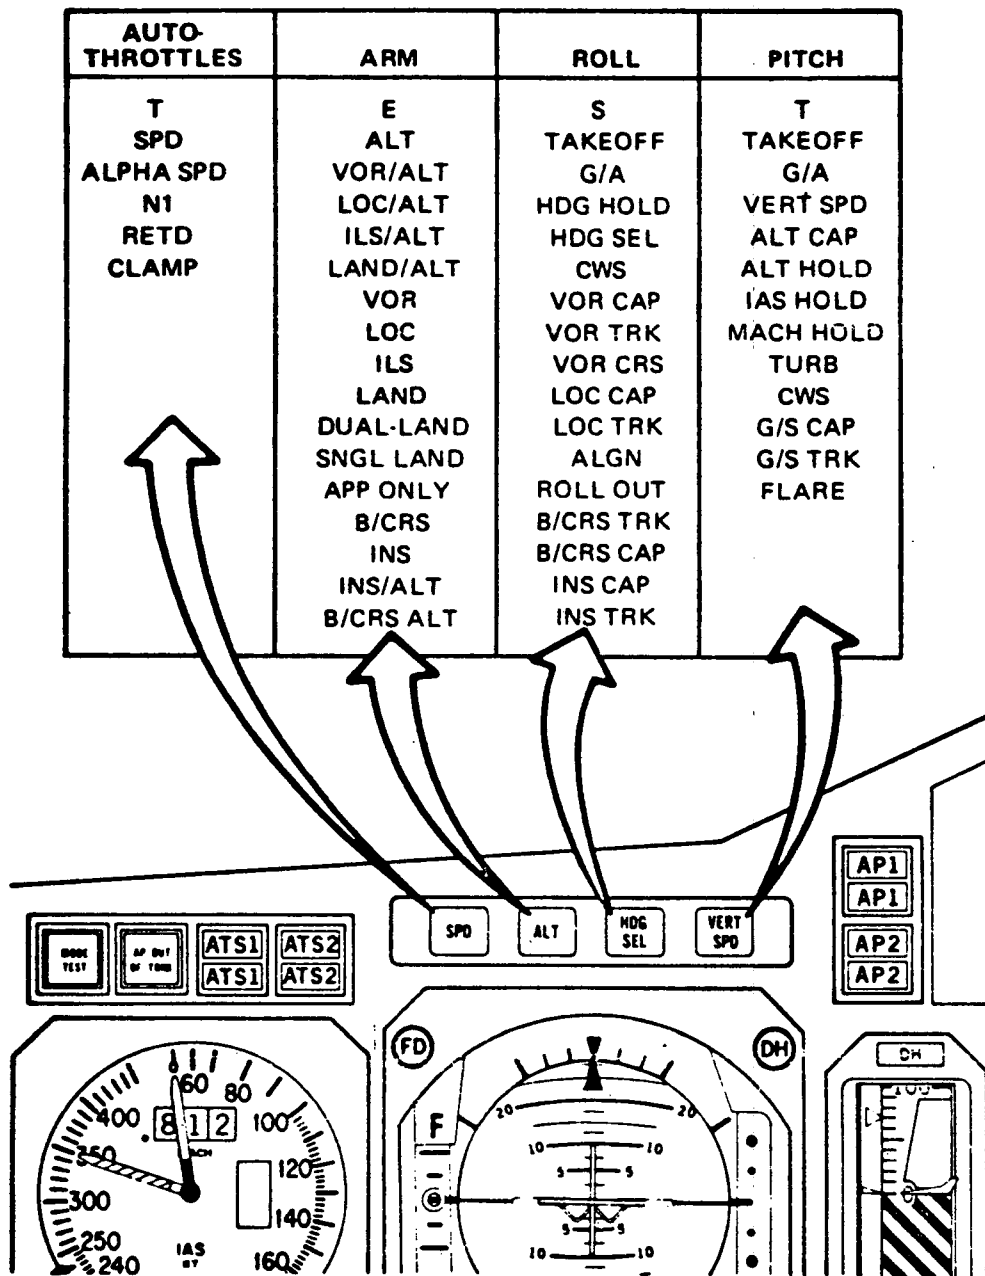
Figure 4.—Mode annunciator panel.

Some airline procedures allow an alternate use of vertical speed mode for the climb. Airspeed must be closely monitored for the vertical speed climb procedure as this FD/AP mode will try to maintain the climb rate programed by the vertical speed wheel, regardless of airspeed or Mach. The autopilot will automatically command the trim and elevator to maintain this rate of climb at the sacrifice of airspeed at the higher altitudes. The flight recorder data for this incident showed a constant rate of climb with continually decreasing airspeed before buffet onset and sustained aircraft stall. A speed selection in the ATS speed readout, if it is in the  $N_1$  mode, would not result in any speed control of the aircraft until the ATS speed mode was engaged. If the ATS speed mode was engaged in the climb, a mode conflict between the FD/AP IAS Hold mode would cause the autopilot to revert to the VERT SPD mode. However, both airspeed and the VERT SPD mode of the FD/AP would be conspicuously annunciated. (See figure 4.)
