PB94-910402  
NTSB/AAR-94/01

## AIRCRAFT ACCIDENT REPORT

RUNWAY DEPARTURE FOLLOWING LANDING  
AMERICAN AIRLINES FLIGHT 102  
McDONNELL DOUGLAS DC-10-30, N139AA  
DALLAS/FORT WORTH INTERNATIONAL AIRPORT, TEXAS  
APRIL 14, 1993

**Abstract:** This report explains the runway departure of American Airlines flight 102, a DC-10-30, after landing at Dallas/Fort Worth International Airport, Texas, on April 14, 1993. The safety issues discussed in the report include weather conditions affecting the flight, flightcrew and air traffic control training and procedures, airplane emergency evacuation lighting, and runway maintenance. Recommendations concerning these issues were made to the Federal Aviation Administration, Dallas/Fort Worth International Airport, and American Airlines, Inc.

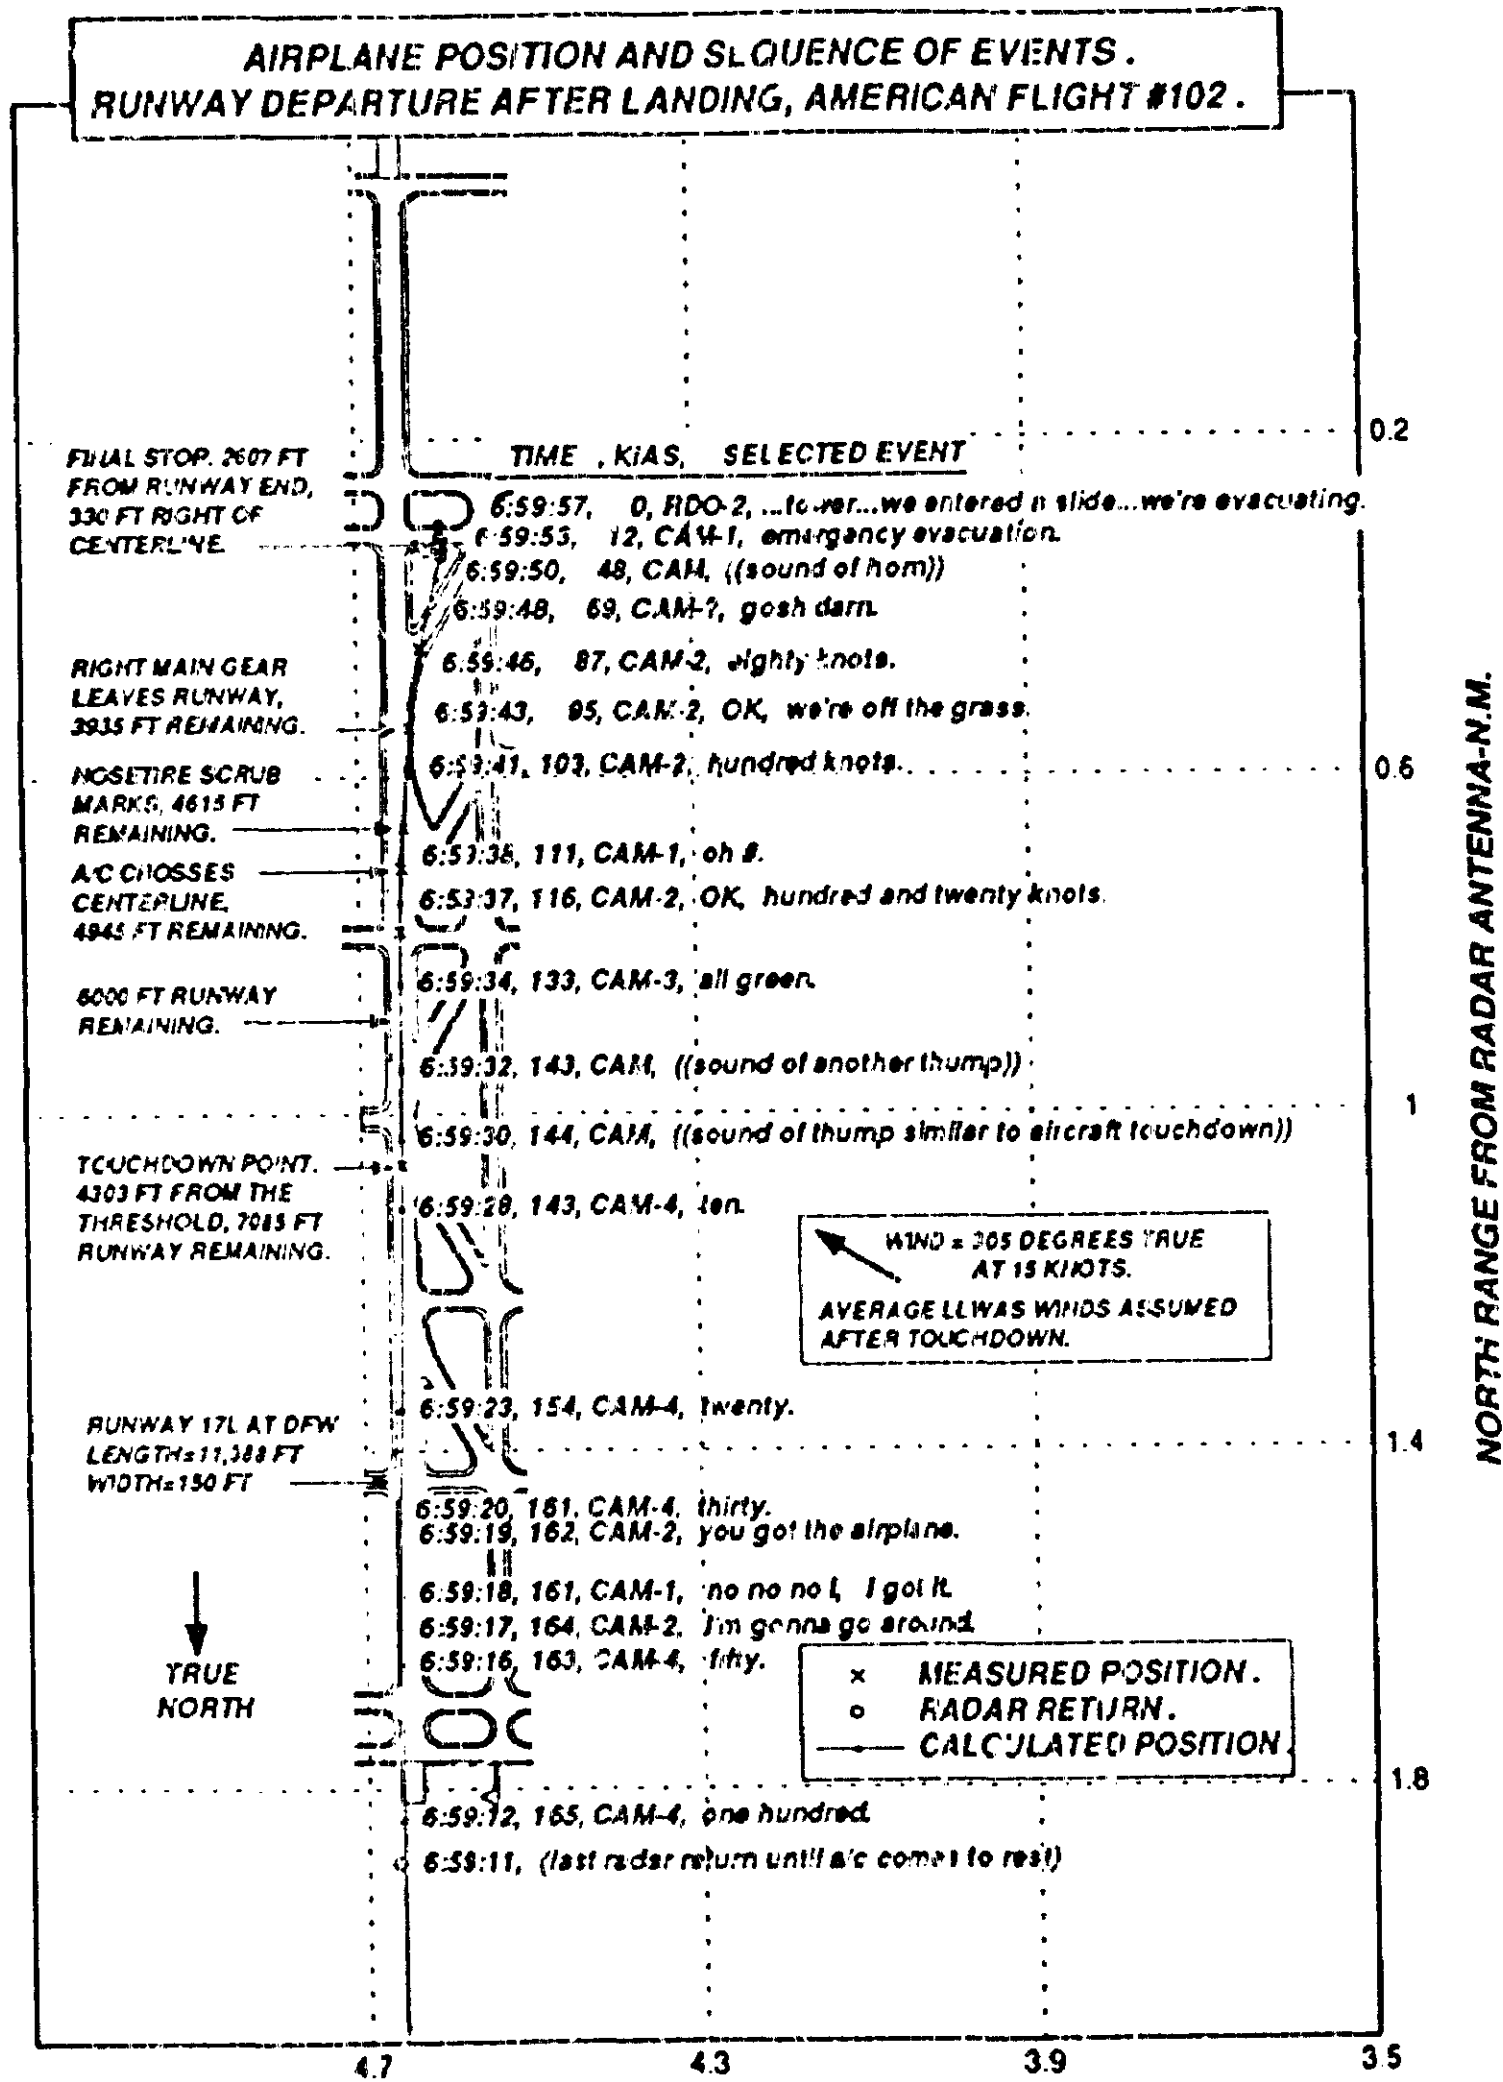
Investigators examined the landing runway after the accident and found three long sets of lightly shaded tire traces that paralleled the centerline but then angled to the right and departed the runway. The tracks from the right main landing gear continued as furrows in the soil.

Then the airplane traveled across high speed taxiway 3S before returning to the soft soil. The airplane came to rest, upright, about 2,607 feet from the departure end of 17L and about 250 feet from the right edge of the runway, with the nose on perpendicular taxiway 31. (See figures 2, 3 and 4).

The first tire marks found on the runway were traced to the left and right main landing gear, and started at 4,303 feet from the beginning of the runway. The tracks approximately paralleled the runway centerline for about 1,700 feet, then turned gradually to the right until they departed the runway.

Figure 2.--Approach and landing.  
History of airplane motion and events.

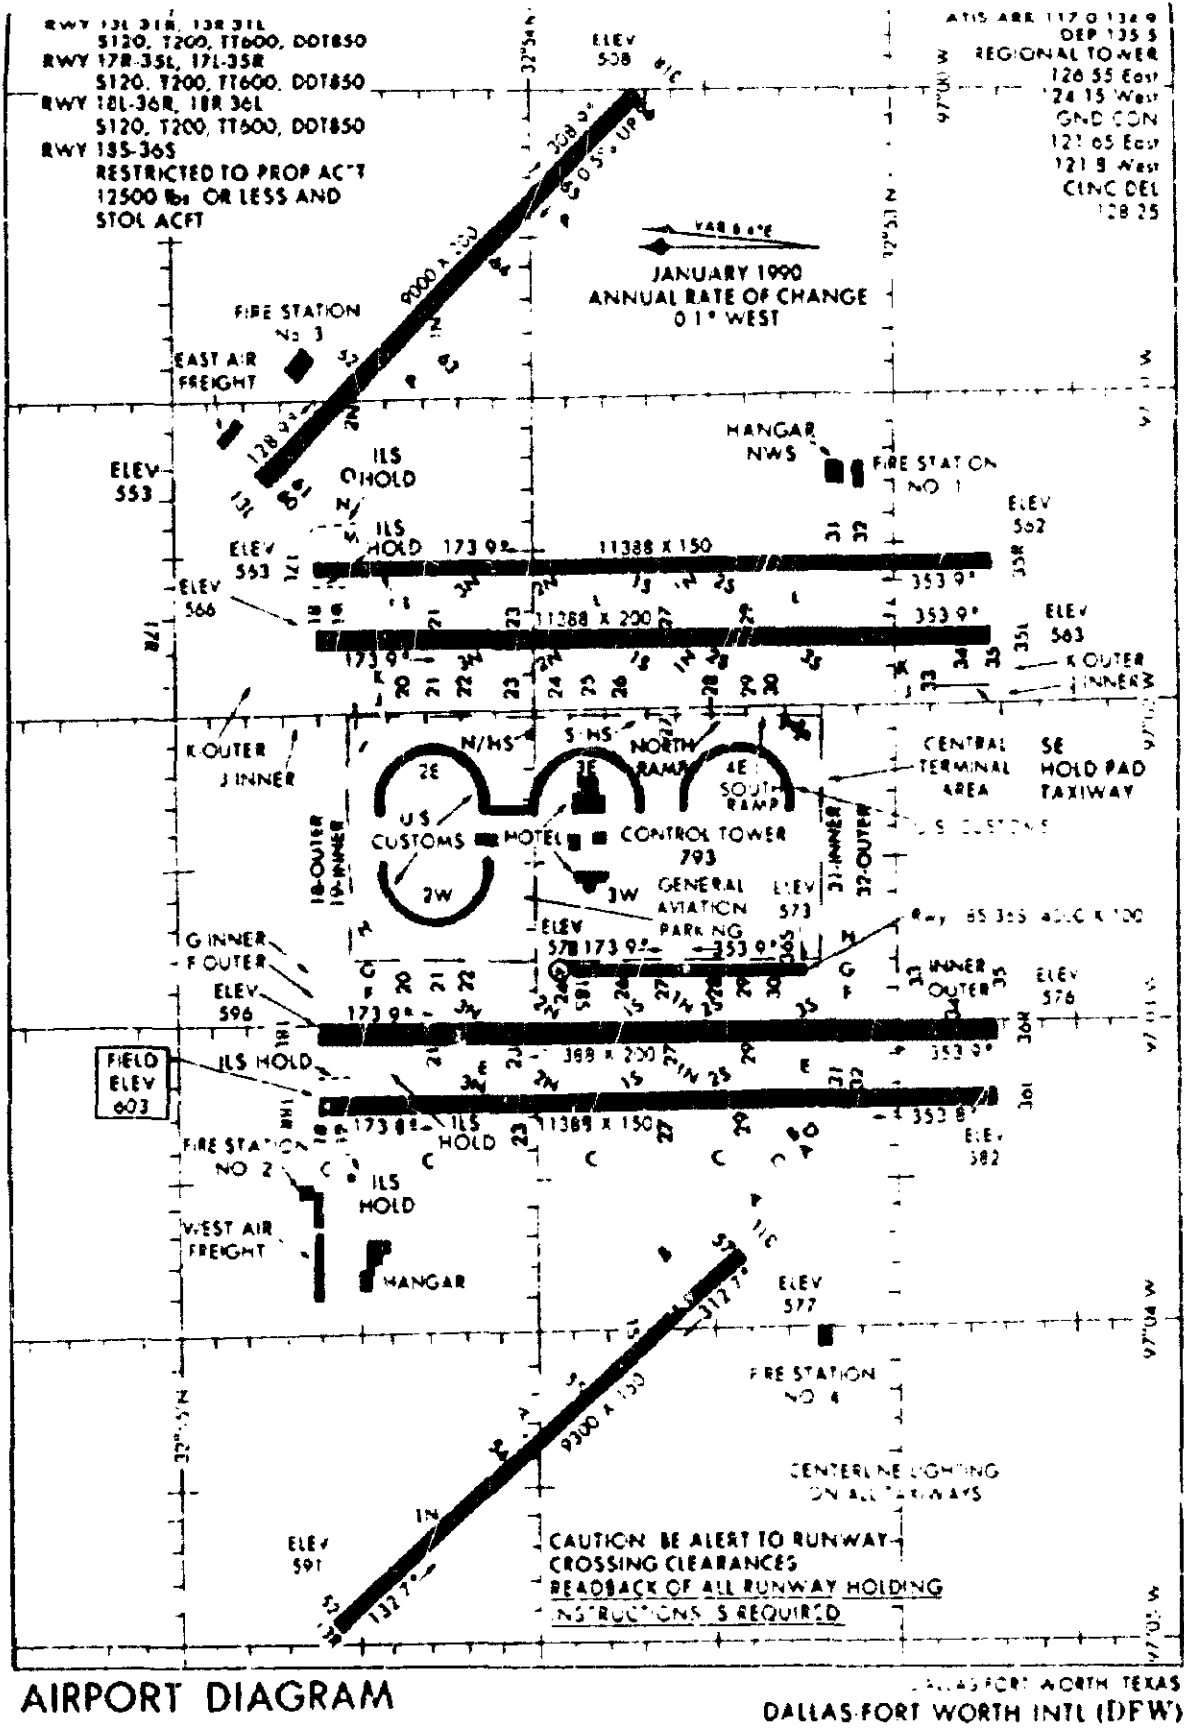
Runway 17L-35R was designed and constructed in accordance with FAA advisory circulars (ACs) and specifications. The runway is constructed of reinforced Portland cement concrete pavement with 35-foot-wide asphalt concrete shoulders. The pavement has a crowned section of 1.0-percent cross slope on the runway, a 2.0-percent cross slope on the paved shoulders, with a 1.5-inch vertical drop at the outside edge of the shoulder pavement. 17L has a negative 0.18-percent gradient constant throughout its length, and the concrete pavement is grooved transversely 130 feet wide, across the runway's entire length. The grooves are 1/4 inch deep and 1/4 inch wide, and are spaced approximately 1 1/2 inches apart.

Following the accident involving AAL102, investigators worked with the FAA friction program manager in conducting coefficient of friction tests on runway 17L-35R, using the airport's Saab friction test vehicle. Initial erroneous data results were followed by minor repairs to the equipment. Subsequent data, taken on April 16, 1993, found that the friction levels on runway 17L-35R were in the .60 to .65 range with the test vehicle traveling on the runway at 40 miles per hour. Friction tests, taken with the vehicle at 60 miles per hour, revealed friction levels in the range

Figure 6.--Airport diagram.

of .52 to .57.<sup>9</sup> Friction values in these ranges fell within the area of "maintenance planning."<sup>10</sup>

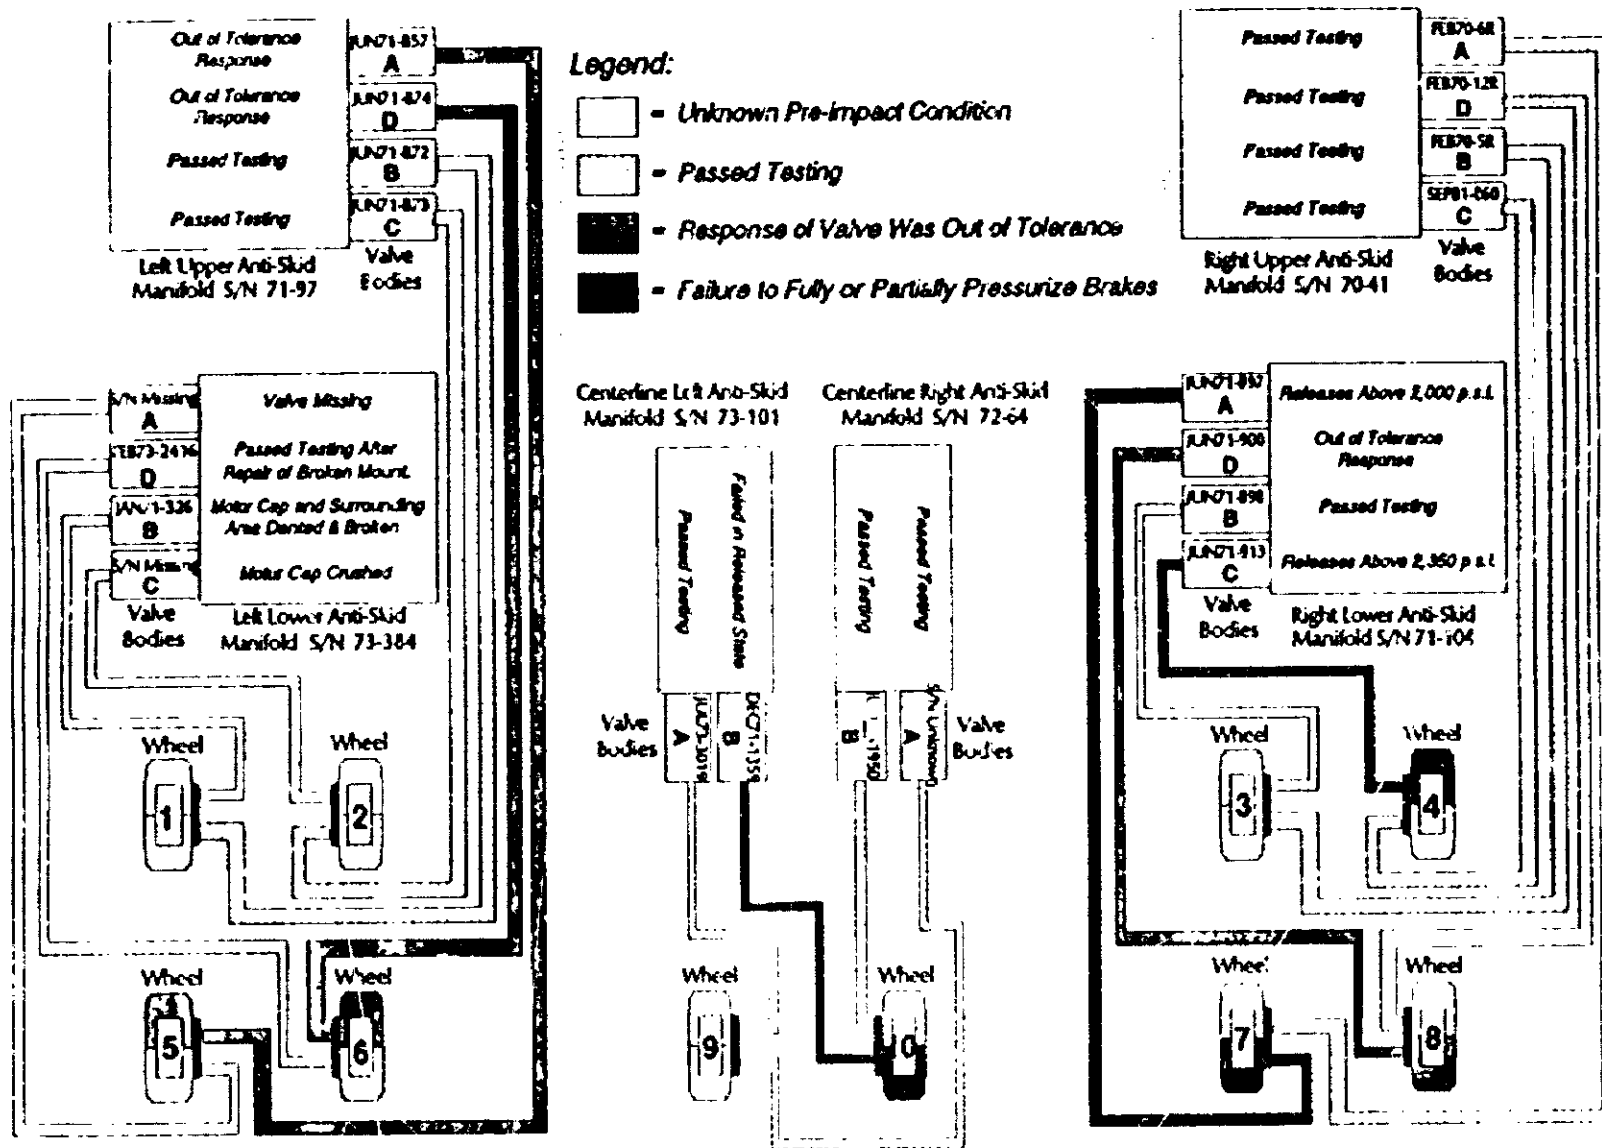
### DC-10 ANTI-SKID SYSTEM FINDINGS

As described in the operator's DC-10 Maintenance Manual, the accident airplane was equipped with 20 antiskid pressure control valves, mounted in six manifolds. Two valves led to the brake assembly at each wheel. Testing revealed that 16 of the valves responded to electrical signal applications, signal step changes, and signal releases. One valve was found to be inoperative, and three had damaged or missing valve motor caps that prevented testing. Five of the 16 valves that responded were found out of tolerance. (Reference diagram of brake manifold system, figure 8).

<sup>14</sup>The manufacturer of the brakes, ABSC, issued a March 15, 1979, Service Letter (DC-10-10-SL-9 and DC-10-30/40-SL-8) stating that antiskid built-in test equipment (BITE) could be used to identify an inappropriate valve circuit malfunction. The manufacturer noted that loss of a wire could diminish pressure release to the associated half of a wheel brake on the affected main landing gear (left, centerline, or right).

Figure 8.--Brake manifold system.

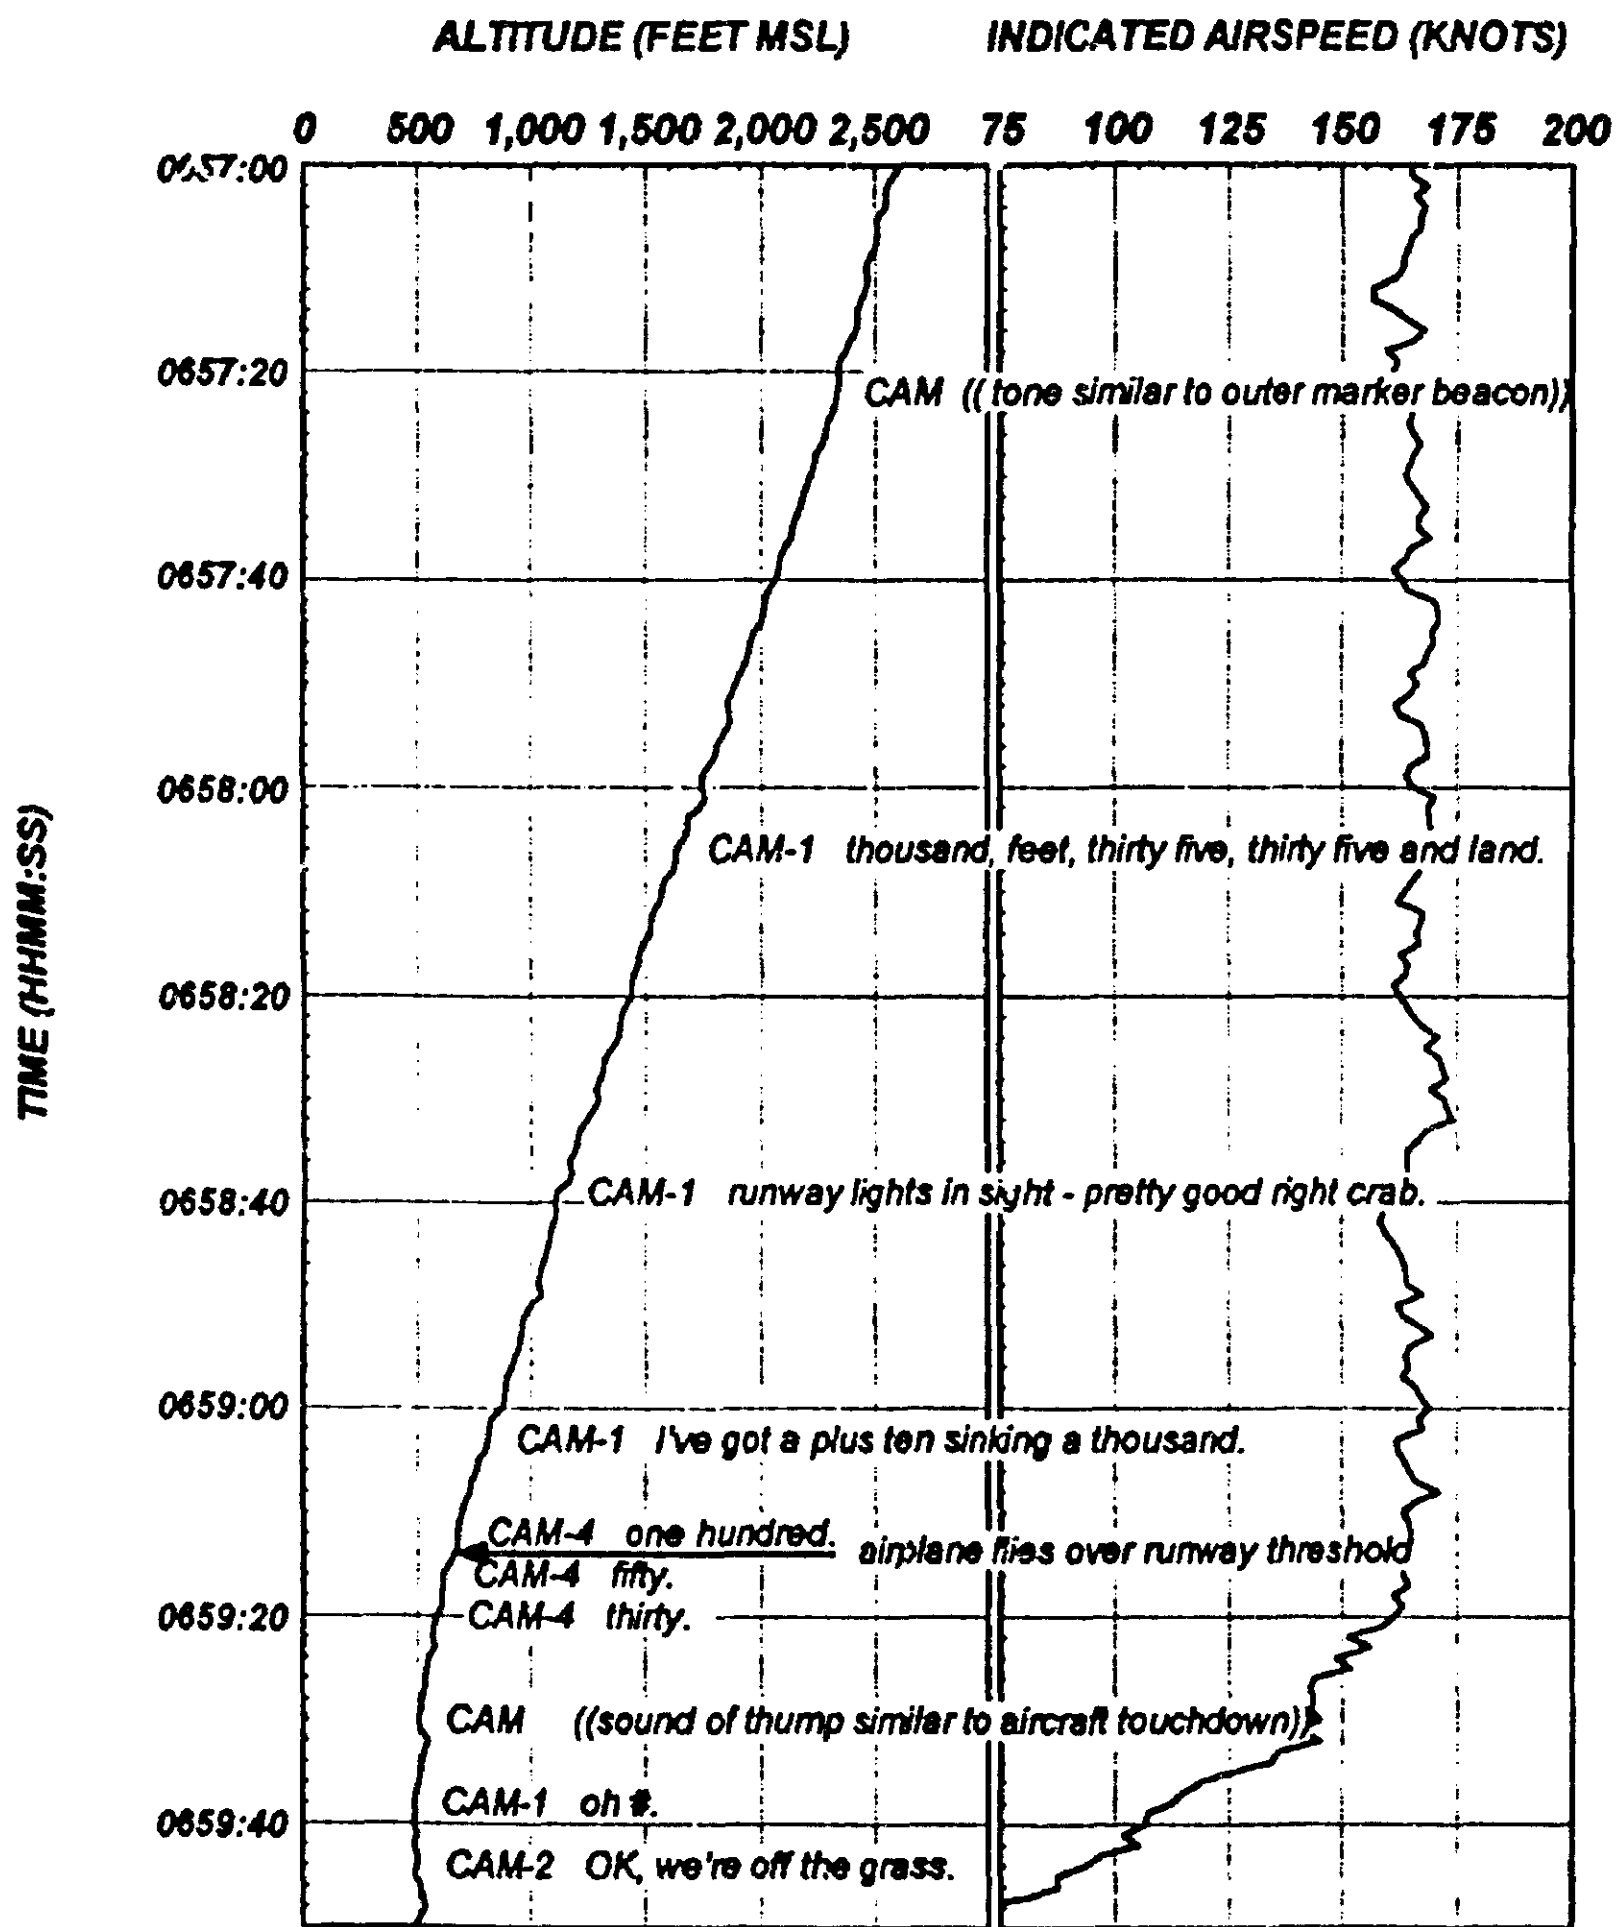
Data from ATC radar, weather, CVR, FDR, and information from the examination of the aircraft wreckage and the accident runway were used to develop a time history of the accident flight's motion during the approach and landing. (See figure 10 for airspeeds and altitudes during the landing sequence). Calculations were made of the crosswind component during the final 2 1/2 minutes before landing. A composite plot was developed that shows, in a graphical format, the flight control positions and airplane headings when key events occurred during the landing sequence. (See figures 11a and 11b).

Figure 10.--Airplane airspeeds and altitudes versus time.

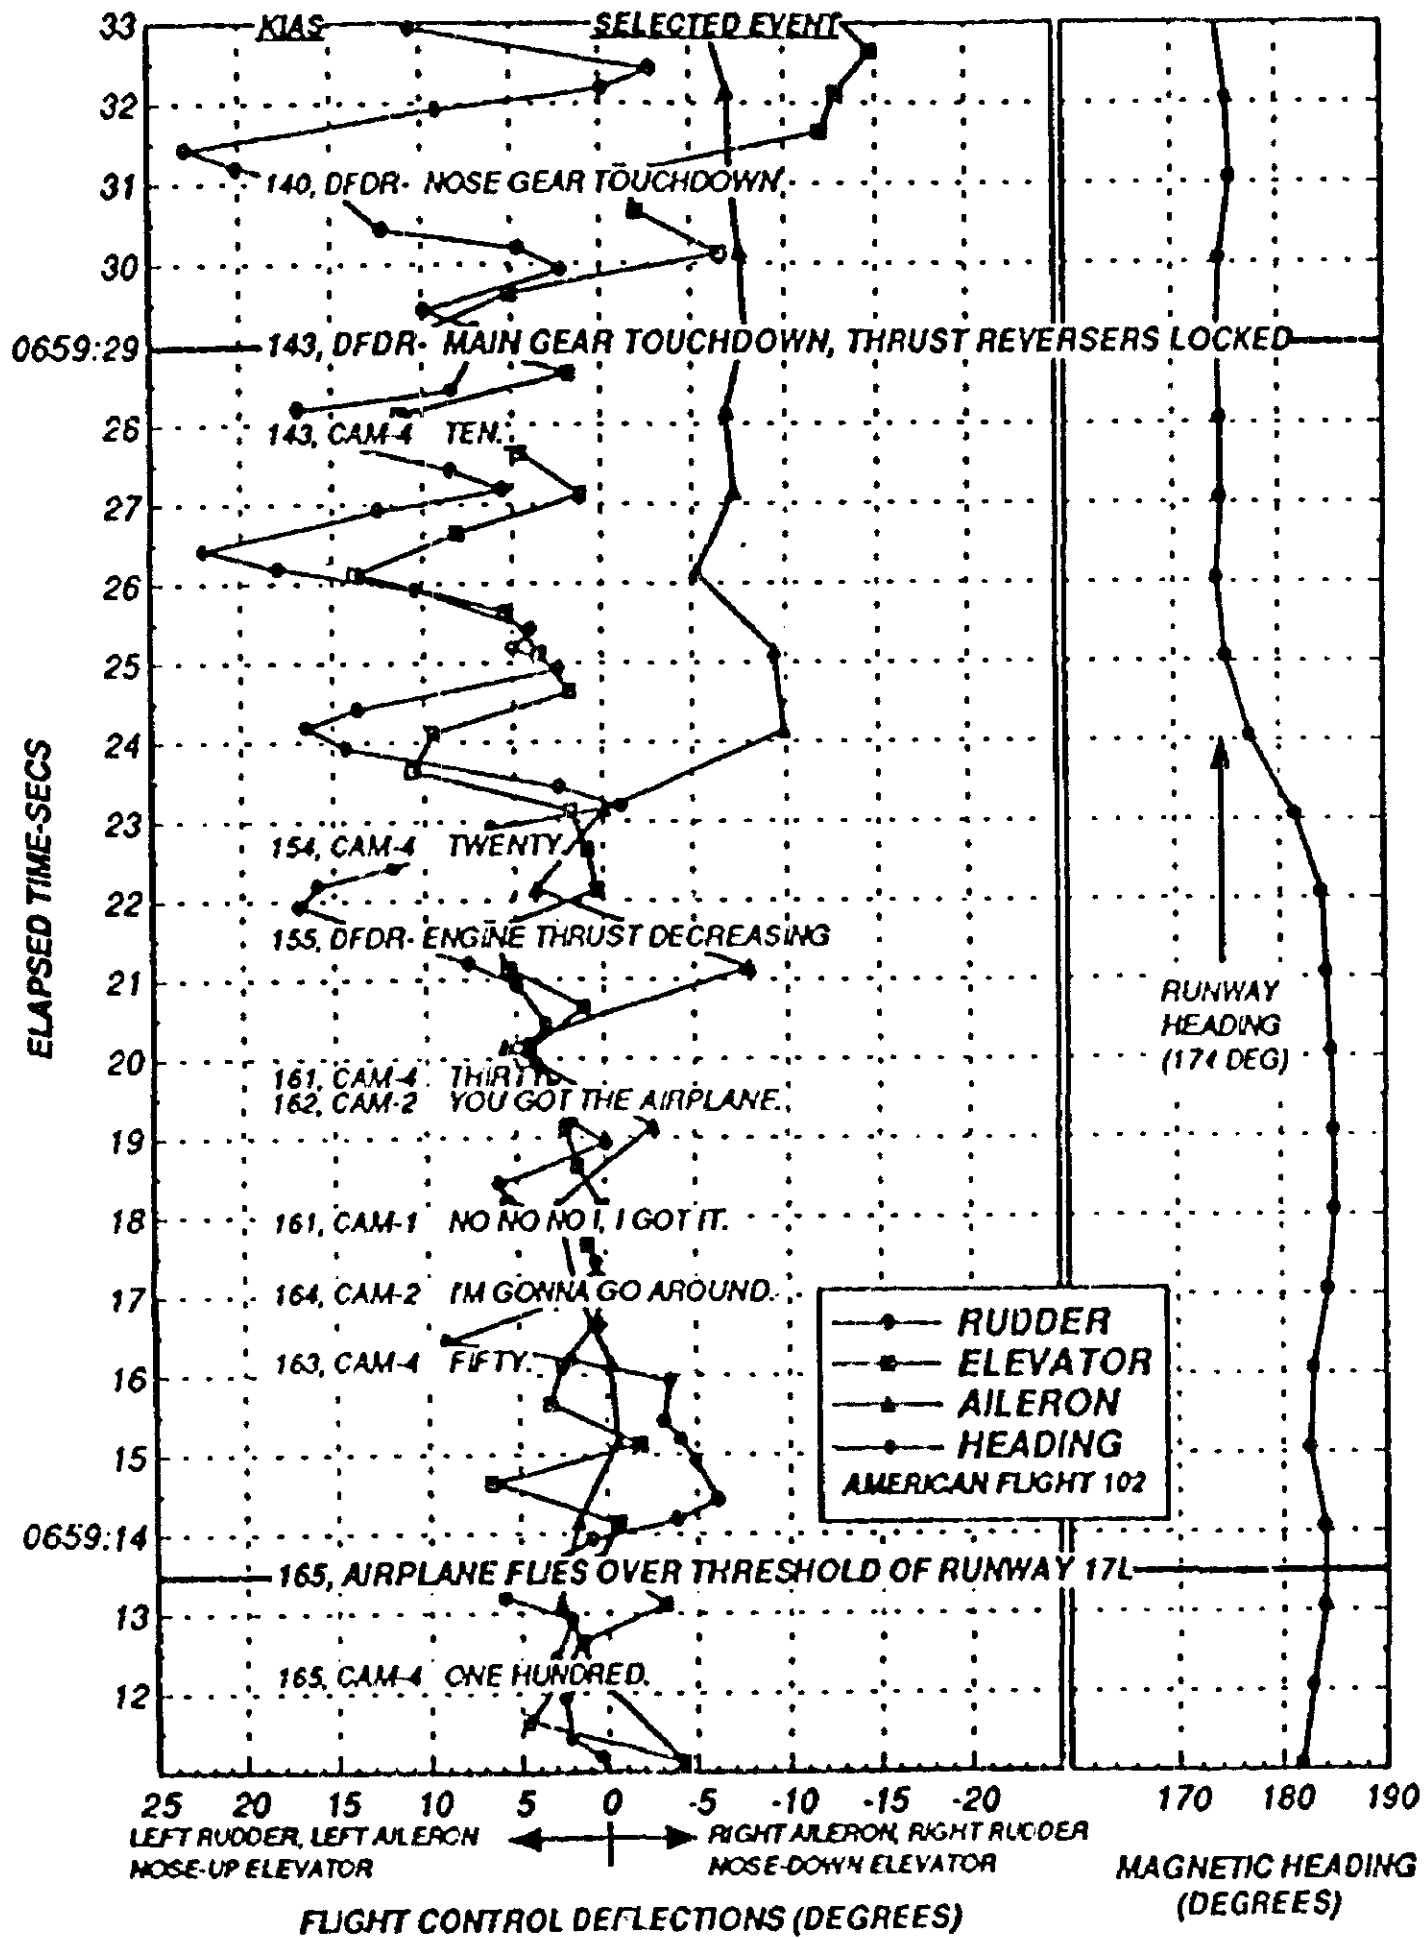
Figure 11a.--Flight control positions and airplane headings during landing sequence.

Prior to touchdown, the airplane transitioned from a 10-degree right crab to a 2-degree right-wing-down (RWD) roll and a 10-degree airplane-nose-left (ANL) rudder deflection. The data show that the airplane touched down at 0659:29 and tracked near the centerline of 17L for about 8 seconds, averaging an 8-degree ANL rudder deflection. During the 8 seconds after touchdown, the airplane decelerated to 116 knots indicated airspeed (KIAS), while the rudder was deflected on average about 8 degrees ANL, the aileron position averaged 5 degree RWD, and the elevator averaged 7 degrees airplane nose down (AND).

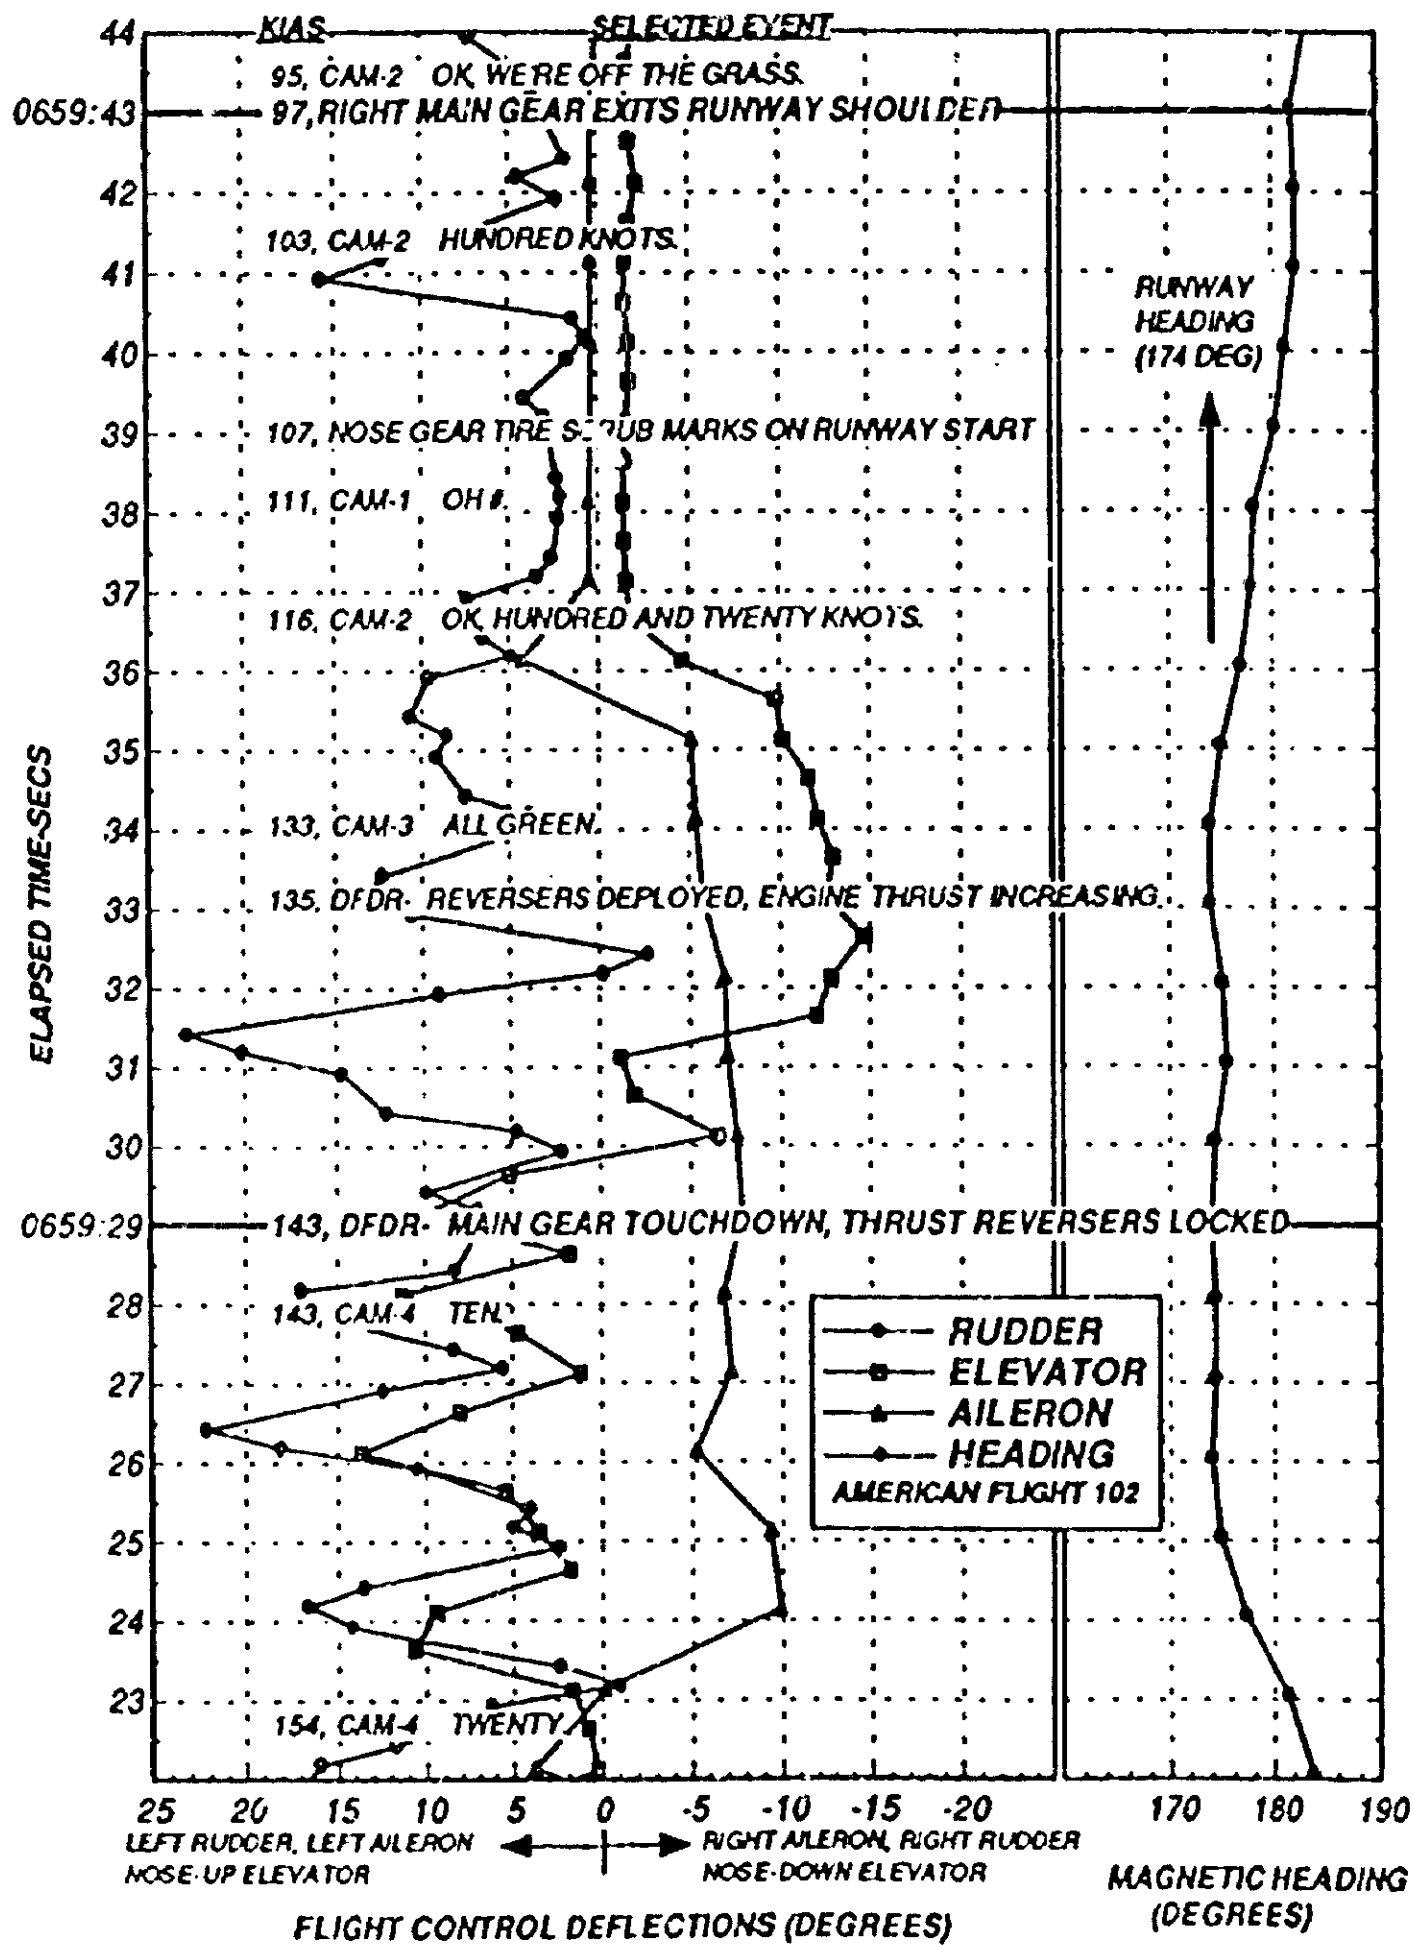
Figure 11b.--Flight control positions and airplane headings during landing sequence.
