## AIRCRAFT ACCIDENT REPORT

CRASH DURING EMERGENCY LANDING  
PHOENIX AIR  
LEARJET 35A, N521PA  
FRESNO, CALIFORNIA  
DECEMBER 14, 1994

**Abstract:** This report explains the accident involving the Phoenix Air Learjet 35A that crashed while attempting an emergency landing at Fresno Air Terminal, Fresno, California, on December 14, 1994. Safety issues in the report focused on maintenance, inspection and quality assurance. Safety recommendations concerning these issues were made to the Federal Aviation Administration, Phoenix Air, and the Department of Defense.

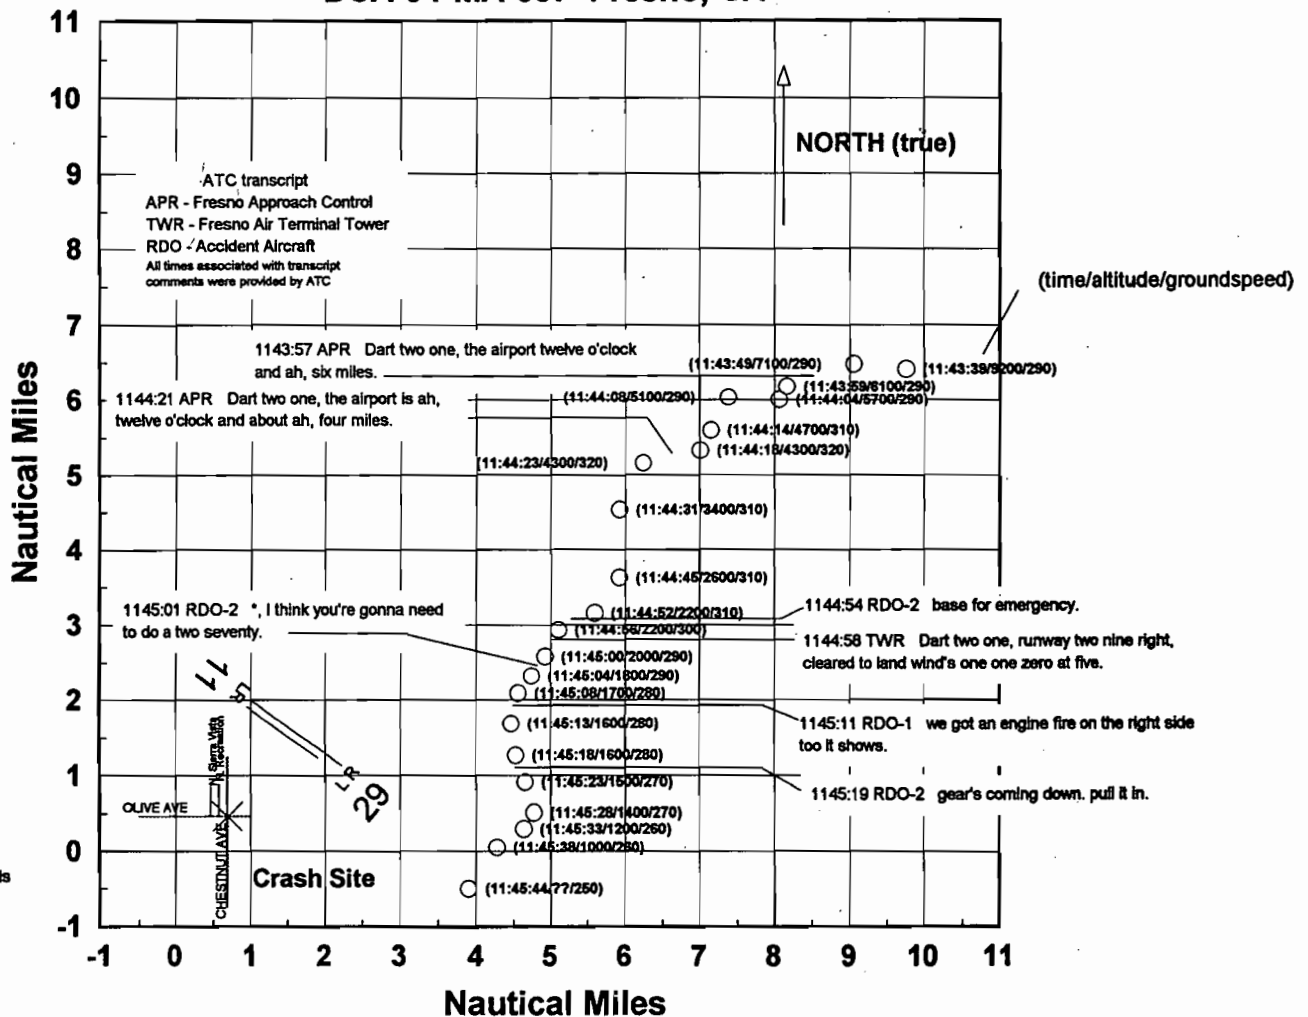
Figure 1a.--Ground track.

About 1145:01, as Dart 21 was about 3 miles east-northeast of the approach end of 29R, on a track toward the southwest (see ground track and flight profile, from NAS Lemoore radar data and Fresno tower radio transmissions, figures 1a through 1c), the first officer stated, "I think you're gonna need to do a two seventy." At 1145:11, the captain stated, "we got an engine fire on the right side too, it shows." Radar data show that the airplane was flying at 280 knots ground speed, about 1,600 feet msl (the field elevation of FAT is 333 feet msl).
