Report EXT Punta Cana 2009

Accident involving an Airbus
330-343 aircraft, registration
EC-JHP, in Punta Cana
International Airport
(República Dominicana),
operated by Iberworld (Orbest),
on 18 January 2009

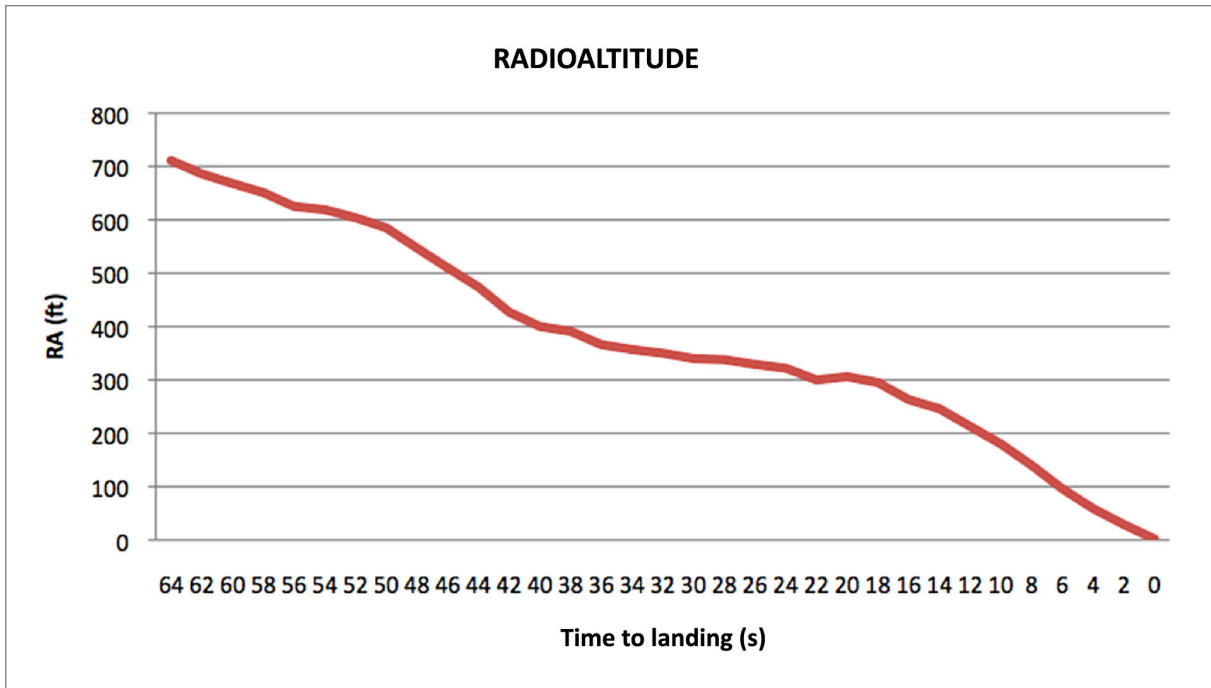
Figure 8. Descent profile

- The graphs in Figures 8 and 9 show the radio-altimeter and vertical speed for the descent phase that took place between the minimums and the touchdown. The descent rate graph shows that this rate reached a peak value of 21 ft/s (1,260 ft/min), decreasing to 14 ft/s (840 ft/min) during the flare.

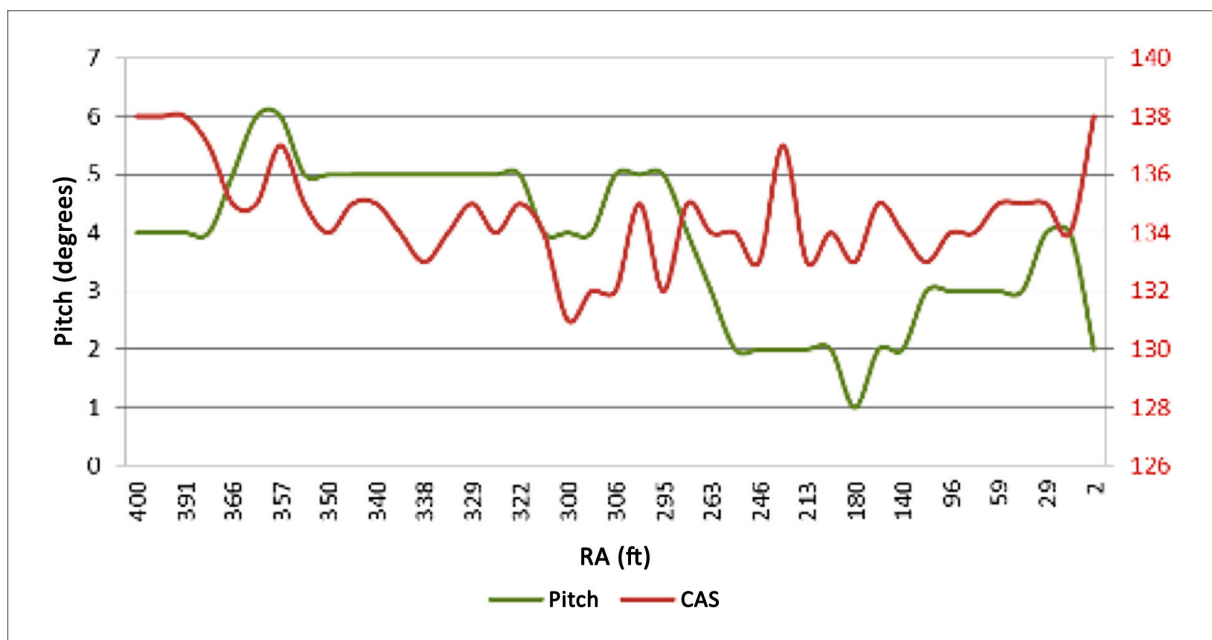
Figure 10. Pitch and CAS

- The aircraft's airspeed (CAS ADC) was 134 kt with slight variations. The pitch angle hovered around 5° , not exceeding 6° , dropping from those values on short final. Figure 10 shows the values for the aircraft's pitch angle and airspeed after 400 ft RA.

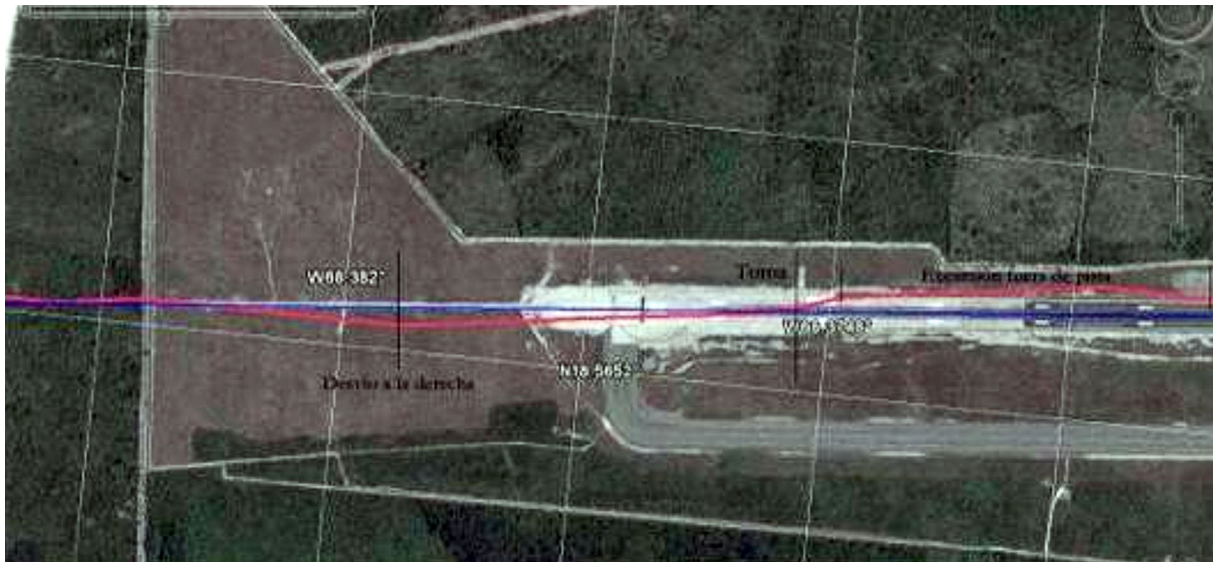
Figure 13. Representation of the approach path and landing based on DFDR coordinates

When it first made contact with the ground, the aircraft was oriented 3° right of the runway centerline and the flight path was 2° left with respect to the runway centerline, meaning that the aircraft's slip angle was 5°.
