DUTCH
SAFETY BOARD

Quarterly Aviation Report

July - September 2018

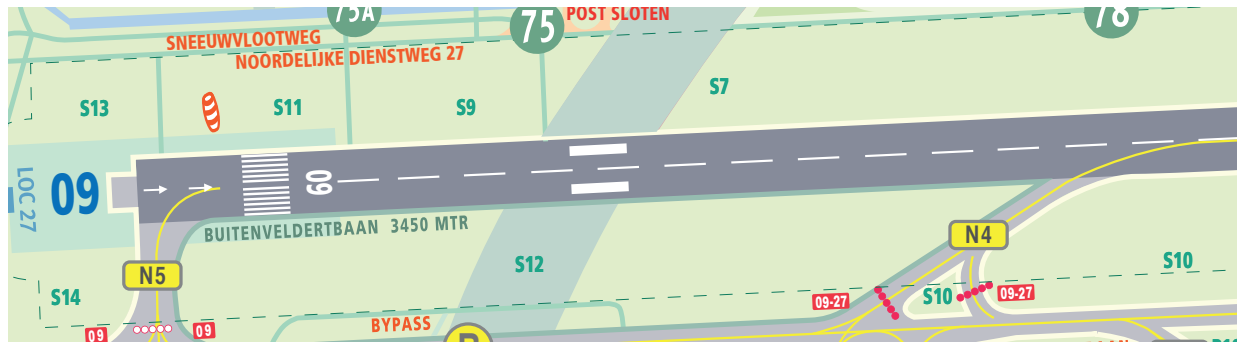
The pilots of the Boeing 737 calculated their take-off speeds and the necessary engine power on the basis of the assumption that they would take off from Runway 09 at Intersection N5. The take-off position was subsequently changed to Intersection N4, reducing the available take-off distance, but the data for the performance calculations were not adjusted. The Boeing 737 then took off from Runway 09 at Intersection N4. The aircraft was rotated at the calculated rotation speed and left the ground only just before the end of the runway.

Runway 09 with Intersections N4 and N5. (Source: Standard Map of Amsterdam Airport Schiphol)

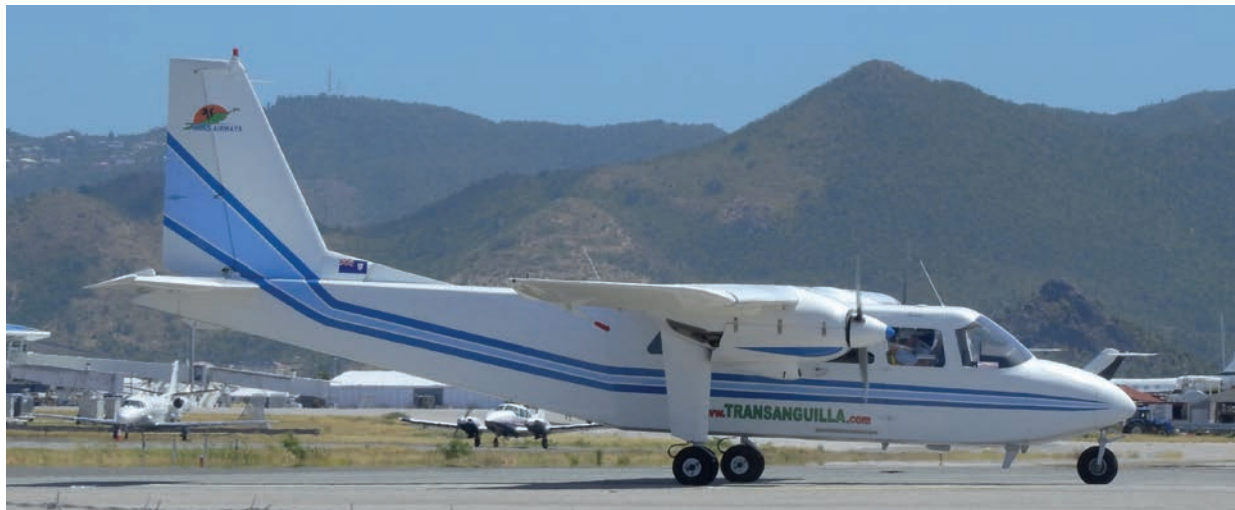
The Britten-Norman Islander took off from Sint Eustatius (in the Netherlands Antilles) in the Caribbean for a flight to neighbouring Saint Kitts and Nevis, part of the British Commonwealth. During the approach to Robert L. Bradshaw Airport, the crew experienced issues with control of the ailerons. An inspection after landing revealed that the control rod for one of the ailerons was broken.

Britten-Norman BN-2B-21 Islander. (Source: J. Allen)

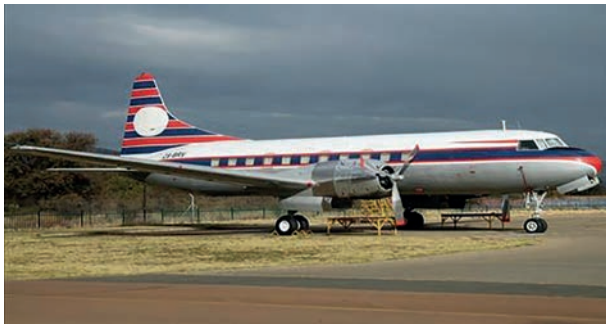
Archive photo of Convair. (Source: South African AIID)

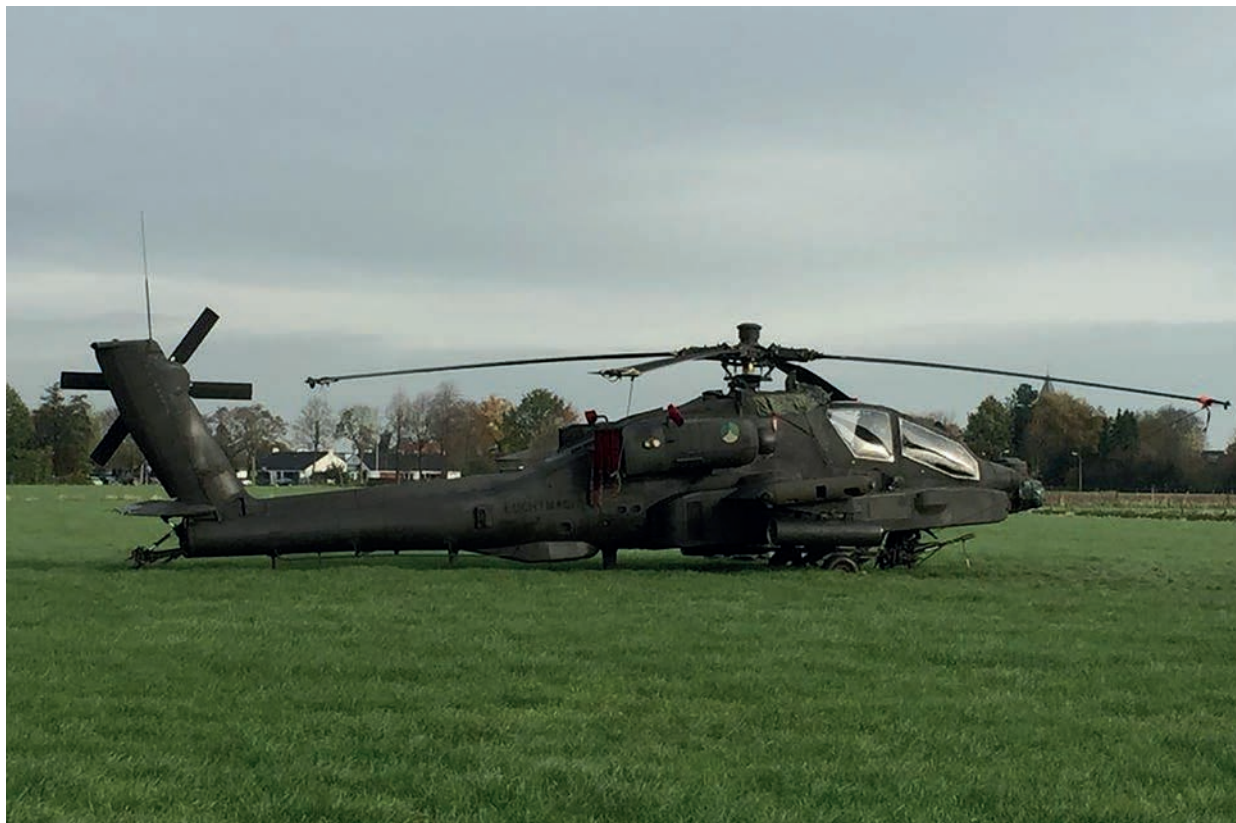
On 13 November 2017, a night flying exercise took place with an Apache-type helicopter (AH-64D) from Defence Helicopter Command (DHC) in the vicinity of Zoelmond. During an evasive manoeuvre, the helicopter made contact with the top wire of a high-voltage power line, the earth wire, which caused a short circuit in the power grid. This situation led to a power cut in the vicinity of the incident, in which approximately 25,000 households were without power for several hours. The helicopter landed in a meadow immediately to the north of the location of the wire strike.

Apache AH-64D.

The Dutch Safety Board made three recommendations to the minister of Defence for options to avoid wire strikes, the availability of flight hours and the use of flight charts.

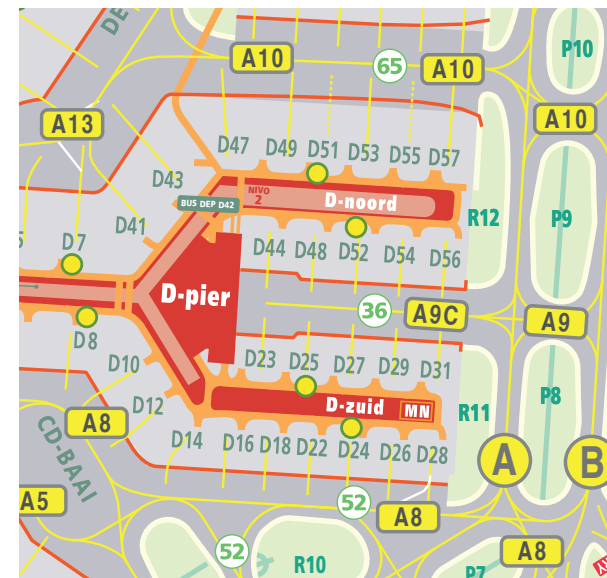
LVNL's investigation report showed that the ground controller involved had not noticed the conflict between the Boeing taxiing to D54 and the Embraer being pushed back. This was partly due to the complexity of the volume of traffic, in combination with the maintenance work on Runway 06-24 and the use of different taxi routes than normal. The analysis also revealed that the occurrence took place due to insufficient collaboration among the ground controllers.

Intersection A9 and the parking spaces around Pier D.
(Source: Standard Map of Amsterdam Airport Schiphol)
