**KOMITE NASIONAL KESELAMATAN TRANSPORTASI
REPUBLIC OF INDONESIA**

Aircraft Accident Investigation Report

PT. Wings Abadi Airlines

ATR 72-212A; PK-WGW

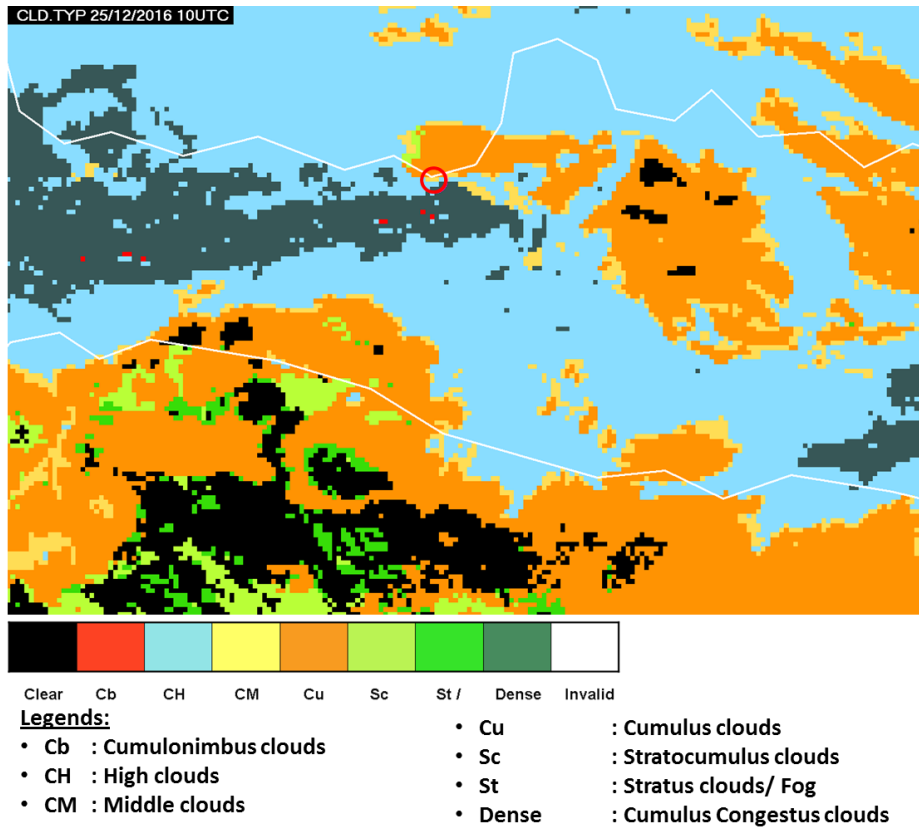
Figure 4: Satellite image at 1000 UTC (Copyright of BMKG)

The following satellite images were provided by *Badan Meteorologi Klimatologi dan Geofisika* (BMKG – Bureau of Meteorology, Climatology and Geophysics) at 1000 UTC, 1100 UTC and 1200 UTC. The images indicated development of Cumulus Congestus clouds (towering cumulus) around Semarang during the accident flight (red circle). The cloud was classified as low clouds which may produce precipitation and often release abundant rain in the form of showers⁷.

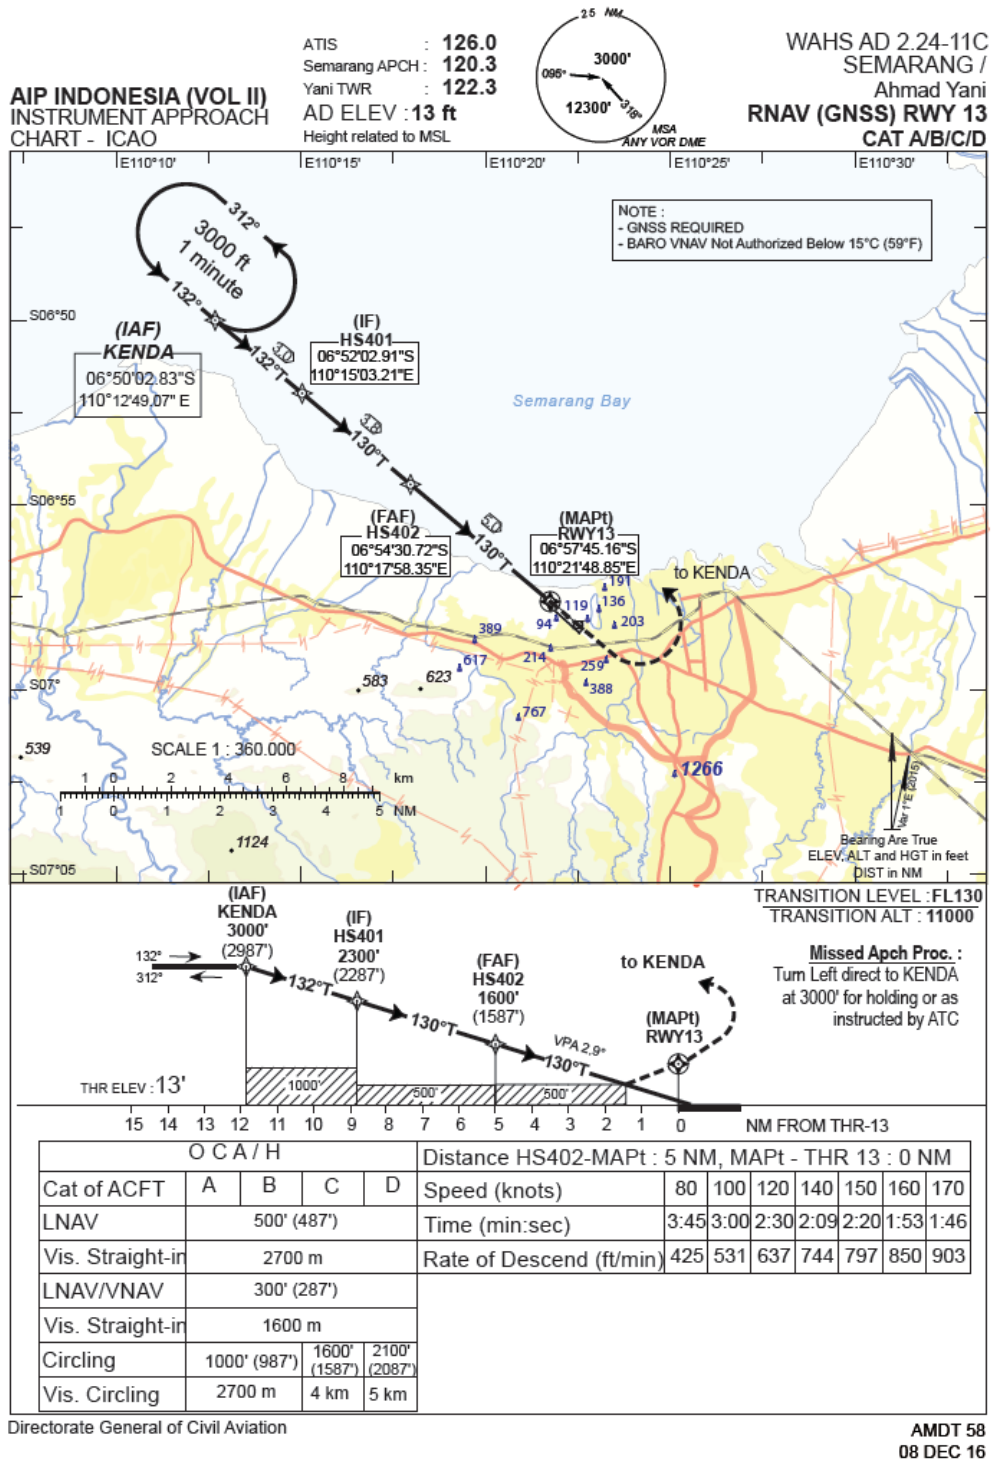
Figure 7: The GNSS approach chart published in AIP Volume II

Runway 13 of Semarang has Performance Based Navigation (PBN) approach guidance facilities which utilized RNAV (GNSS) approach. The instrument approach chart provided by Directorate General of Civil Aviation on Aeronautical Information Publication (AIP) Volume II showed on the following figure.
