PRELIMINARY
KNKT.15.12.28.04

Aircraft Accident Investigation Report

**PT. KalStar Aviation
Embraer 190-200LR; PK-KDC
El Tari Airport
Kupang, Nusa Tenggara Timur
Republic of Indonesia
21 December 2015**

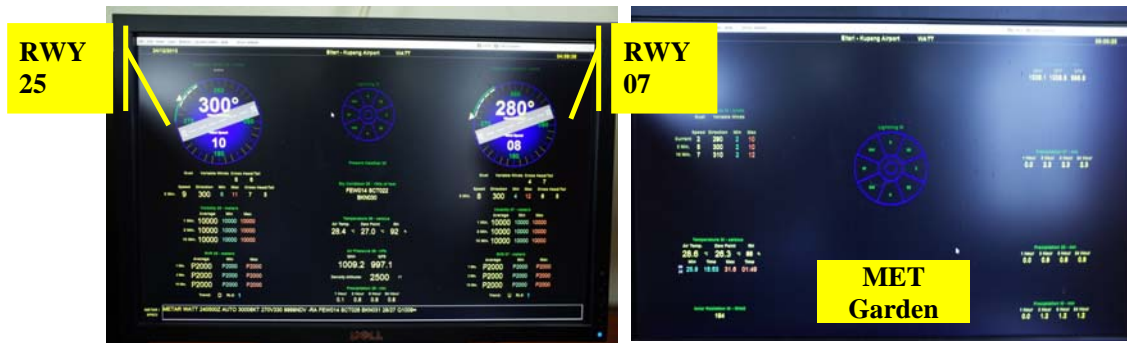
Figure 3: The display of AWOS

Kupang Meteorological Station utilized Automated Weather Observation System (AWOS) with three different displays from three different sensor locations. The first sensor located at touchdown area runway 07 – approximately 130 meters on the left of runway 07 centerline and approximately 400 meters from beginning runway 07. The second sensor located at touchdown area runway 25 – approximately 98 meters on the right of runway 25 centerline and approximately 350 meters from beginning runway 25. The third sensor located near the tower building named MET Garden.

The AWOS information displayed in Meteorology Station office and also in El Tari Tower station. The display showed information according to its sensor location, which were labeled 07, 25 and M (figure 3).

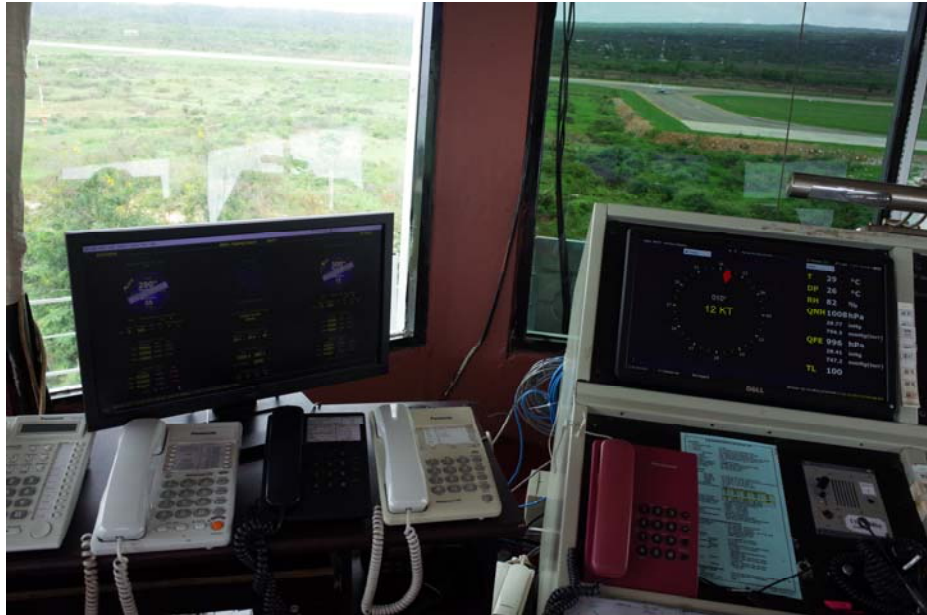
Figure 4: AWOS display (left) and Tower Set display (right)

On 1 December 2015, the AirNav Office District Kupang as a unit providing Air Traffic Services at Kupang installed a new tower set display to provide meteorological information. The display provides information of wind, temperature, dew point, QNH and QFE.

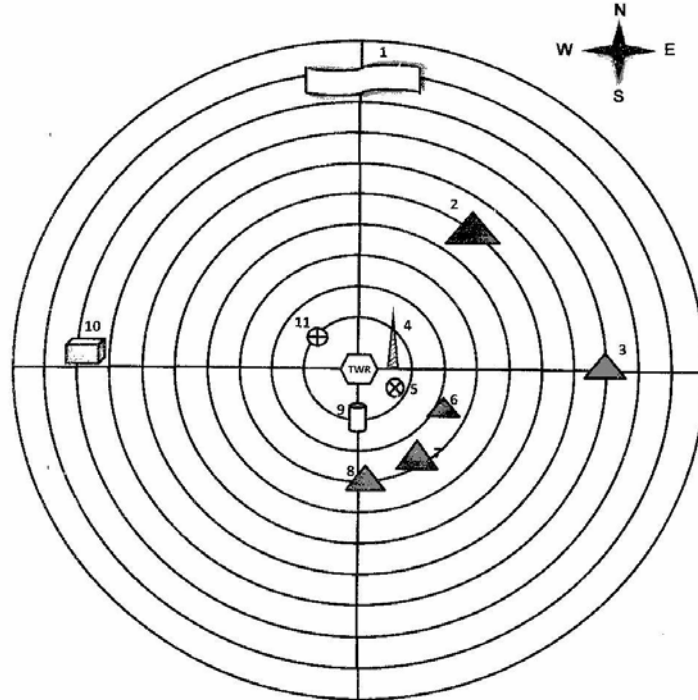
VISIBILITY CHART

Based on interview of the ATC on duty, the visibility chart is used to compare the information on the AWOS display with the actual condition from ATC observation from Tower.

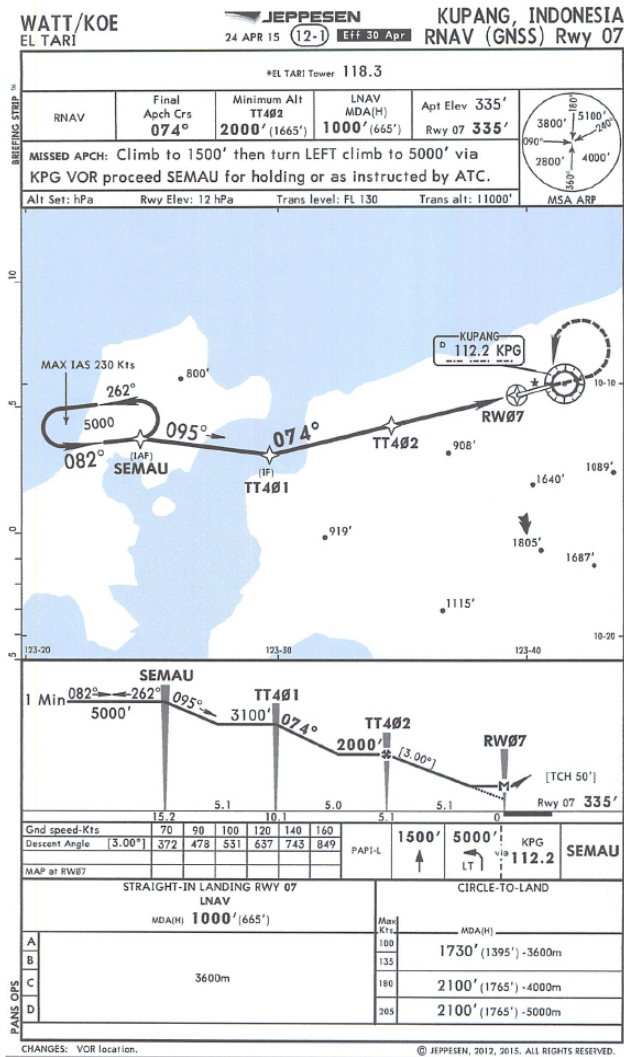
Figure 7: RNAV approach runway 07 chart published by Jeppesen

Runway 07 Kupang equipped with Global Navigation Satellite System (GNSS) that can be used for RNAV Approach since 25 August 2012. The detail of RNAV Approach can be seen figure 7.

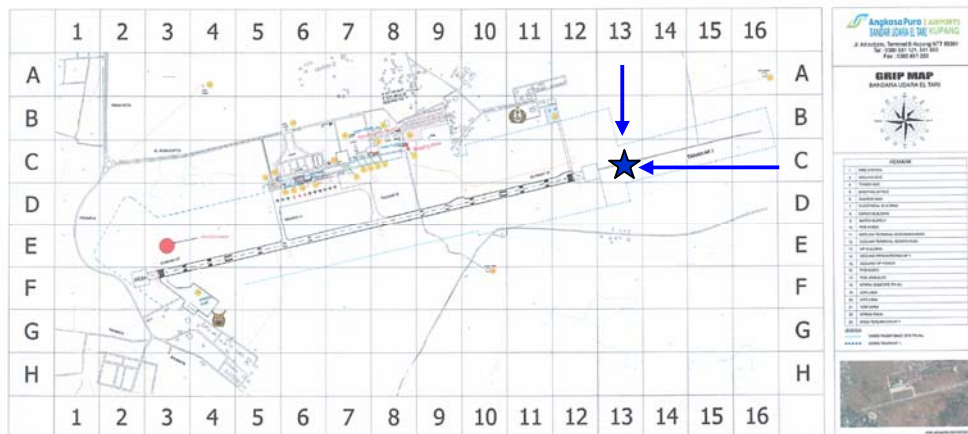
Figure 13: The aircraft location on grid map

At 0946 UTC, the El Tari Tower controller noticed that the aircraft overrun and pushed the crash bell to inform the Aircraft Rescue and Fire Fighting (ARFF) personnel. The controller then called the ARFF personnel and informed that there was aircraft overrun from runway 07 on sector C13 of grid map (figure 13). The ARFF then deployed three vehicles.
