AIRCRAFT ACCIDENT REPORT 1/2014

**Report on the accident to
Airbus A330-343, G-VSXY
London Gatwick Airport
16 April 2012**

Air Accidents Investigation Branch

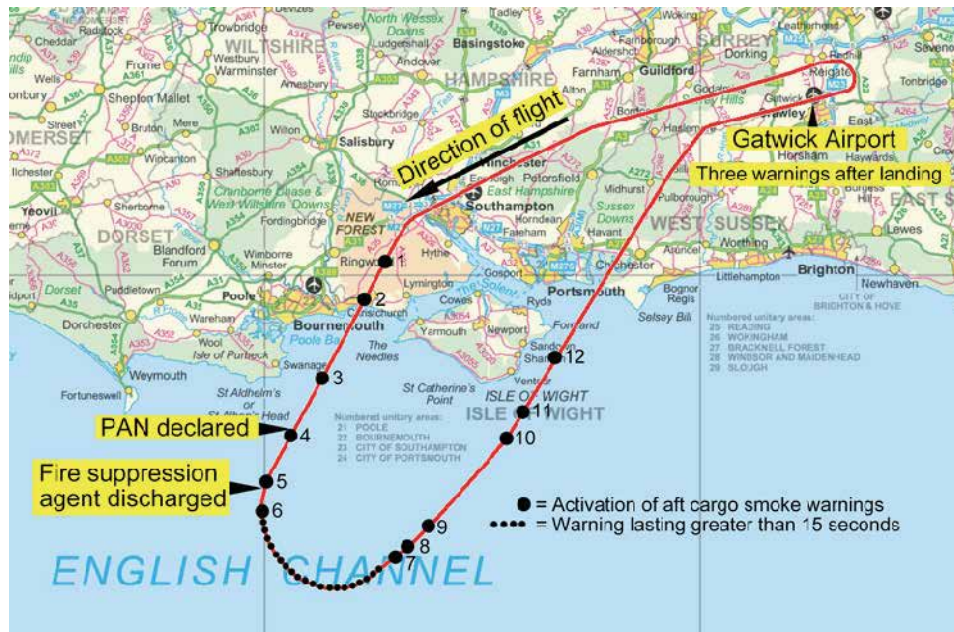
Figure 1

Flight track showing the activation of aft cargo smoke warnings (times in Figure 9)

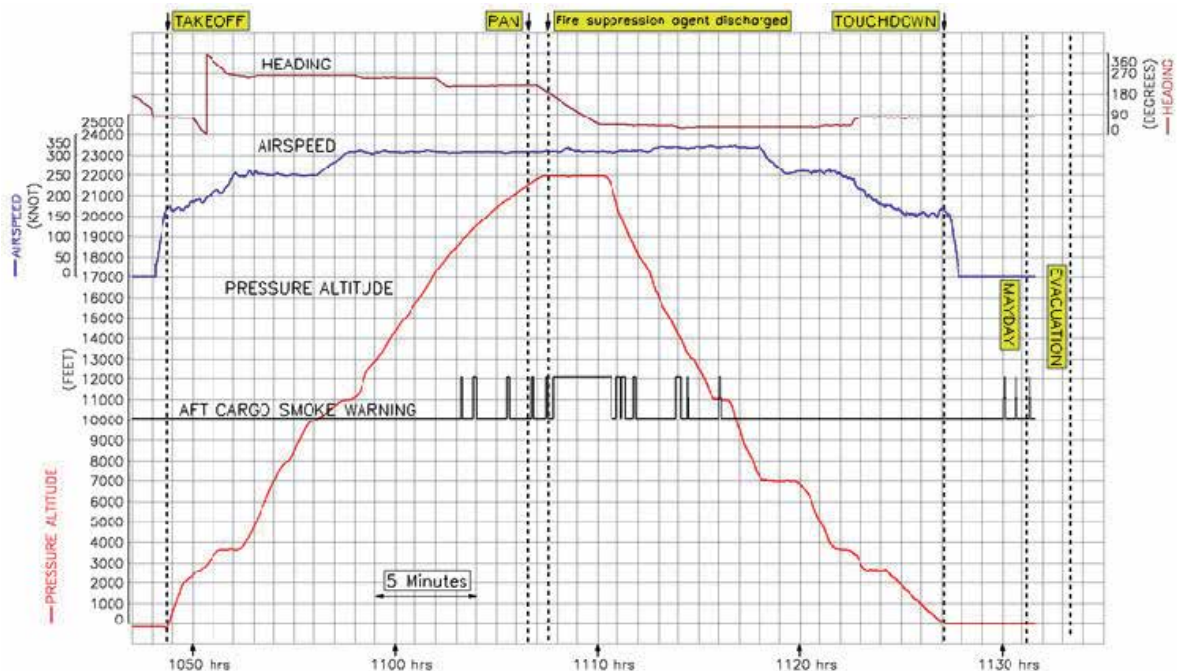
Figure 9

The aircraft was airborne for a total of 38 minutes and 36 seconds. Activation of the aft cargo smoke warning was recorded on fifteen separate occasions, 12 of which occurred in flight and three after landing. The total duration of the warnings was 260 seconds. Figures 9 and 10 provide more information on the activation times and duration of the warnings.

Flight profile - activation of aft cargo smoke warnings

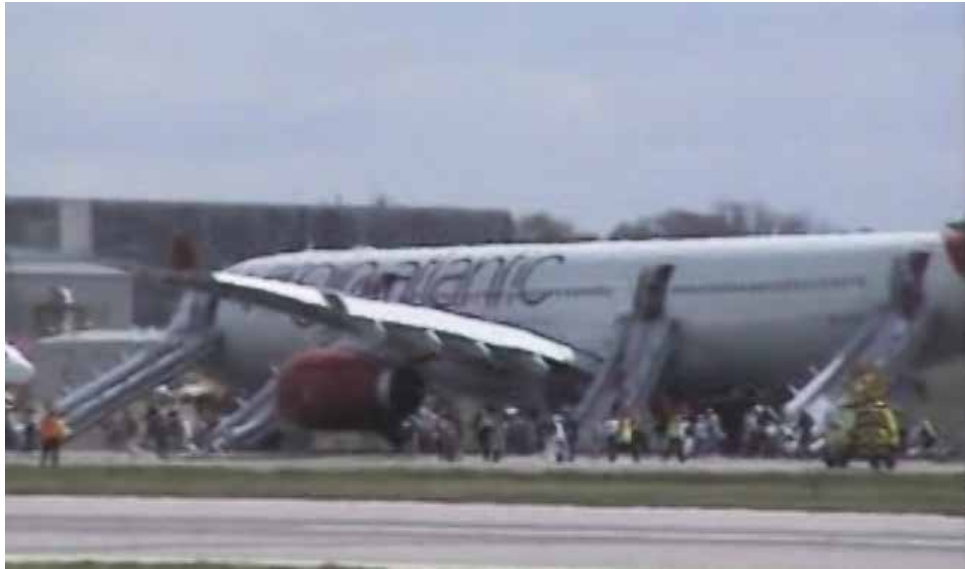
Figure 12

The videos showed that the flow of people from the left doors (Figure 12) was much quicker than from the right (Figure 13). On the right side a number of people sat down in the doorway before descending the slide; some people fell to the ground at the bottom of the slide and others slowed their own evacuation because they were carrying hand baggage (Figure 14). The video also showed members of the RFFS standing at the bottom of the slide at Door 3R directly in line with the escape path.

Still image from video showing left side approximately 30 seconds after evacuation commenced

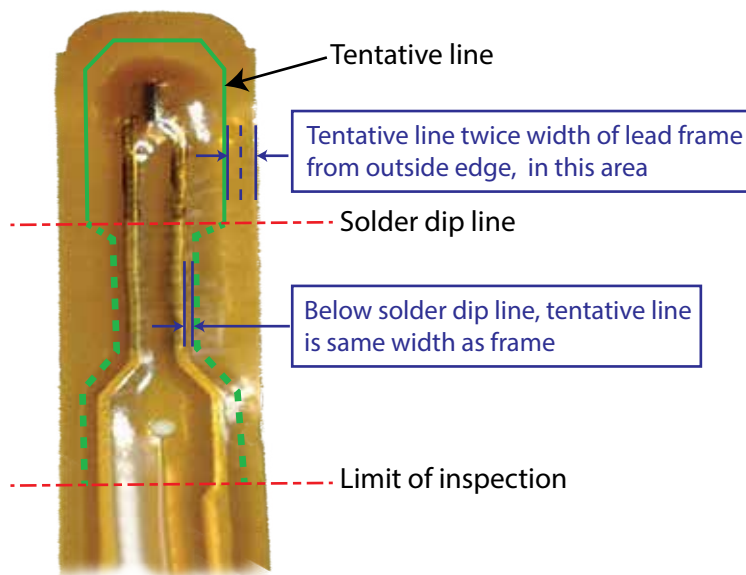
Figure 17

Following manufacture, each thermistor is subject to inspections of visual appearance and the insulation resistance is tested by immersion in water. The presence of bubbles between the insulating films is a normal part of the thermistor assembly process and the supplier's inspection criteria define the permissible locations of such bubbles. The supplier defines a 'tentative line', which follows the profile of the thermistor chip and frame (Figure 17). Bubbles inside this line are permitted; bubbles on or outside this line may compromise the sealing of the edges of the insulating envelope and are not permitted. The supplier considers that the bubbles do not affect the performance of the thermistor and there is no limitation on bubble size, provided they are within the tentative line.

Thermistor tentative line
