Air Accidents Investigation Branch

**Report on the accident to
Aerospatiale (Eurocopter) AS 332L Super Puma
registration G-PUMI
at Aberdeen Airport, Scotland
on 13 October 2006**

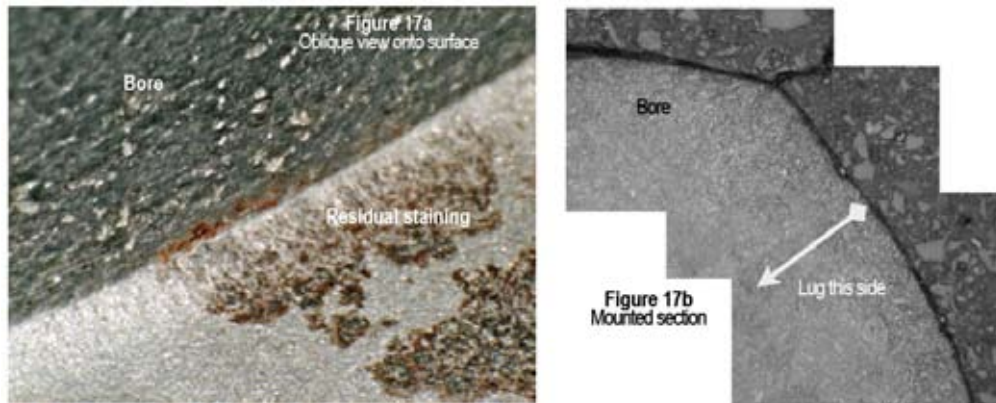
Figures 17a and 17b

There was a clear difference between the surface of the bore and the face of the exemplar lug, see Figure 17a. The bore had a regular dimpled surface texture consistent with that produced by shot-peening, whereas the face displayed a rough, but much finer-textured, finish consistent with it having been grit blasted.

The corner profile itself was more of a chamfer, as called up in the manufacturer's drawings, than the radius profile of the failed lug from G-PUMI.

Exemplar lug: Surface finish at inner corner of bore at location corresponding to G-PUMI crack origin

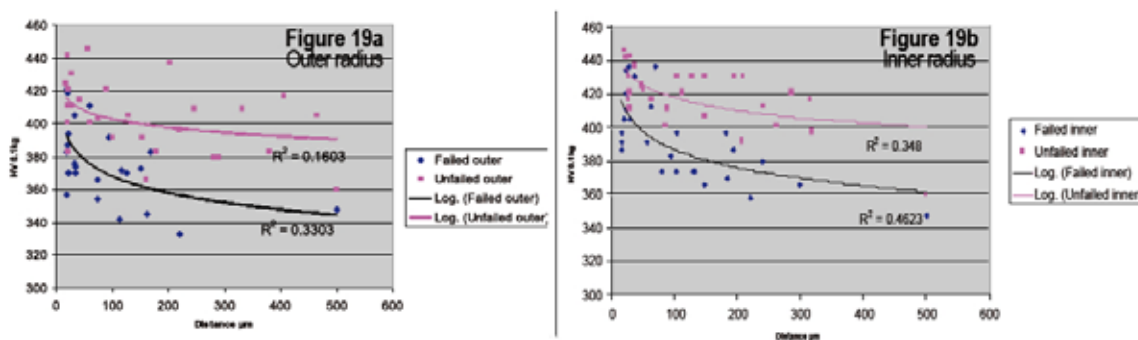
Figures 19a and 19b

Hardness - A series of micro-hardness traverses was carried out on the transverse metallographic sections from both the failed and the exemplar yokes, using a 100 gram load on a diamond pyramid indenter, along the lines shown in Figure 18. Logarithmic regression curves of the results, obtained from plots of hardness vs distance from the surface of the yoke, showed a consistent difference in the scatter of the hardness values obtained from the exemplar and the failed yokes, shown Figures 19a and 19b, which suggested that the hardness of the failed yoke in the surface region was marginally lower than the exemplar.

Regression curves from plots of hardness vs distance from surface

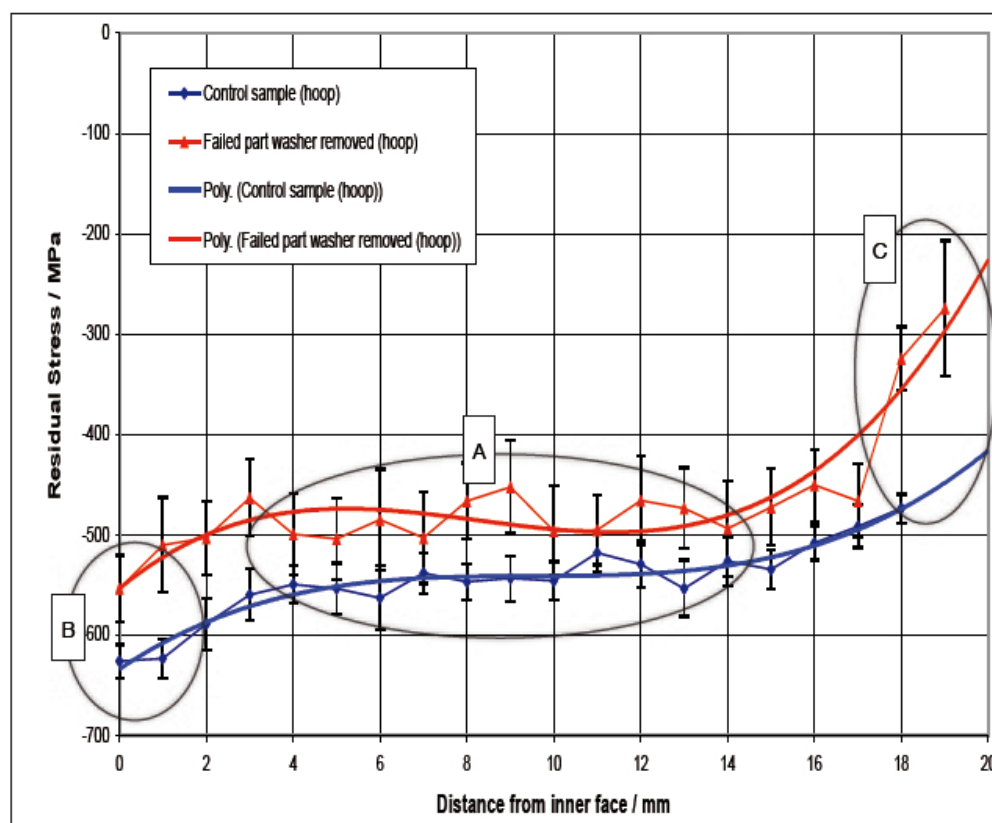
Figure 20

Both the exemplar and the failed lug from G-PUMI exhibited significantly high residual compressive stresses at the surface in the bore of the yoke, see Figure 20.

In the central region of the bore (region A in Figure 20), the failed lug from G-PUMI these stresses measured in the *hoop* direction were of the order of 500 MPa; near the outer face (region C), they were approximately 30% below this value and at the inner corner of the bore, in the region corresponding to the fatigue crack origin (region B), they were some 10% higher.

The exemplar exhibited a similar residual compressive stress distribution in the hoop direction but the stress intensities were generally some 10% higher than those of the failed lug.

Plot of measured hoop stress in surface of the bore vs distance from inner face of lug

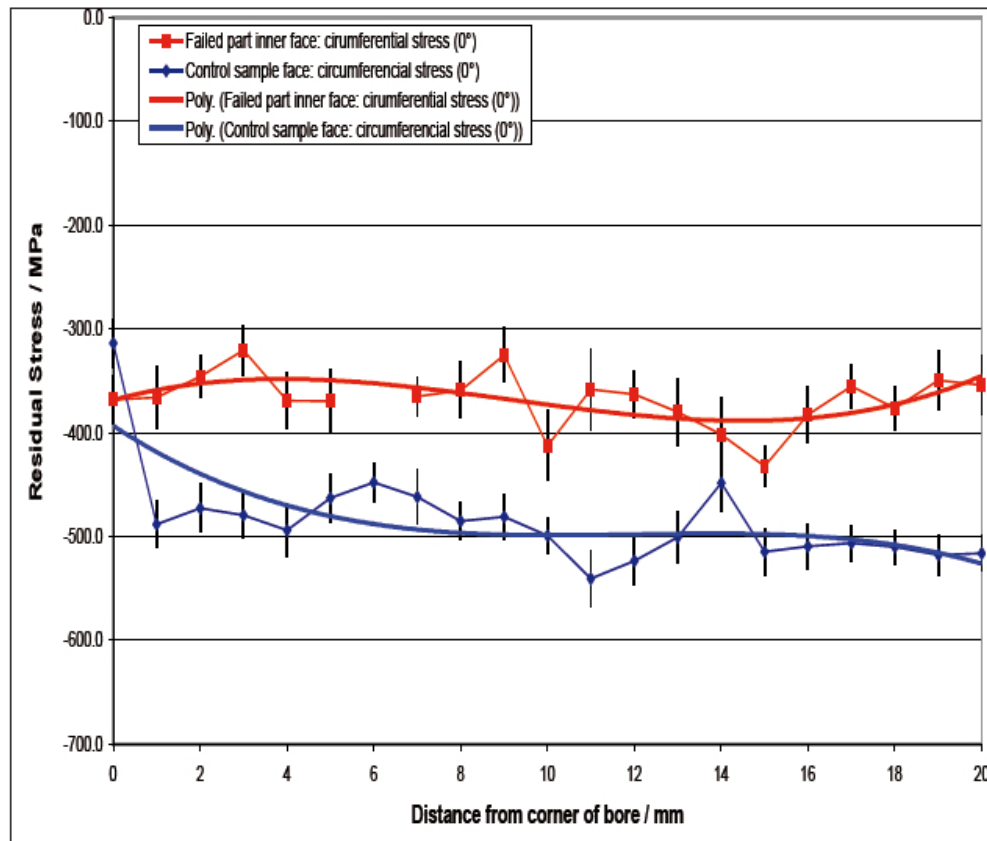
The residual compressive stresses measured on the inner face of the failed lug in the hoop, radial, and 45° orientations were slightly lower than the corresponding values measured in the bore, generally at between 350 and 400 MPa. The exemplar showed similar trends, but with magnitudes generally about 20% greater than those in the failed component. Figure 21 shows these trends for the hoop component.

Plot of measured hoop stress at the inner face surface vs distance from corner of the bore

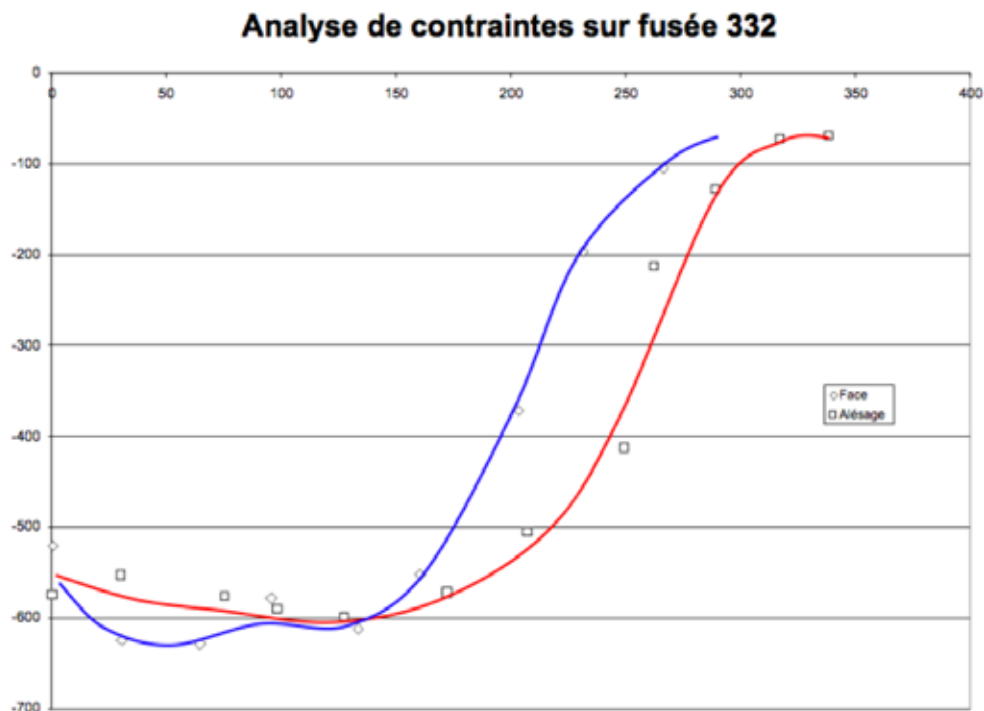
Figure 22

The manufacturer initially carried out a series of residual stress measurements in the failed lug at two sites, one in the central region of the bore and the other in the central region of the inner face. Between each measurement, the surface locally at each site was progressively cut back over the very small measurement region so as to expose progressively the sub-surface material, and the stress measured at the newly exposed surface *at depth* measured and plotted to produce a stress gradient through the surface layer³. The results, which are reproduced at Figure 22, implied a residual compressive layer of some 600 MPa magnitude to a depth of approximately 100 microns, thereafter reducing to insignificant values at a depth of some 300 microns below the surface.

Plot of residual stress vs depth from surface for the failed lug, measured at locations near the centre of the bore (red) and inner face (blue)

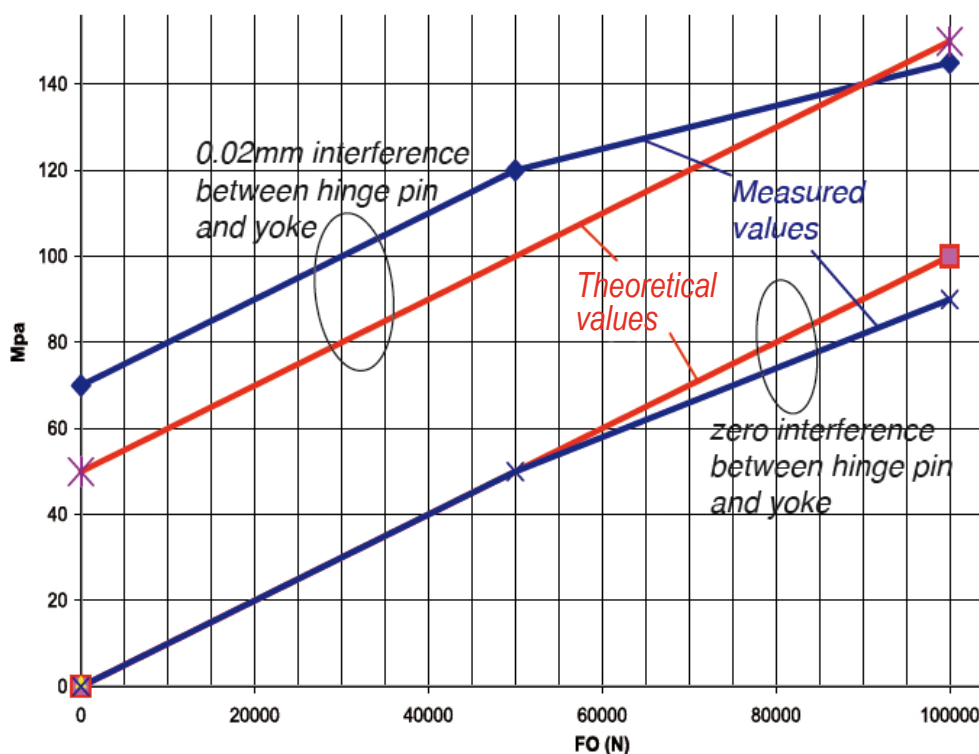
It is evident that the combination of a wear gap and a relatively tight-fitting pin would provide conditions whereby excessive tie bolt tension could generate potentially damaging stresses in the fatigue origin region, especially if combined with an interference fit. The generalised form of plots proposed in Figure 27 correlates well with the experimental results of the manufacturer’s laboratory tests carried out to explore these effects, as shown in Figure 28.

Stress on inner face of yoke at failure location as function of tie bolt preload

Figure 28 shows the recorded stress at the inner face of the yoke at the failure location, as a function of tie bolt tension (pre-load). The measured values are coloured dark blue. The red plots are the theoretical values, based on a relationship derived from the FE analysis but corrected to account for the standing stress induced by the diametral interference between the flapping hinge pin and the yoke. Taking due account of the limited range of conditions tested, and extrapolating from the ~145 MPa maximum stress recorded during the tests, the manufacturer concluded that with grease on the tie bolt, standing stresses as high as 190 MPa could potentially be developed during assembly of a spindle with both wear and grease present.

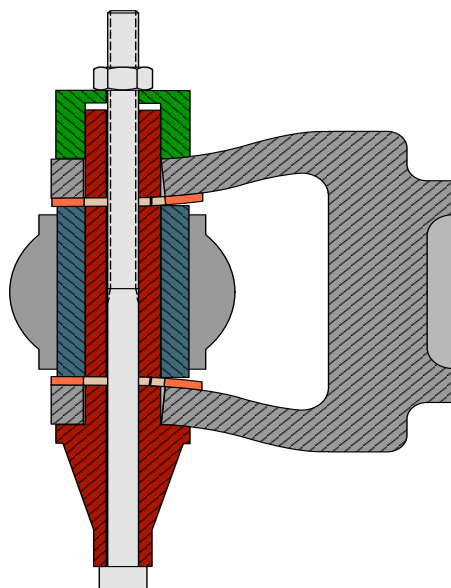
The washer fractures each comprised a brittle static fracture of the carbide layer, followed by propagation of a fatigue fracture through the backing material from origin sites in the root of this static fracture. Neither the static nor the fatigue fractures were of significance in the overall failure, but the location and orientation of the washer cracks (parallel with, but slightly inboard of, the yoke fracture) is fully consistent with the yoke failure causal mechanism proposed in paragraph 2.3.3.1. Specifically, the deflection of the yoke arms, and hence of the washers bonded to them, as the tie bolt is tightened would put the carbide layer into tension – producing the static fracture – and the washer's location on the outside of the bend would have induced a standing tensile stress in the washer, contributing to the subsequent fatigue propagation through the backing material.

It is considered highly significant that, under these conditions, the position of maximum bending deformation of the washer, the expected line of fracture, will be slightly inboard of the hinge pin axis at approximately the positions identified in the schematic diagram Figure 29 (a reproduction of Figure 26c, amended to include the inner pair of washers).

Schematic showing coincidence of maximum bending stress
and location of the washer cracks

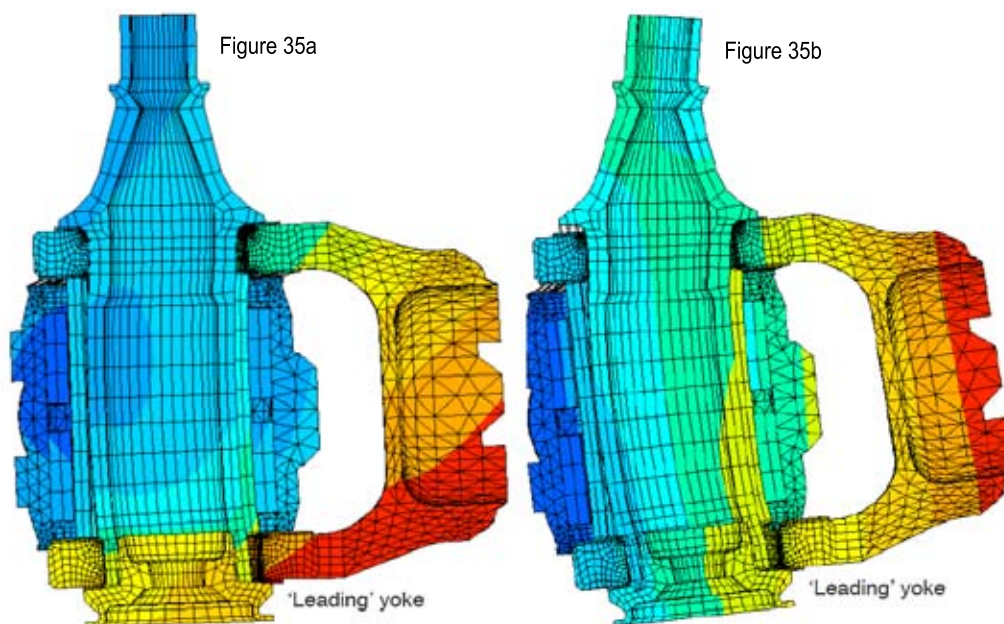
**Figure 35a**

- 4) Centrifugal blade force + blade-drag shear force, with zero damper-induced bending moment, produced the asymmetric pattern of deformation of the yoke shown (in much exaggerated form) in Figure 35a.

Deformation pattern with centrifugal and blade-drag shear loading only

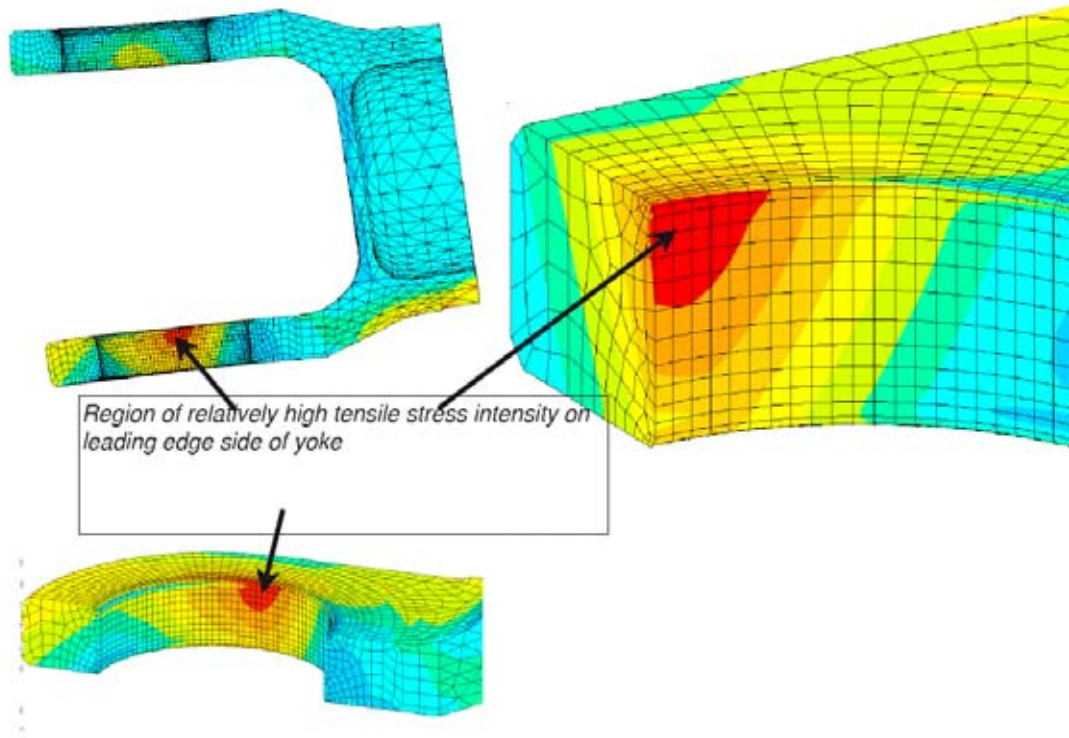
**Figure 36**

- 5) The addition of damper-induced lead-lag bending forces increased both the extent of flexure and the asymmetry, see Figure 35b.
- 6) A stress concentration was identified under most loading conditions that coincided with location of the failure origin on G-PUMI, at the inner corner of the bore of the lug on the leading side of the yoke, see Figure 36.

- 8) It was not possible to model the corner radius in the failure origin region with a sufficiently small mesh size to predict with confidence the stress concentration factor due to the radius geometry per se, but a simplified analysis of this geometry was undertaken using a chamfer of comparable dimensions, which is a more critical case. The results indicated that a stress concentration of the order of 1.2 was likely to apply at the corner radius, the local stress at the radius was likely to be some 20% above the baseline values predicted by the model.

Position of maximum tensile stress at the surface adjoining the inner corner in the bore of the lug on the leading side of the yoke, at approximately the failure location on G-PUMI
