AAIB Bulletin

11/2018

Published 8 November 2018

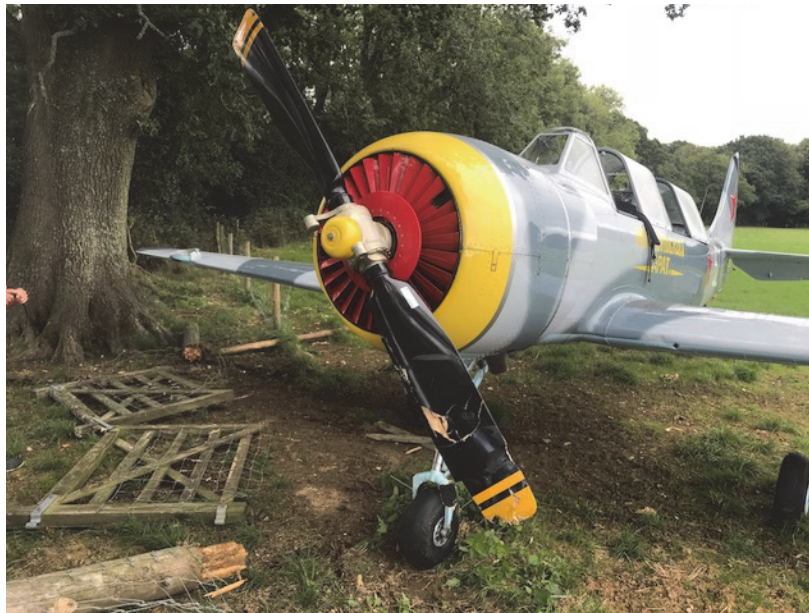
Figure 1

continued to rotate. The aircraft overran the runway at approximately 10 mph and collided with a fence. It came to a stop a few metres beyond the fence and the pilot was able to exit the aircraft unaided (Figure 1).

G-CCJK after the accident

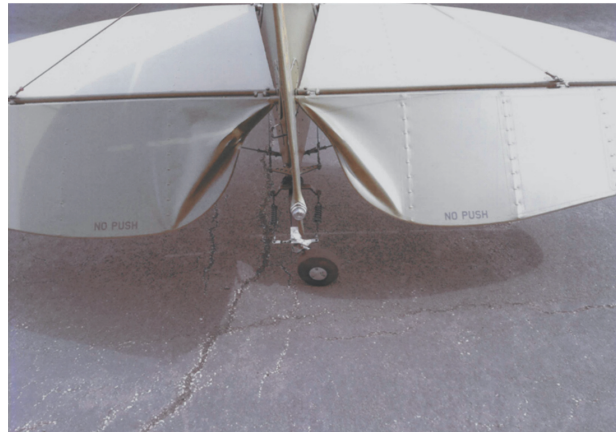
Figure 3

Damage caused to the elevator inboard edge frames
