**AIRCRAFT SERIOUS INCIDENT
INVESTIGATION REPORT**

**OKAYAMA GLIDER CLUB
J A 2 3 3 0**

CONTINUED HALT OF POWER OF ENGINE DURING FLIGHT

SCHEIBE SF25C FALKE (MOTOR GLIDER, TWO-SEATER)

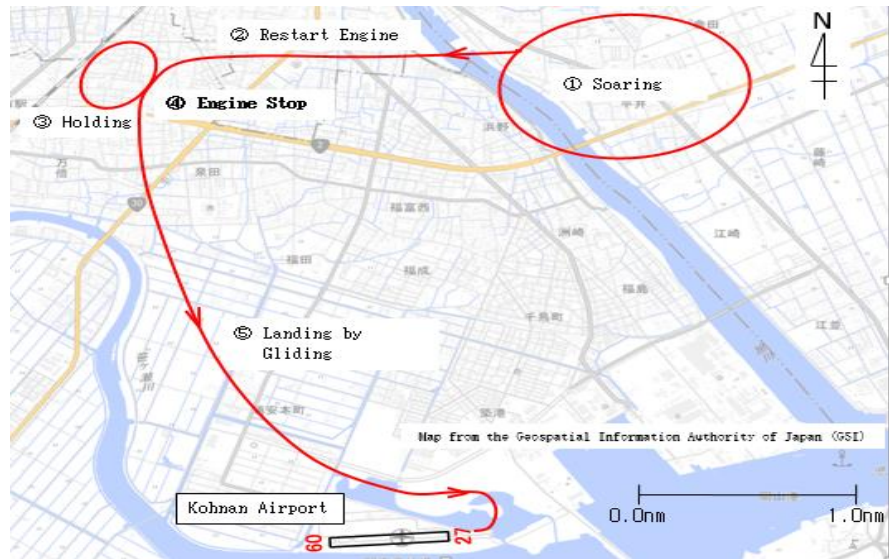
Figure 1 Estimated Flight Route

This serious incident occurred at about 15:10(I) on February 12, 2017, at the point with an altitude of about 2,000ft, about 3nm northwest of Kohnan Aerodrome (34° 38' N, 133° 54' E).

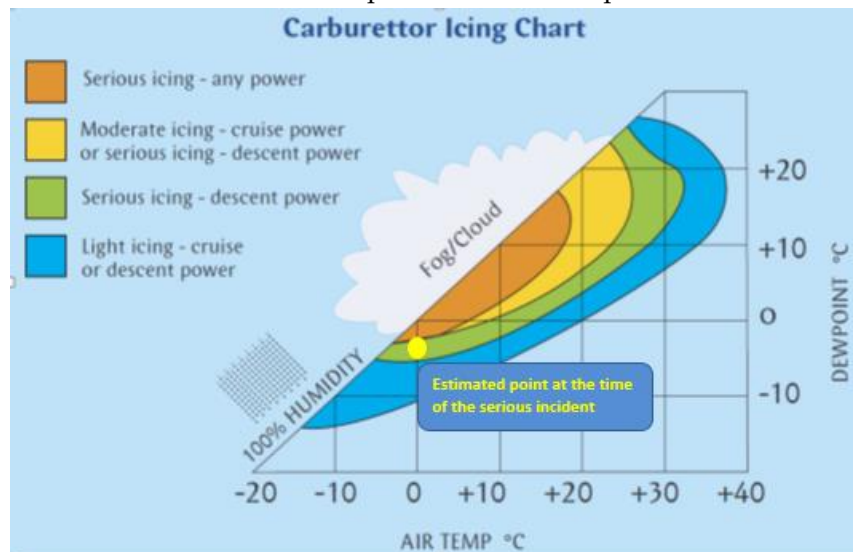
Figure 2; Carburettor Icing Chart (partially revised)
 CIVIL AVIATION AUTHORITY OF NEW ZEALAND “Winter Flying” 2005 p11

Civil Aviation Authority of New Zealand has introduced “Carburettor Icing Chart” which is able to predict an occurrence of the carb-ice based on outside temperature and dew point.

3.1 Involvement of weather	Yes
3.2 Involvement of pilot	Yes
3.3 Involvement of equipment	None
3.4 Analysis of known items	<p>(1) The atmospheric condition around the time of the serious incident occurrence</p> <p>At the time of the serious incident occurrence, since the Chugoku region was under the winter weather pattern which is high atmospheric pressure to the west and low atmospheric pressure to the east and based on the statements of the captain and the lower bad weather forecast diagram, it is highly probable that the outside temperature at 2,000ft over Okayama City was approximately 0 °C.</p> <p>Also, around the time of the serious incident occurrence, multiple pilots had confirmed that they had seen snow clouds and local snowing/rainfall phenomena, was flying with care of icing, and since the aircraft was flying near snow clouds, it is probable that the dew points around the aircraft at 2,000ft was from 0 °C to -3 °C.</p> <p>Furthermore, applying 0 °C for outside temperature and -3 °C for dew point as conditions to the Figure 2 Carburettor icing chart, it fell into the range of serious carb-ice occurrence at descent power.</p> <p>Based on these, it is highly probable that the aircraft was flying through the airspace where was at high risk of the carb-ice.</p> <p>(2) As for the reason that the engine halted and was unable to restart</p> <p>The aircraft had normally completed the restart of the engine to return to the aerodrome, descended by idling and was holding to wait for a turn to land at. According to the captain, the oil temperature at the time was 40 °C or less. It is highly probable that it was far below 70 °C of the temperature where was at the high risk of the carb-ice.</p> <p>About five minutes later, when the trainee opened the throttle, the rpm of the aircraft engine halted without following.</p> <p>It is highly probable that the carb-ice occurred because the aircraft was flying by idling without using carb-heat through the airspace at low temperature and high humidity. As for the reason that the engine halted, it is highly probable that because changing the throttle position in the state with occurrence of carb-ice resulted in inability to keep the appropriate air/fuel ratio.</p> <p>Also, why the engine was not able to restart, it is probable that because of the continuous carb-ice occurrence, the engine could not obtain an appropriate air/fuel ratio to start.</p> <p>After the landing, it is highly probable that the test run of the</p>
