FINAL INCIDENT REPORT

Boeing B-737/300F

EC-KDJ

FINAL INCIDENT REPORT Nr. 07/INCID/2008

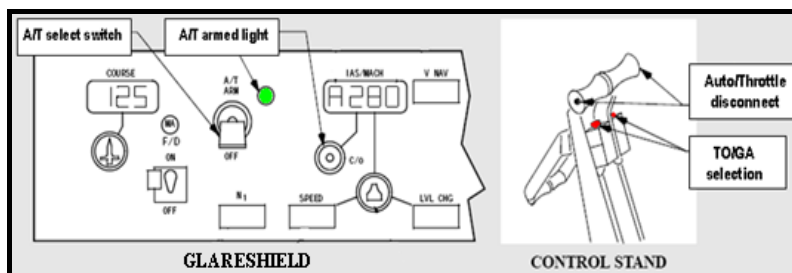
Picture Nr: 9

Pilot interface is made through A/T select switch, on glareshield, and disconnect and “TO/GA” switches, located on thrust levers (picture nr. 9).

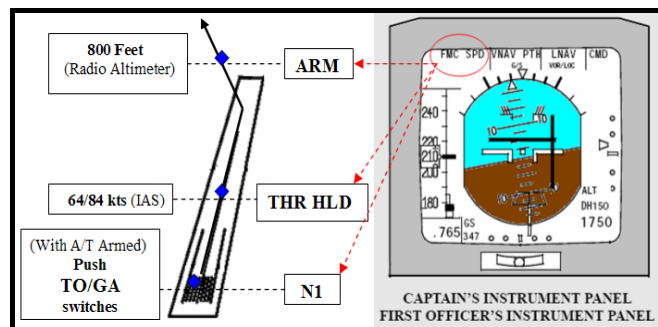
Picture Nr: 10

A/T status is indicated on top of Electronic Attitude Director Indicator (EADI), left column (picture nr. 10), on Captain & F/O instrument panels.

During take-off roll, after “TO/GA” engagement, thrust levers cannot be manually repositioned before reaching 84kts (64kts for older versions) and “THR HLD” mode be displayed, or on “ARM” mode (displayed after passing 800’ radio altimeter), unless the pilot disengages A/T.

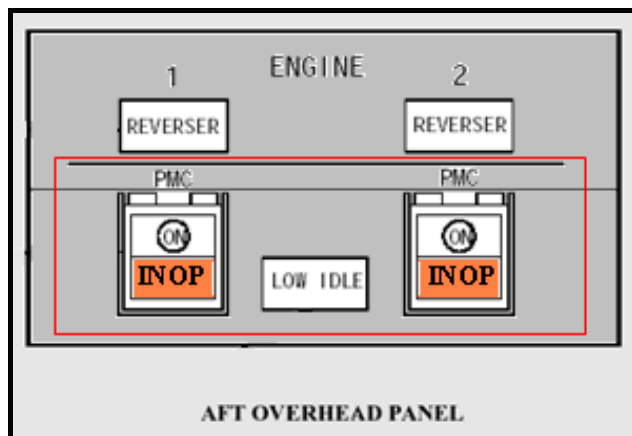
Picture Nr: 11

In case of malfunction of any PMC above 46%N2, or in case of PMC disconnected, an amber “INOP” light will come on, on after overhead panel (*picture nr. 11*).

A guarded switch allows the pilot to disconnect affected PMC. Anyway, Boeing recommends switching off both PMC when using the A/T.

There is not evidence that any PMC was switched off or malfunctioning, which could contribute to power asymmetric setting, and nobody referred the lighting of a PMC warning. Considering that PMC malfunction warning is provided only after 30 seconds of a slow N1 drift over, there was no time enough for such warning to be activated, once the pilot reduced thrust approximately fifteen seconds after power setting. As there is no registry of PMC performance on FDR, no conclusions can be made on this subject.

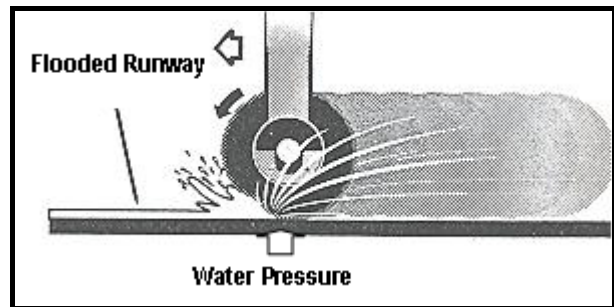
Picture Nr: 12

At high speeds, tire forward motion tends to displace great amounts of water from the tread contact area. This displacement action can generate sufficient water pressure to lift and separate part of the tire contact area from the runway surface. This phenomenon is known as **dynamic hydroplaning** (picture nr. 12).

In extreme circumstances the tire may lift off the runway and ride on the wedge of water, like a water-ski. In such extreme conditions there are no braking or cornering capabilities.

EC-KDJ aircraft never reached enough speed, neither water quantity was enough (runway was wet, not flooded) to develop this kind of hydroplaning.

Conditions 1 and 2 were missing.

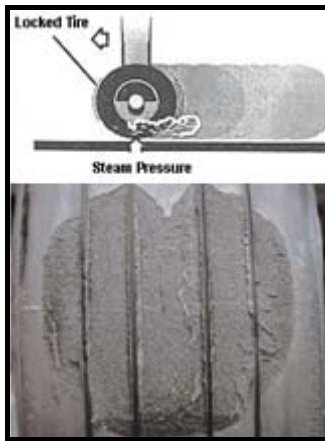
Picture Nr: 13

Another form of hydroplaning may occur when, even if there is some tread contact with the runway surface, the wheel is either locked or rotating slowly, with aircraft travelling at high speed. The friction produced by the skidding tire causes the tread material to become extremely hot. The resulting heat evaporates the water and generates steam in the contact area, providing additional upward pressure on the tire. The hot steam reverses the vulcanizing process and the tread rubber becomes irregular in appearance (gummy), resulting in a very low friction levels and braking capabilities (*picture nr. 13*).

Based on this characteristic it's called **reversed rubber hydroplaning**.

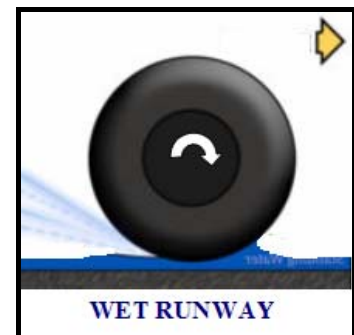
Picture Nr: 14

It's called **viscous hydroplaning** and it occurs anytime there's a wet runway (*a thin film of fluid no more than 0.025mm in depth is enough*) and a normal slipperiness or water lubricating action is felt (*picture nr. 14*). The tire cannot penetrate the fluid and it rolls on top of the film. This viscous hydroplaning can occur at a much lower speed than dynamic hydroplaning, but requires a smooth or smooth-acting surface such as an oil, dust or rubber contaminated flat runway.

EC-KDJ aircraft didn't reach minimum speed for dynamic or reversed rubber hydroplaning. Nevertheless there were visible runway marks of skidding, which confirmed the occurrence of viscous hydroplaning, due the presence of dust on the runway smooth surface, covered by a light wet film.
