FINAL ACCIDENT REPORT

PRIVATE
COLOMBAN MC-15

F-PYNN

FINAL ACCIDENT REPORT Nr. 38/ACCID/2009

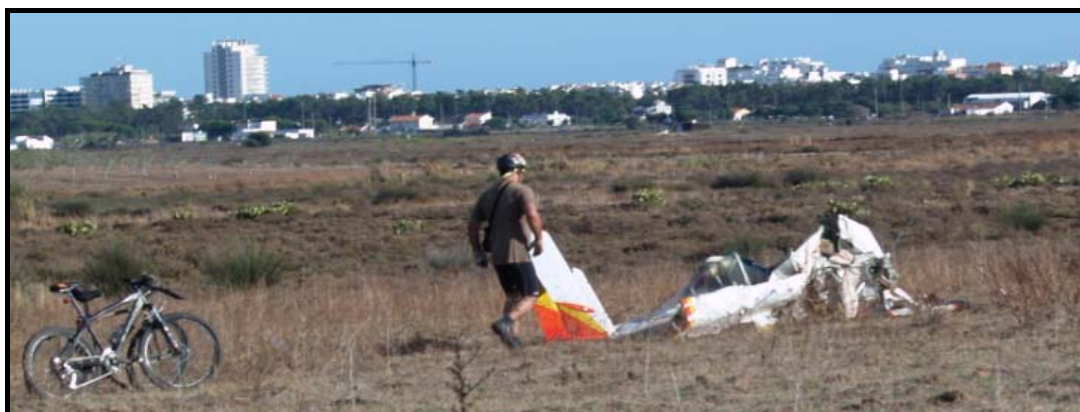
Picture Nr. 3

When the first witness (*picture nr 3*) arrived at the scene, the pilot was seated lifeless, with seatbelts fastened and he has been declared dead by the paramedics that arrived soon after, with rescue services.

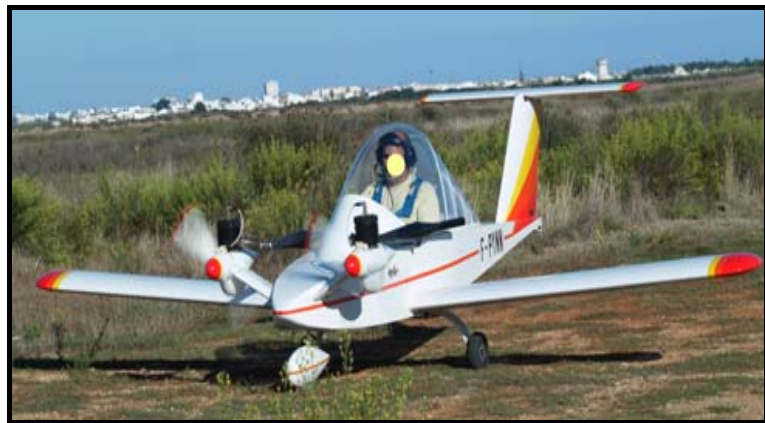
Picture Nr. 5

Monoplane, low wing, fixed tri-cycle landing gear, metallic skin, homebuilt aircraft (*picture nr 5*), the Colomaban MC-15 was classified as an experimental plane, with cabin room for one people, Maximum Take-off Mass (MTOM) of 182kg and following references (*table nr 3*):

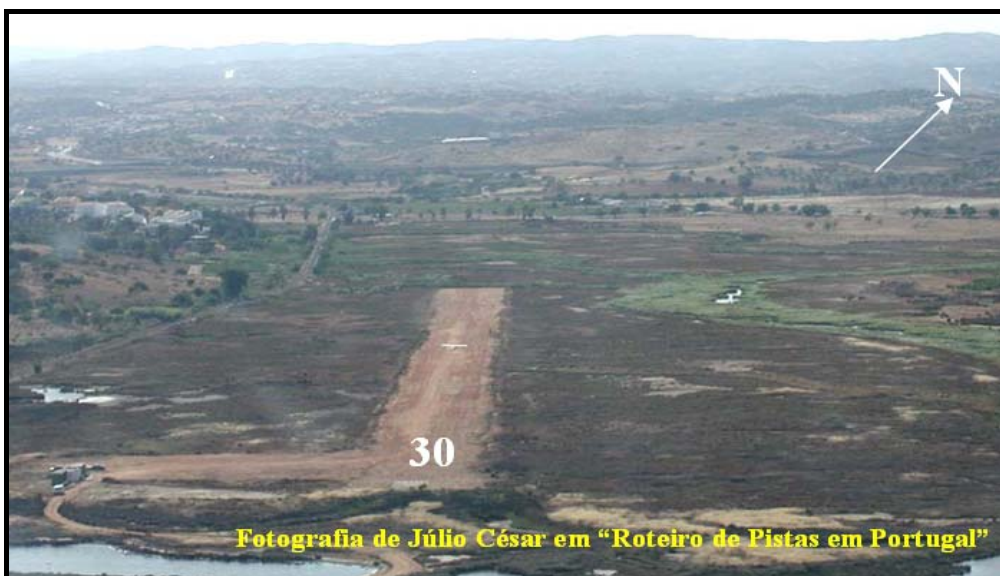
Picture Nr. 6

Praia Verde airfield (*picture nr 6*), located 2km Northeast of Monte Gordo holiday resort, Algarve, is a private property, being all aircraft operations subject to previous authorization. Being included in Civil Pilot Manual (MPC)⁴ list of aerodromes, it was closed by Civil Aviation Authority on the 8th of August, 1996. When the accident happened runway looking was substantially different, as per picture nr 1 (page 5), reason for the pilot to perform a hard cleaning, prior to use it.
