## **FINAL ACCIDENT REPORT**

**AIR TRACTOR 802-F**

**VH-LIH**

**FINAL ACCIDENT REPORT N° 28/ACCID/2009**

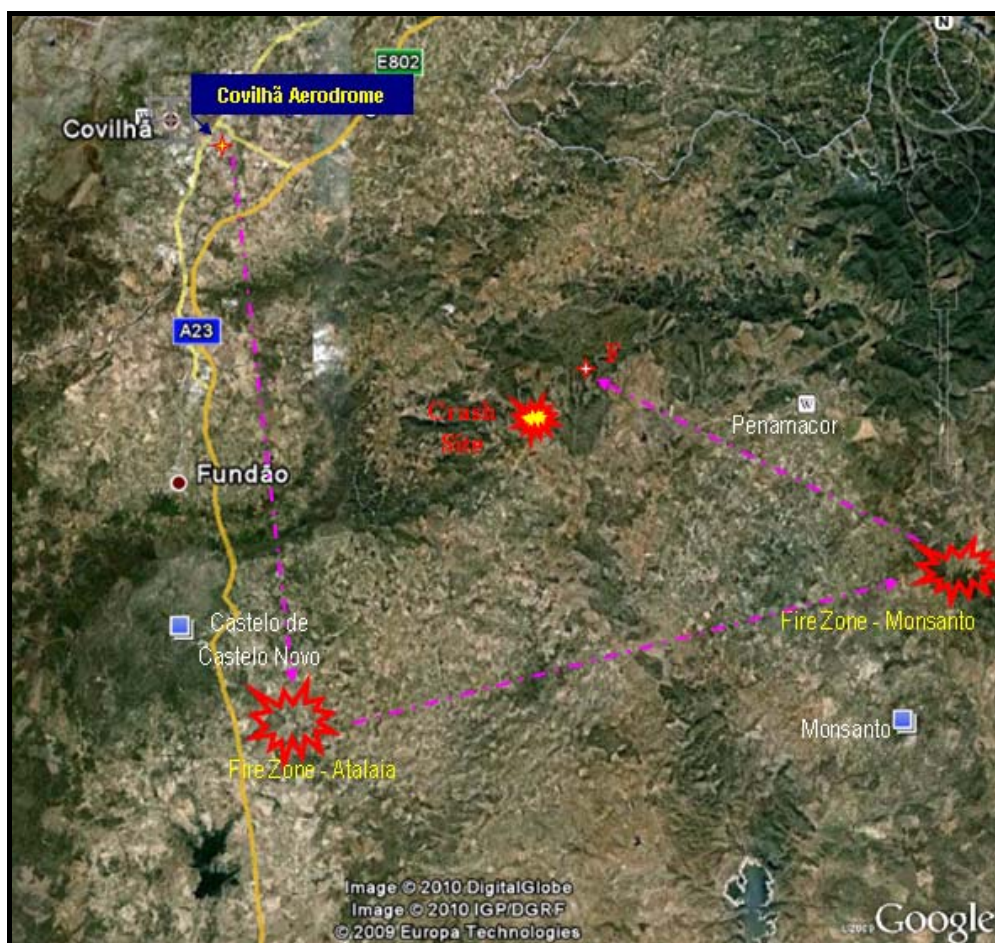
Picture Nr 1

On the 12<sup>th</sup> of August, 2009, there were several wild fires burning in Castelo Branco district, namely in Atalaia do Campo (Fundão) and Monsanto (Penamacor) regions. Support aircrafts based at Covilhã airfield were called for fire fighting, taking off, by 10:45, two *Airtractor aircraft*, with registrations VH-LIC e VH-LIH, and call signs A-13 e A-14, respectively, heading to Atalaia fire scene (*picture nr 1*).

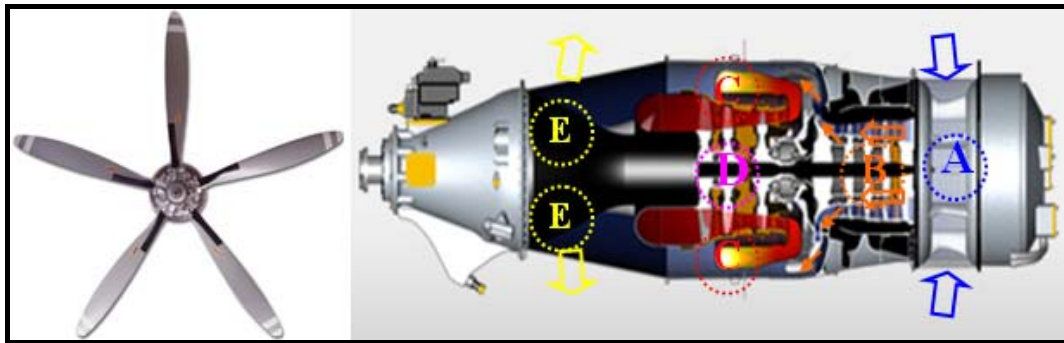
Picture Nr 5

The aircraft was equipped with a Pratt & Whitney Canada *PT6A-67R* turboprop engine, coupled to a *Hartzell HC-B5MP-3F* five blades variable pitch propeller, with feather and reversion pitch capability (*picture nr 5*).

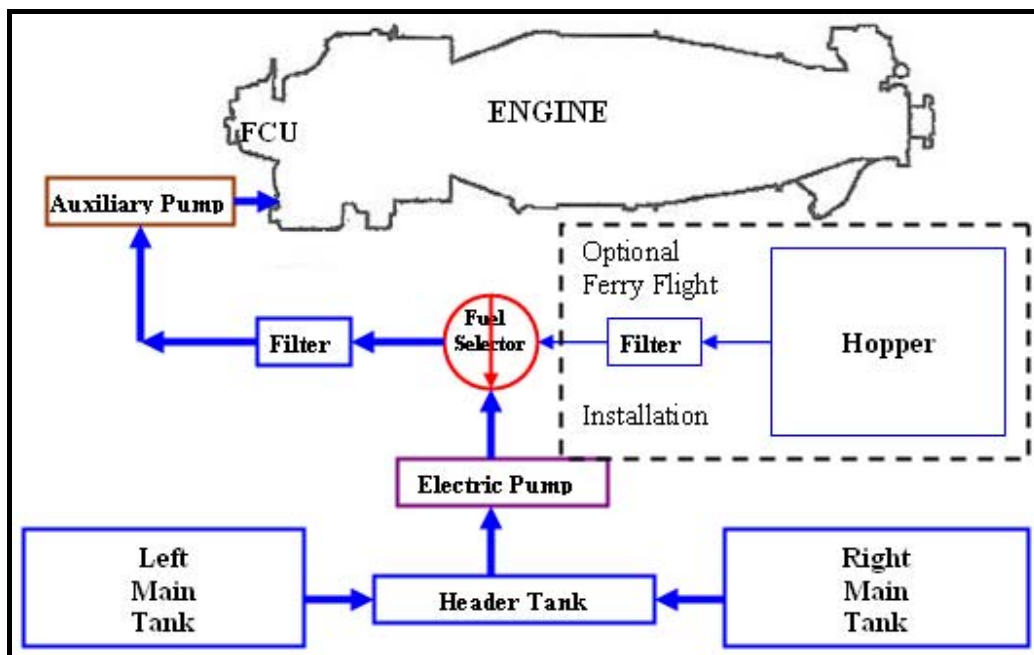
Picture Nr 6

Air Tractor AT-802 may carry 380USG (1438litres) of fuel stored in two main tanks (in the wings), feeding by gravity a central tank (in the fuselage), from where it flows to the engine *fuel control unit* (FCU), through an *electric fuel boost pump*, a *fuel selector*, a *fuel filter* and an engine driven *airframe fuel boost pump* (picture nr 6).

Connection from wing tanks to central tank is provided by a straight line, without check valves, which allows the fuel to migrate from one main tank to another.

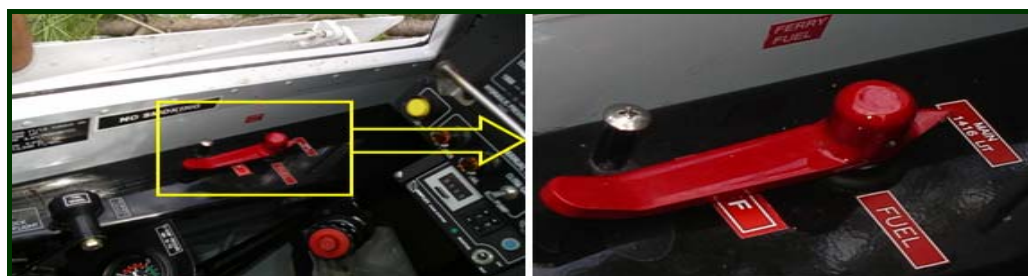
Picture Nr 7

For long distance flights, specially “ferry” flights, the aircraft has the capability to carry fuel in the “hopper”, increasing its endurance. A fuel selector valve, situated in front cockpit left side, enables the pilot to select normal tanks or “hopper”, besides a fuel shutoff position (picture nr 7).

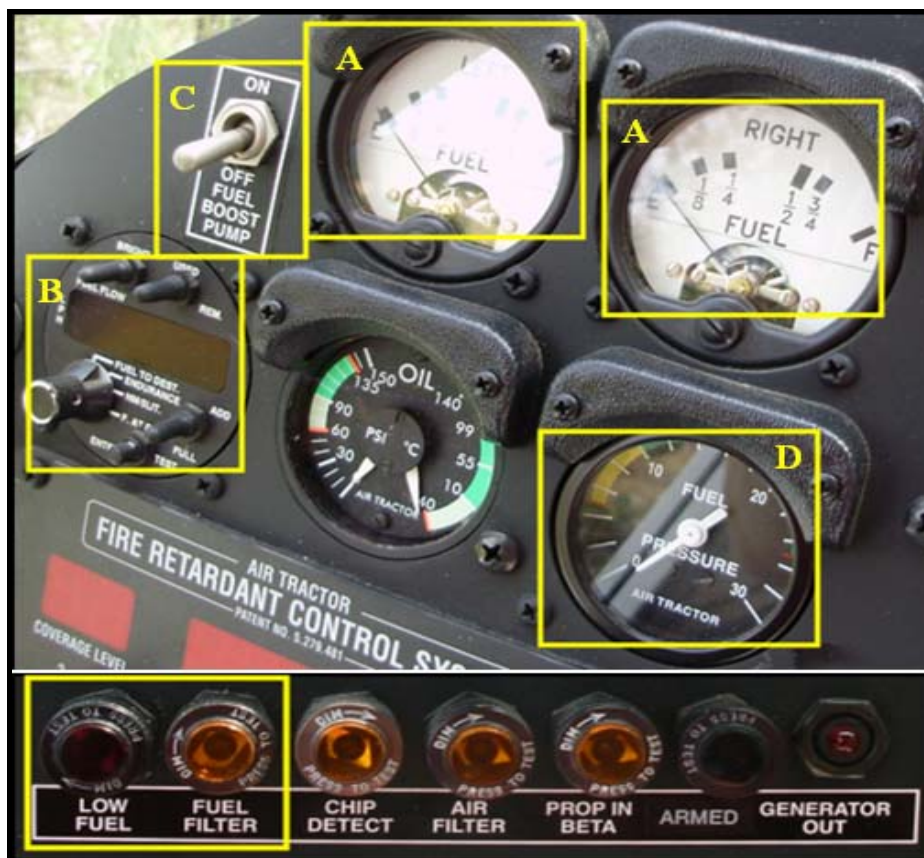
Picture Nr 8

Two fuel quantity indicators (A), located on instrument panel left side (picture nr 8), show fuel remaining quantity in tanks, while the “fuel flow meter” (B), more to the left and bellow, may provide other information relating to fuel consumption and endurance. A switch (C)

commands electric fuel *boost pump* operation and a pressure indicator (D) shows fuel pressure in engine fuel feeder line ( $\pm 15\text{psi}$ ).
