FINAL INCIDENT REPORT

Stoddard-Hamilton, Inc.
GLASAIR II RG

PH-EQV

09th of June 2009

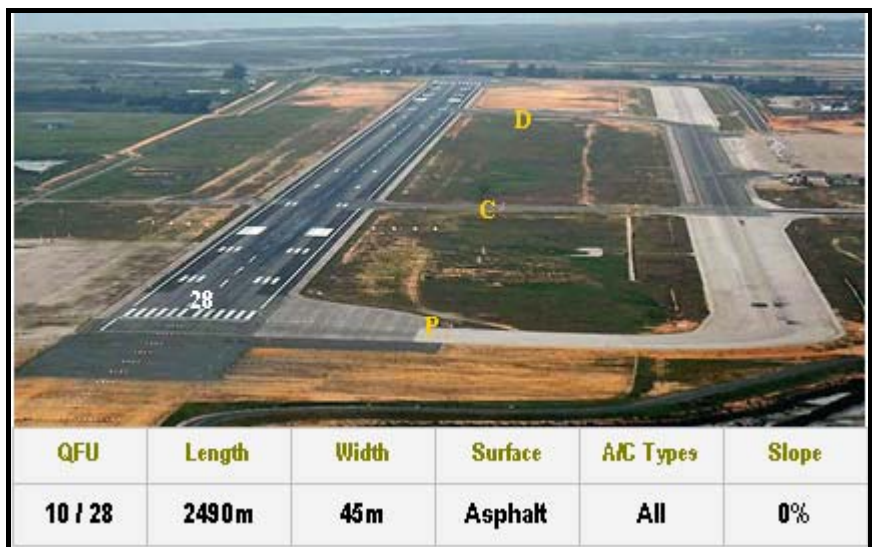
Picture Nr. 3

Faro airport is part of national airports network and it is open to all national & international traffic, except for non-resident ultra light aircrafts.

It's served by an asphalt runway, with 2490m X 45m, oriented on a 100° / 280° magnetic, supported by some landing aids (lights, PAPI, ILS), which were not used by the aircraft, operating according Visual Flight Rules (VFR).
