FINAL INCIDENT REPORT

BUFFALO AIRWAYS
CANADAIR CL-215

C-FTXB

FINAL INCIDENT REPORT Nr. 10/INCID/2009

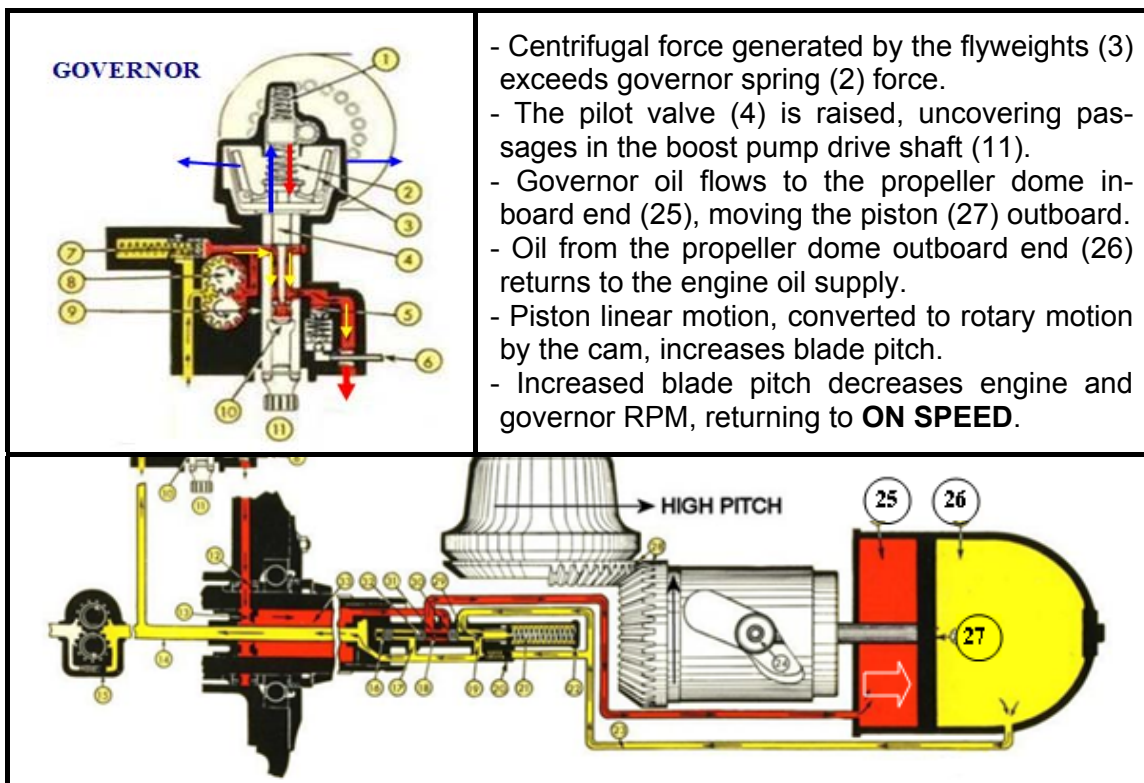
Picture Nr. 7

1.6.2.3 Overspeed Control

Aircraft speed increasing reduced propeller load and caused an increase of engine and propeller RPM.

Engine and propeller acceleration should increase centrifugal force of flyweights and raise the pilot valve, bringing the system to onspeed condition.

The presence of dirt and other contamination material in the body part prevented the pilot valve to be raised by flyweight's centrifugal force (*picture nr 12*).
