MINISTÉRIO DAS OBRAS PÚBLICAS, TRANSPORTES E COMUNICAÇÕES
GABINETE DE PREVENÇÃO E INVESTIGAÇÃO DE ACIDENTES COM AERONAVES

INCIDENT PRELIMINARY REPORT

TAAG – ANGOLA AIRLINES

PRELIMINARY REPORT Nr. 18/INCID/2010

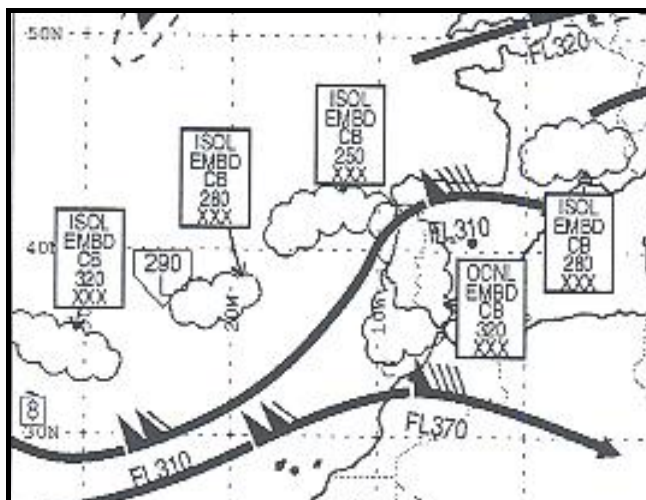
Figura Nº 1

The situation was characterized by strong winds, specially in altitude, sky partially cloudy and possibility of precipitation, due to a South-westerly circulation, under the influence of a Low pressure situated over the Atlantic, Northwest of Lisbon (*picture nr 1*).
