FINAL ACCIDENT REPORT

PRIVATE
CESSNA 182P

D-ENEW

FINAL ACCIDENT REPORT Nr. 15/ACCID/2010

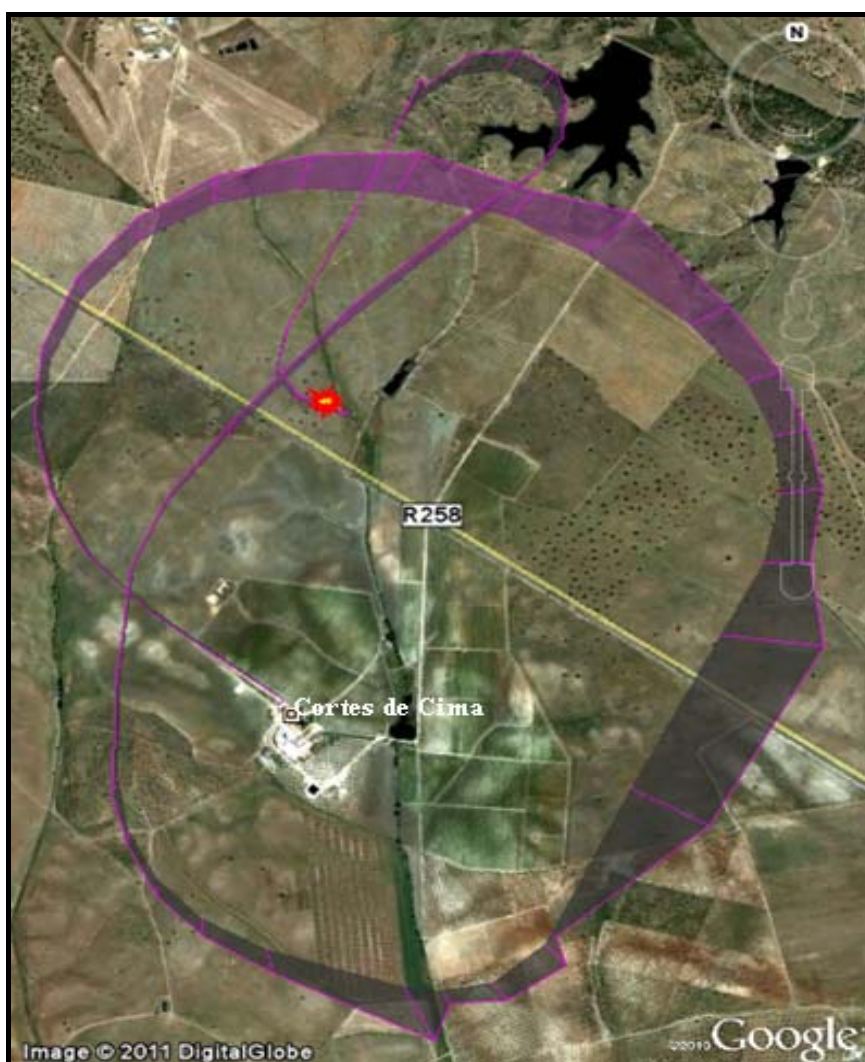
Picture Nr 1

After take-off, the pilot started a 450° right turn, keeping low altitude ($\leq 900'$ /275m), overflow part of its property and proceeded to Northeast, for starting picture taking (*picture nr 1*).

There was a satellite navigation equipment aboard, from which it was possible to recover some flight information and reconstruct horizontal and vertical track of the aircraft, as shown on picture nr 1.

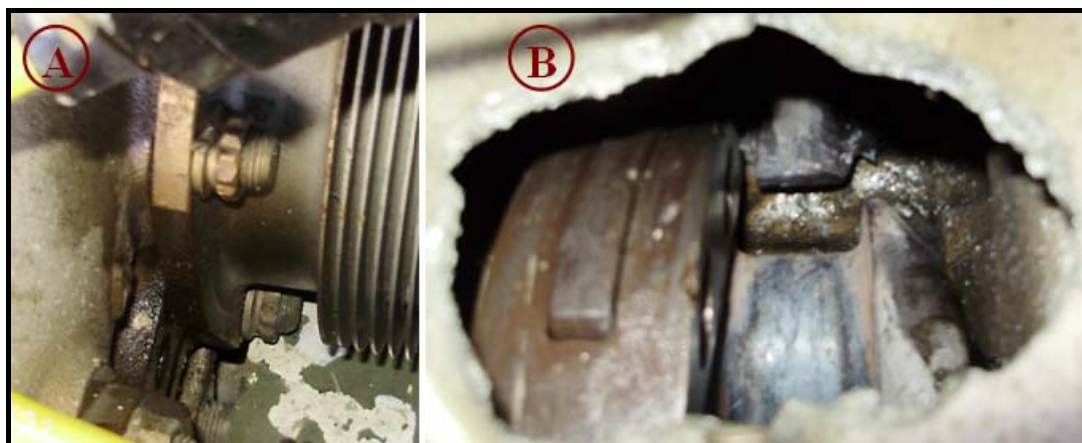
Picture Nr 16

Oil loss and consequent lack of cooling caused the engine to become flodded. Cylinder nr 2, being the one situated on the rearmost position and having less exposition to cooling air flow, reached the highest temperature (*picture nr 16A*) and led the connecting rod (*picture nr 16B*) to break, causing the fracture of engine block. The engine block fragment was expelled violently and forced left magnet out of its seating.
