# **PRELIMINARY ACCIDENT REPORT**

**KAMOV KA-32A11BC**

**CS - HMO**

**PRELIMINARY ACCIDENT REPORT Nr. 15/ACCID/2012**

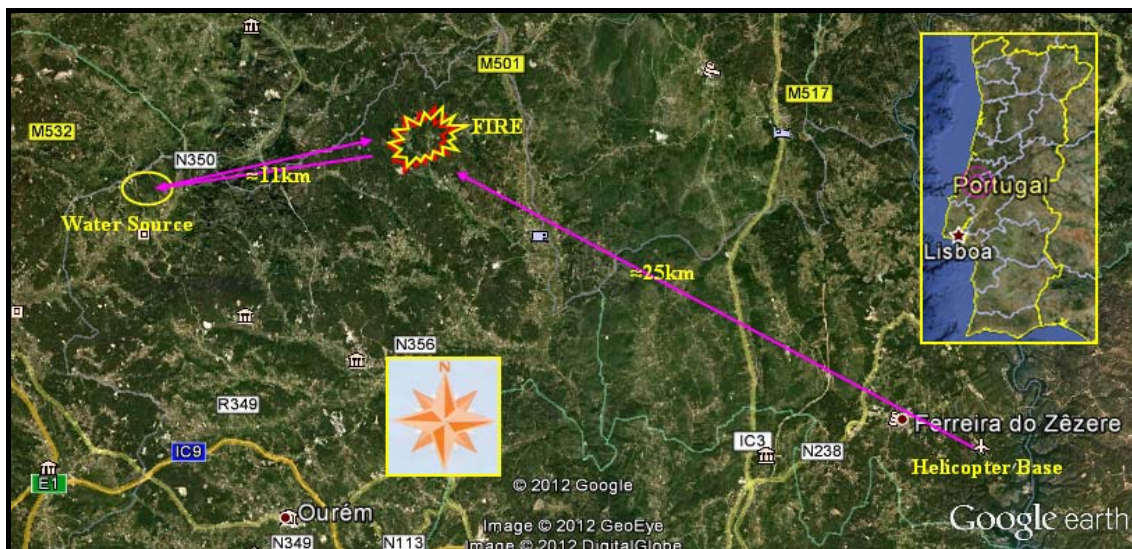
Picture Nr 1

On the 3<sup>rd</sup> of September, 2012, by 11:05<sup>1</sup>, KA-32A11BC helicopter, s/n 9905, Portuguese registration CS-HMO, stationed at Ferreira do Zêzere, was called to perform a fire fighting mission, with “Bambi Bucket” installed, on a wild fire spreading at Ourém area (*picture nr 1*).

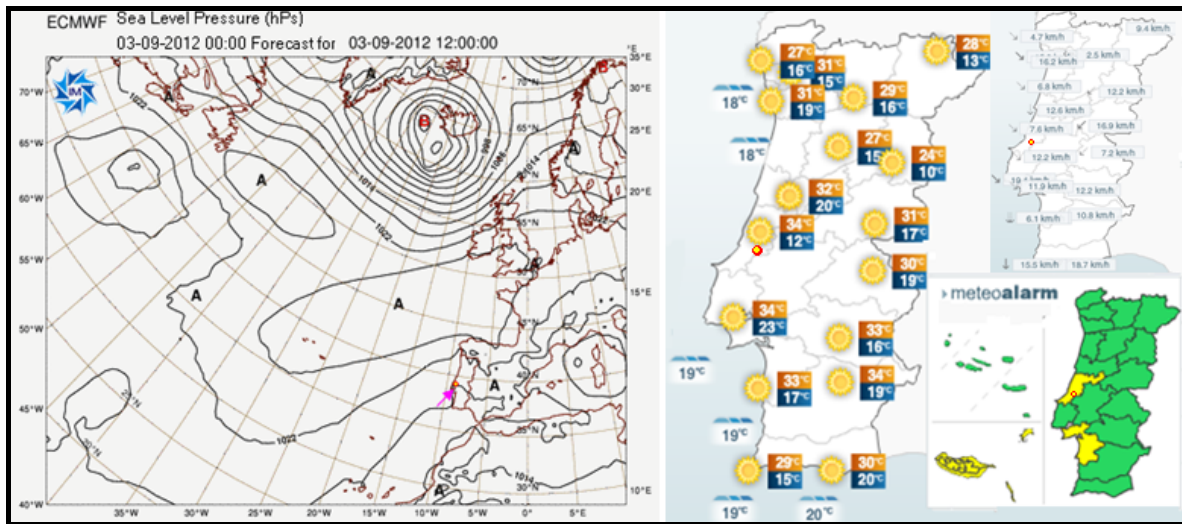
Picture Nr 3

It was a nice summer sunny day being the country under the influence of a High Pressure System, which covered North Atlantic and a great part of Europe, Iberian Peninsula included, with wind calm to moderate, variable direction, sky clear and high temperatures, combined with low humidity. Meteorological Institute issued a yellow alarm for three districts, alerting for the risk of wild fires. Accident area was covered by this alarm (*picture nr 3*).

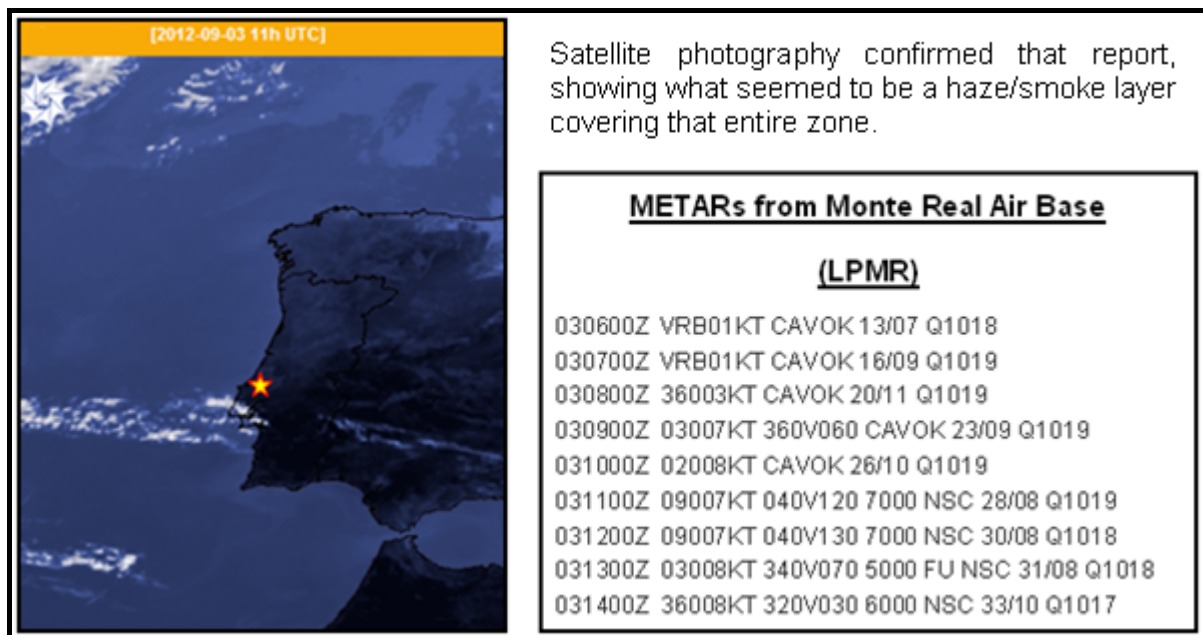
Picture Nr 4

Weather information from nearest airfield (Air Force Base of Monte Real) referred an East-erly wind with 7kt, variable between 040° and 120°, 7000m visibility, no clouds, 28°C temperature and 1019hPs QNH (*picture nr 4*).
