FINAL ACCIDENT REPORT

TECNAM P-96 GOLF

CS - UOO

FINAL ACCIDENT REPORT Nr. 19/ACCID/2010

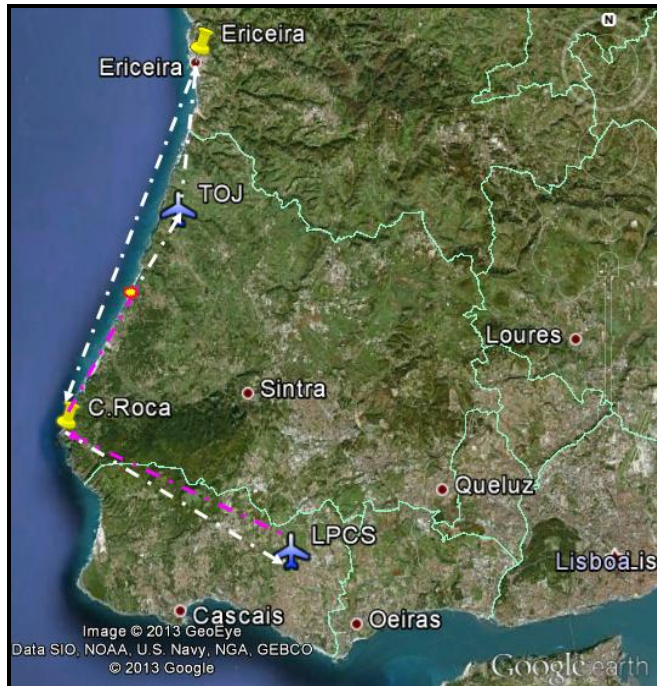
Picture Nr 1

On the 15th of December, 2010, an ultralight aircraft model Tecnam P-96 Golf, with s/n 285 and Portuguese registration CS-UOO, took-off from Cascais Municipal Aerodrome (LPCS) at 15:11. On board there were two people performing a leisure flight, at 1500ft altitude, flying North of the aerodrome, to Roca Cape, Tojeira airfield (for a touch-and-go landing), Ericeira and back, by Roca Cape, to LPCS (*picture nr 1*).

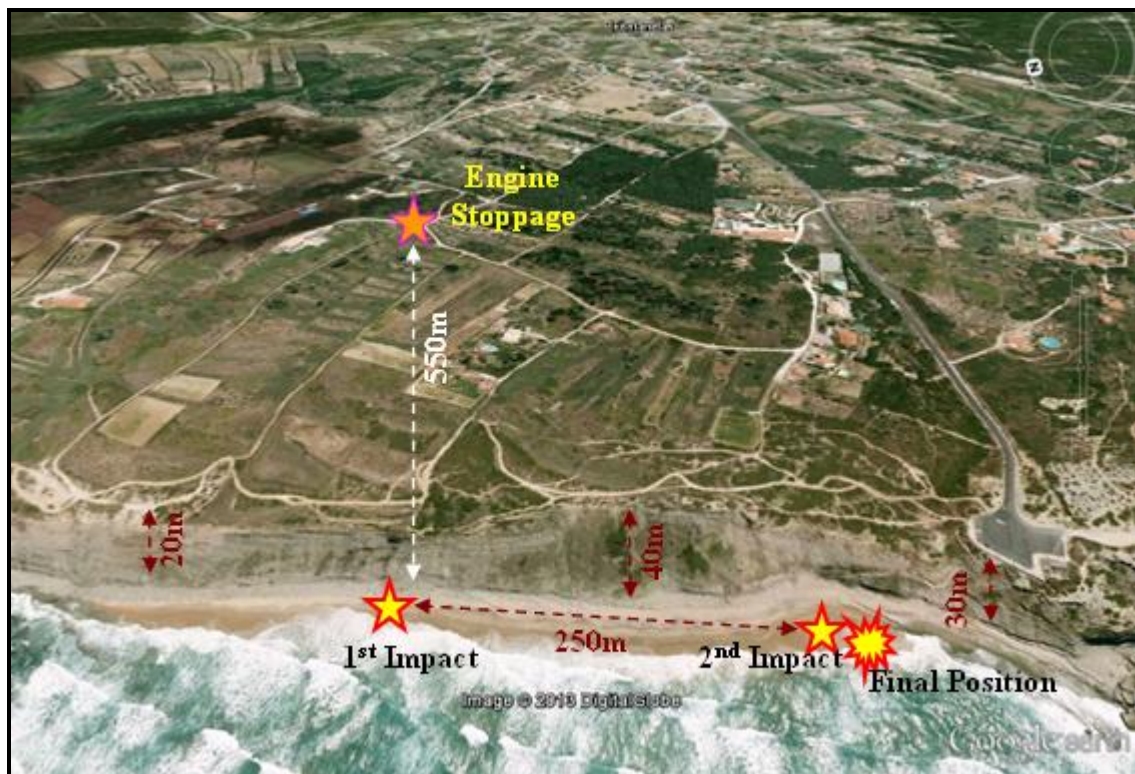
Picture Nr 9

The accident occurred at Aguda Beach, near Fontanelas, Sintra, a narrow sand stripe with variable dimensions, according sea tide, from 800m to 430m long and 50m to 15m width, along a high cliff (20m < 40m) and located about 550m from the vertical of engine failure aircraft position (*picture nr 9*).

The aircraft approached the beach from West (from the sea), on a right turn, trying to land on a southerly direction (*picture nr 9*).

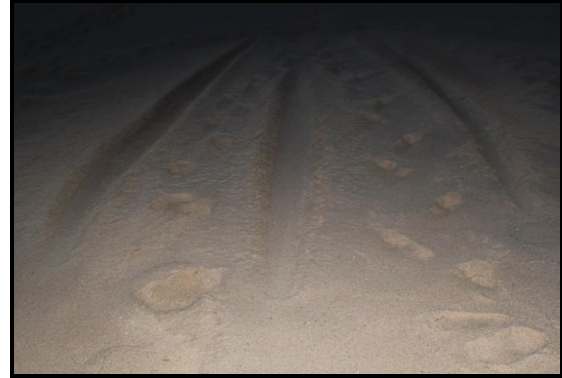
Picture Nr 10

First ground impact was more or less at mid-point of the sand stripe, on a three-point position (on three wheels), leaving three 5m long marks on the soil (*picture nr 10*).

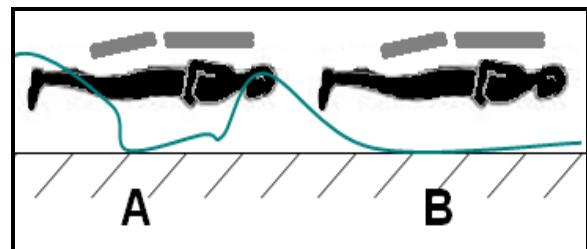
Picture Nr 14

The pilot was unconscious and presenting a great cyanosis² index. He was in a hypothermic condition, with respiratory arrest and feeble heart beating. He was facing down and his body extended, suspended by the seat belts that kept him tied to the seat, which back had been distorted and was leaning backwards (*picture nr 12*).

This must have contribute to his survival allowing the water ingested to his lungs, during the period the wave covered his mouth (*picture nr 14-A*), to be partially expelled by gravity, when the wave receded and the mouth became uncovered by water (*picture nr 14-B*).

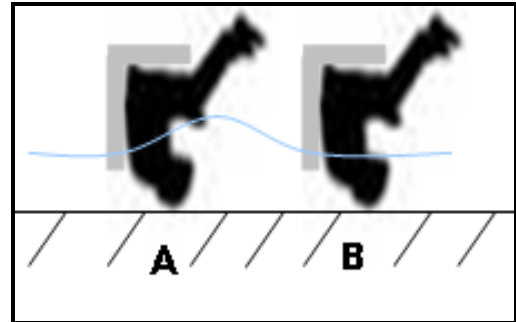
Picture Nr 15

The passenger was unconscious, seated on his seat with seat belts fasten and his head resting on the ground, under water. In this position, sea water coming & going, with seasaw motion, covered his head, blocking his airway permanently (*picture nr 15*), preventing him from breathing and forcing him to swallow sea water into his lungs and stomach.

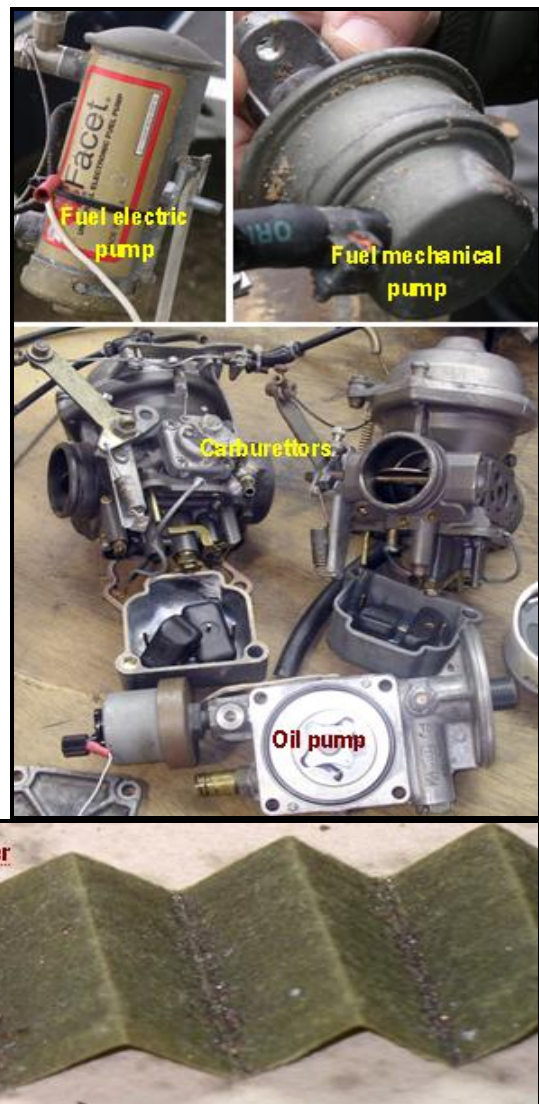
Picture Nr 17

- Ignition system didn't show any defect or discontinuity, with magnetos in perfect operating condition and spark plugs were clean, well tight and presenting adequate clearance.
- Both fuel pumps were operational and full of AVGAS. All fuel lines were clean, unobstructed and without leaks. Both carburettors were in normal condition with fuel inside float chambers and throttle valves moving freely.
- Lubrication system was adequately refuelled, with oil pump operating properly, but the oil filter was dirty and showing silver & copper coloured metallic particles, which were also detected on magnetic probe in great quantity.

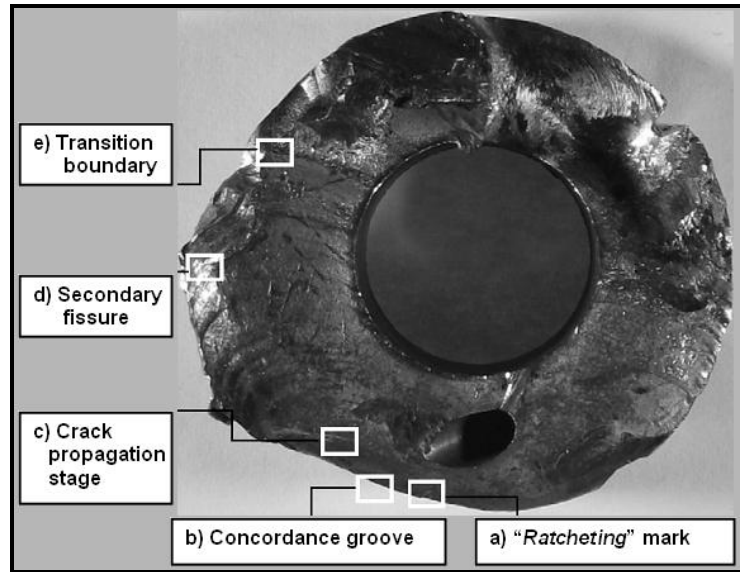
Picture Nr 24

In order to perform a more detailed examination of fracture surface morphologic characteristics, using a scanning electron microscope (SEM), five different zones were selected along the entire area of bearing fracture surface (*picture nr 24*).

a) "Ratcheting" mark – This mark, looking like a tooth (*picture nr 25-A*), results from the junction of two micro-fissures propagation plans, originating in the maximum stress region along the concordance groove between connecting rod bearing and adjacent crank web, being associated to the extreme mechanical strain developed in that area. This mark coincides with crack initialization zone corresponding with initial stage of fatigue process.

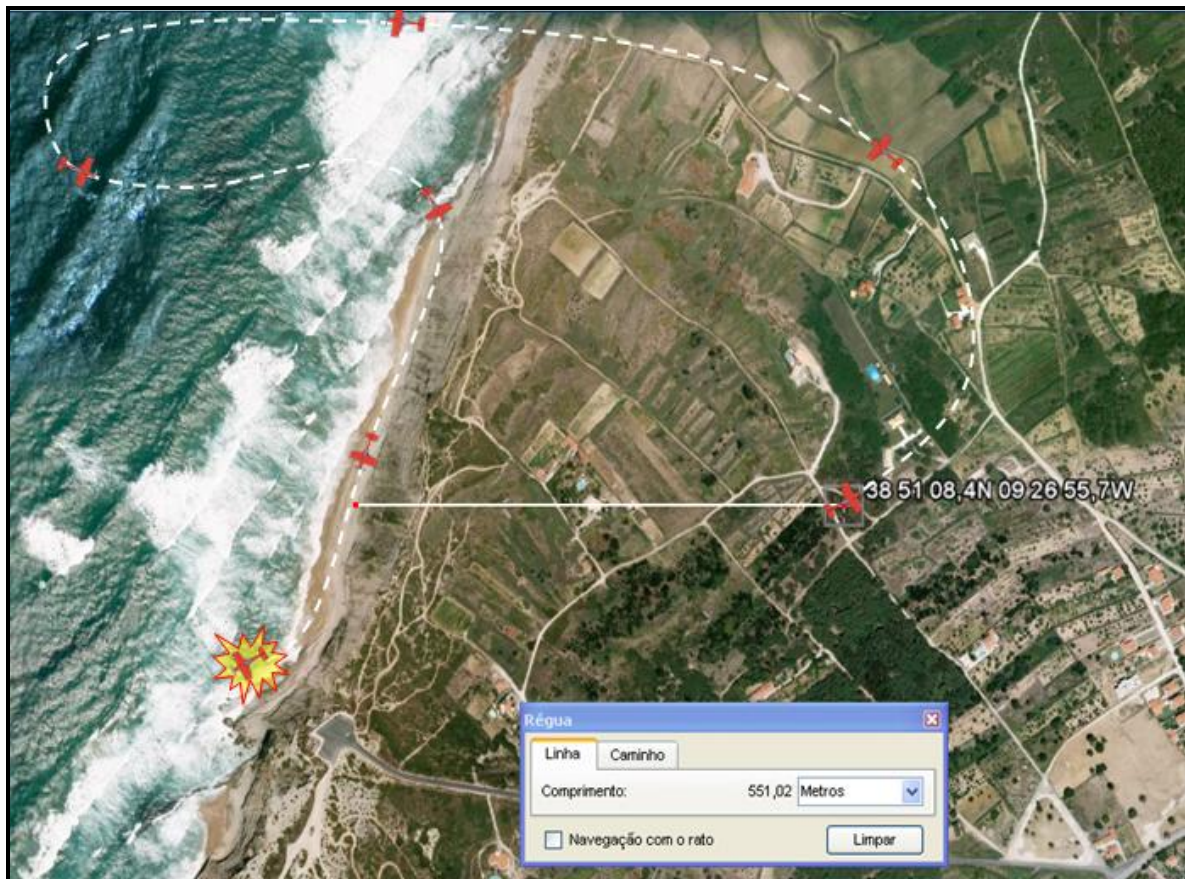
Picture Nr 29

From aircraft last radar position, recorded at 15:21:00 (38 51 08.4 N / 009 26 55.7 W), until it became immobilized in the sea, a probable trail was drawn (*picture nr 29*), based on pilot report and other local testimonies narration of the events.

Facing the engine failure, the pilot headed towards the sea, turning by his left, keeping the aircraft clean and leaving ATC contact, probably due a main power cut, which could also explain the loss of transponder signal by radar controller (on cockpit inspection, main switch key and ignition switches were found in "OFF" position).

Looking in detail to covered track (*picture nr 29*), it's reasonable to believe it was possible for the aircraft to reach Tojeira airfield, gliding, if the pilot had opted for that solution. Anyhow

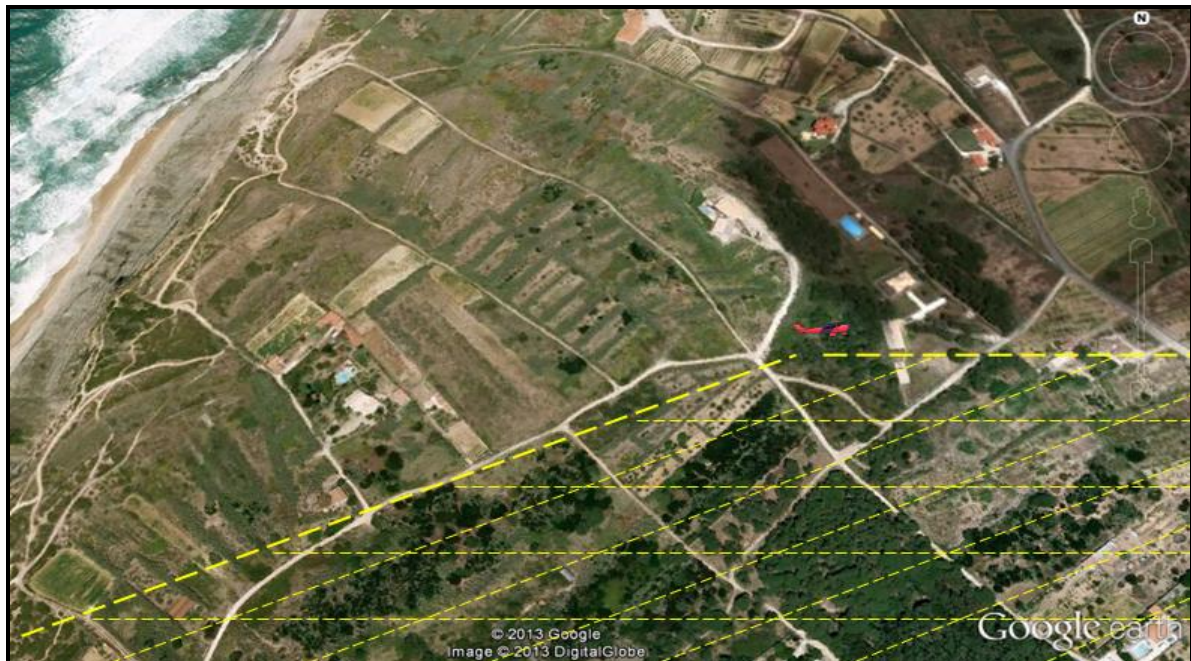
Picture Nr 30

When the engine stopped, surrounding area was full of reasonably flat and unhindered grounds, except a small zone, south of aircraft position (*picture nr 30*). Moreover, that region was well known for the pilot, as he used to fly there regularly.
