MINISTÉRIO DA ECONOMIA E DO EMPREGO  
GABINETE DE PREVENÇÃO E INVESTIGAÇÃO DE ACIDENTES COM AERONAVES

## AIRCRAFT INCIDENT REPORT

<b>Date/Time:</b> 24-01-2012 @ 16:30 UTC <sup>1</sup>	<b>Proc. Nr.:</b> <b>01 / INCID / 2012</b>
<b>Operator:</b> Leiria Flying Club	<b>Type of Incid.:</b> RUNWAY EXCURSION
<b>Id. of aircraft:</b> Cessna 152, Reg. G-CGSP	
<b>Local:</b> Leiria Aerodrome ( LPJF )	
<b>Type of flight:</b> Pleasure	<b>Phase of flight:</b> Landing
<b>People on board:</b> Crew- 1 Pax- 1	<b>Injuries:</b> Nil
<b>Aircraft Damage:</b> Light	
<b>Synopsis:</b> The Cessna 152 aircraft with a British registration G-CGSP, privately owned but flying with Leiria Flying Club, was engaged on a local flight in the vicinity of José Ferrinho aerodrome, Leiria (LPJF). When performing a landing manoeuvre on runway 02, the pilot was unable to maintain the aircraft inside runway, which veered to the right, exited the tarmac and travelled for about 30m on the grass before it came to a stop. The weather was fine, with a clear sky, good visibility and wind calm, being not considered a contributory factor for the incident. Pilot and passenger exited the aircraft unharmed but the aircraft suffered li

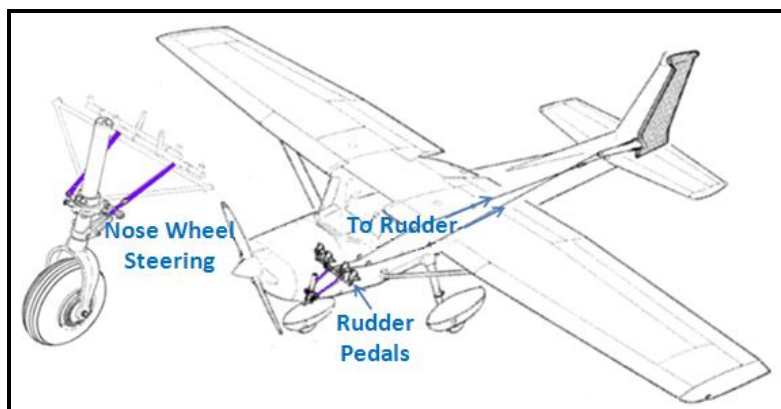
Picture Nº 3

Nose gear leg is provided with an air/oil shock absorber and a steering control system actuated by rudder pedals, allowing an 8.5° amplitude turn to each side (*picture nº 3*).

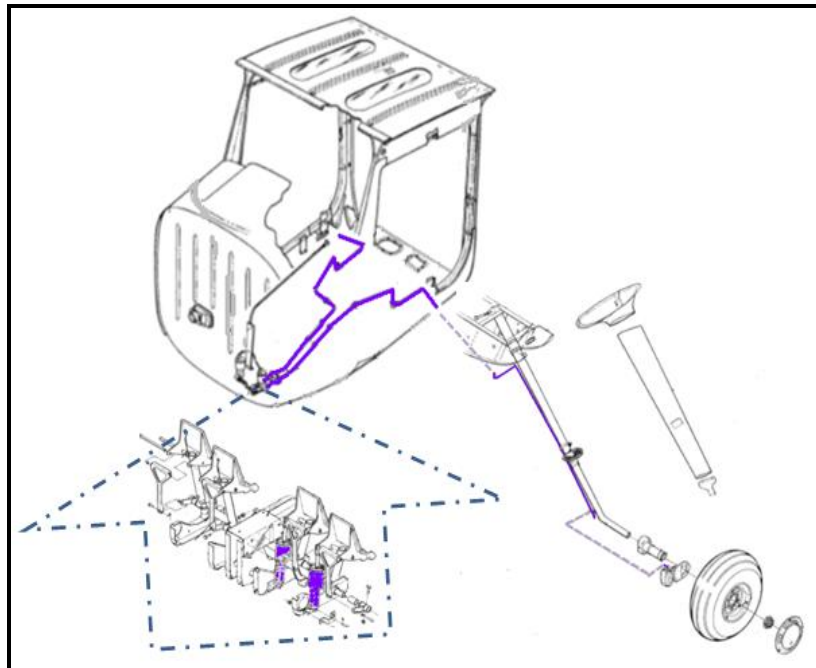
Picture Nº 4

Main gear wheels are equipped with a disc-type hydraulic braking system (picture nº 4).

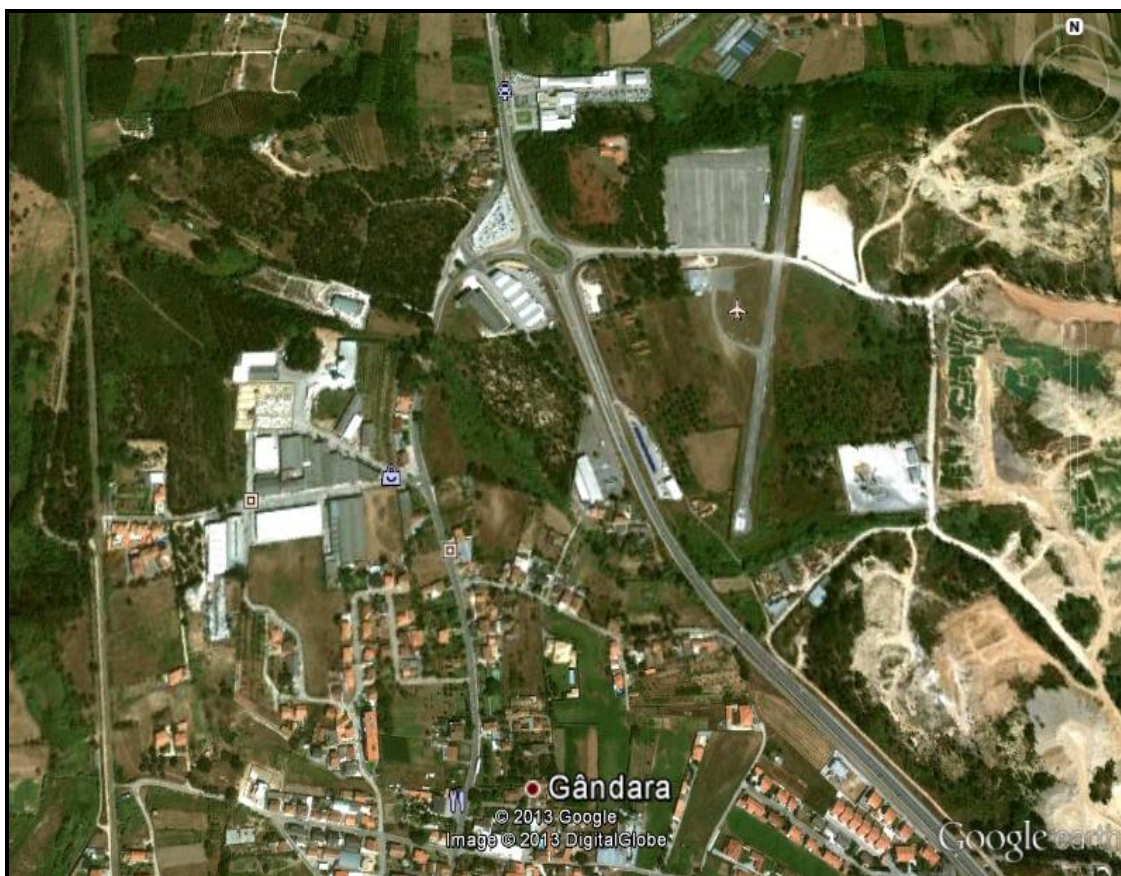
Picture Nº 6

According pilot statement, the aircraft touched down on runway first 80m and rolled freely for more 200m, in order to dissipate speed. Only after speedometer stopped to indicate (<40kt), the pilot started to brake gently and the aircraft started veering to the right. Assumable right main wheel blockage occurred near runway right edge (*picture nº 6*), about 300m from runway threshold.

That is to say that runway mark extension and chroma (picture nº 6) as well as soil dug grooves' extension and deepness (picture nº 7) don't conciliate with an aircraft speed of less than 50-60kt.
