**ACCIDENT**

| <b>Aircraft Type and Registration:</b> | AS350 B3e Ecureuil, G-MATH | |

**Synopsis**

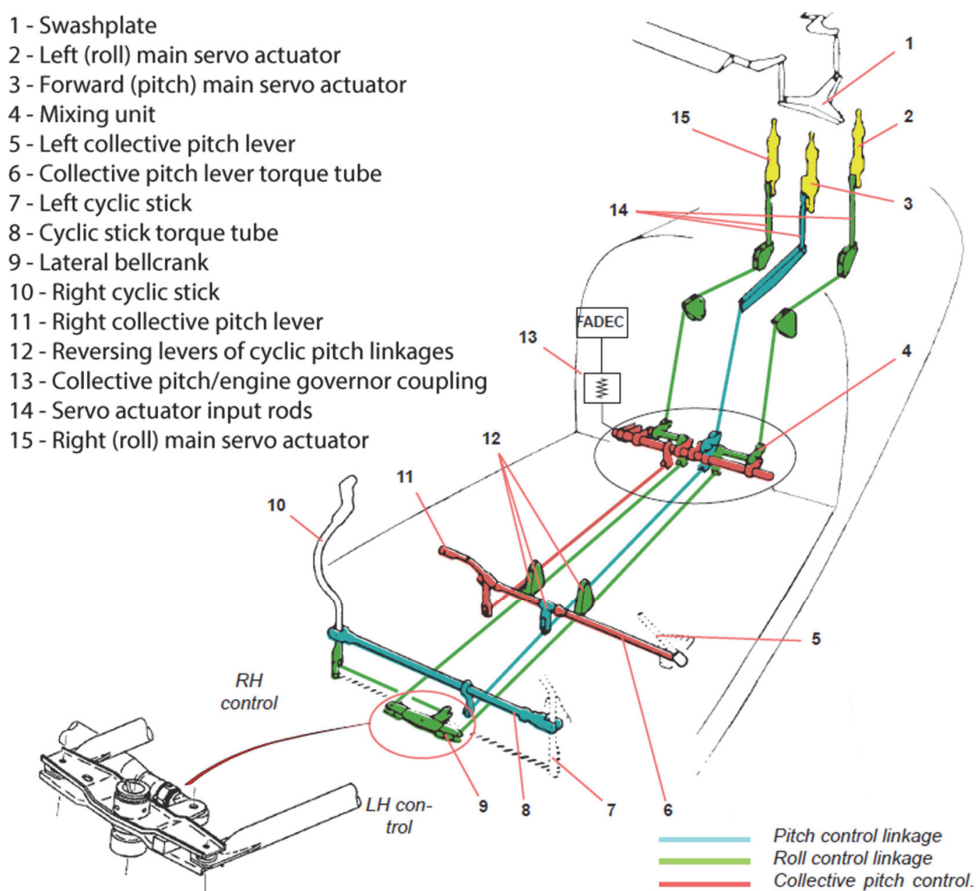
**Figure 2**

The cyclic pitch control stick and collective pitch control lever operate three main servo actuators via a series of push-pull rods, bellcranks and a mixer unit (Figure 2). Moving the cyclic fore and aft actuates the forward servo actuator; this actuator controls pitch attitude by tilting the main rotor swash plate fore and aft. Moving the cyclic left and right actuates the left and right servo actuators; these actuators control roll attitude by tilting the swash plate left and right. The collective lever actuates all three servo actuators together to increase blade pitch, and it also increases engine power, with a resulting increase in rotor thrust.

Diagram of the AS350 B3e main rotor flight controls  
(Image courtesy Airbus Helicopters)
