***Final report RL 2013:01e***

**Incident involving the helicopter SE-JNE  
in Gällstad, Västra Götaland County,  
on 6 February 2012**

Ref no L-12/12  
2013-01-11

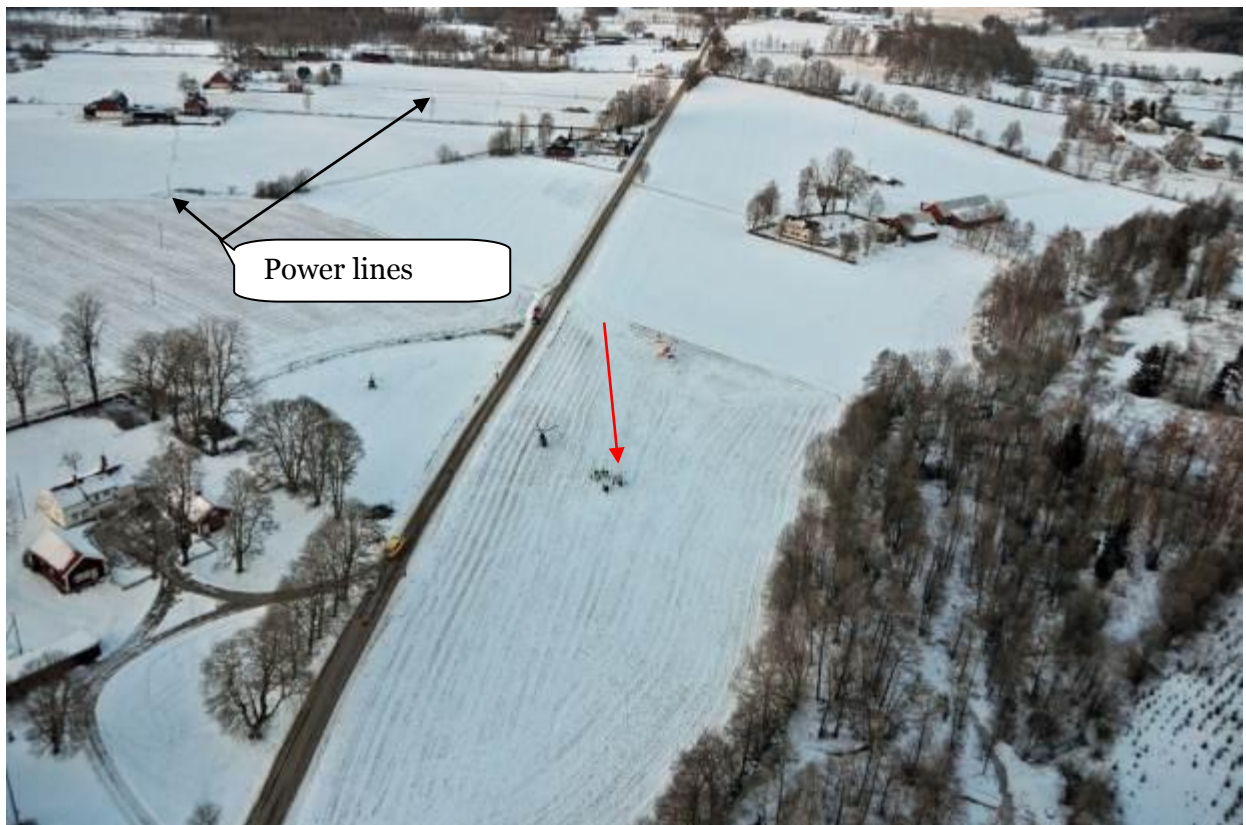
**Figure 1** - The helicopter with pilot and some members of the rescue team; the red arrow tip indicates the emergency-landed helicopter (Photo: The Swedish Police Wing)

The pilot had selected two fields in the direction of flight as possible for an emergency landing, and he manoeuvred towards the larger of the two fields. As he got closer, he noticed that several power lines limited obstacle clearance, see Figure 1, and he then chose the somewhat smaller field further on in the direction of flight. When he raised the nose to reduce forward speed and simultaneously raised the collective to reduce the rate of descent, there was a marked increase in the vibrations. The helicopter yawed to the right, and he was forced to return the collective to the autorotation position. Full displacement of the left pedal did not correct the yaw. In the present case, the rpm was about 10% under the nominal value.

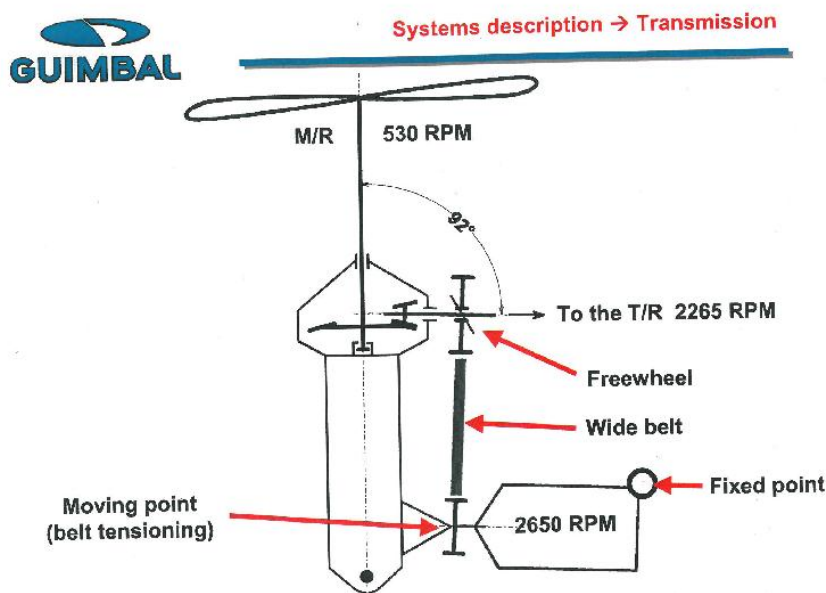
The engine is mounted in three points using a statically determinate mount. The front point consists of a single row deep groove ball bearing mounted in the engine pulley (Fixed and moving points, see Figure 2). The bearing is at the same time the engine's moving bearing point for the eccentric that tensions the drive belt between engine and transmission. The second point (bolt) of the eccentric is fixed in the helicopter's firewall - structure (unit 30 in Figure 3).

Figure 2 - Schematic of the transmission and engine (Hélicoptères Guimbal)
