**Statens haverikommission**  
Swedish Accident Investigation Board

***Report RL 2009:17e***

**Accident to aircraft D-EBKB at Veberöd,  
Skåne County, on 6 June 2008**

Case L-11/08

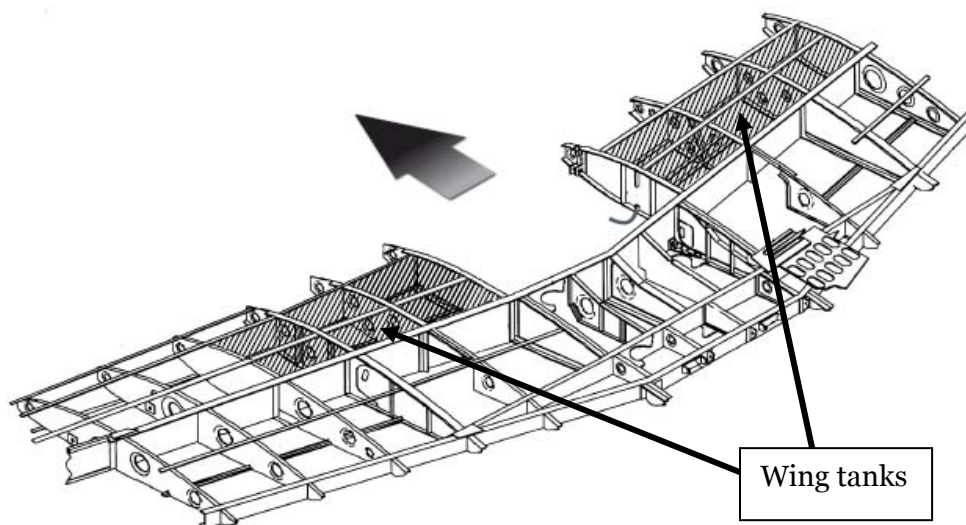
At control of the tanks it was found that there were possibilities for small amounts of water to collect at the bottom of the tank, and that this –if the aircraft was leaning unfavourably – not fully could be drained out.

Each tank is traversed by two ribs which, in addition to the design of the pierced framework, also has interconnection holes drilled in the bottom edges to facilitate fuel flow between the pockets and to prevent any water present from becoming trapped. The side walls of the tanks are made with sealed ribs and the rear edge of the tanks are the wing spars. The suction part from the tank, i.e. the fuel pipes to the engine, are located at the rear of each tank, with the suction pipes about 10 mm above the skinning forming the bottom of the tank. The suction pipes are made in the form of downward bent pipes.

The drain points are located in the same areas as the suction pipes and the top of each drain valve is located at the same height as the suction pipes, about 10 mm above the skinning forming the bottom of the tank. The places in the tanks where these valves are located are at the lowest point while the aircraft is level. A small amount of water can collect at the bottom of each tank in the layer below the tops of the drain valves.
