Statens haverikommission
Swedish Accident Investigation Board

Report RL 2009:18e

**Incident to Aircraft LN-RPA at Luleå/Kallax
airport, Norrbotten county Sweden, on
27 February 2007**

Case L-02/07

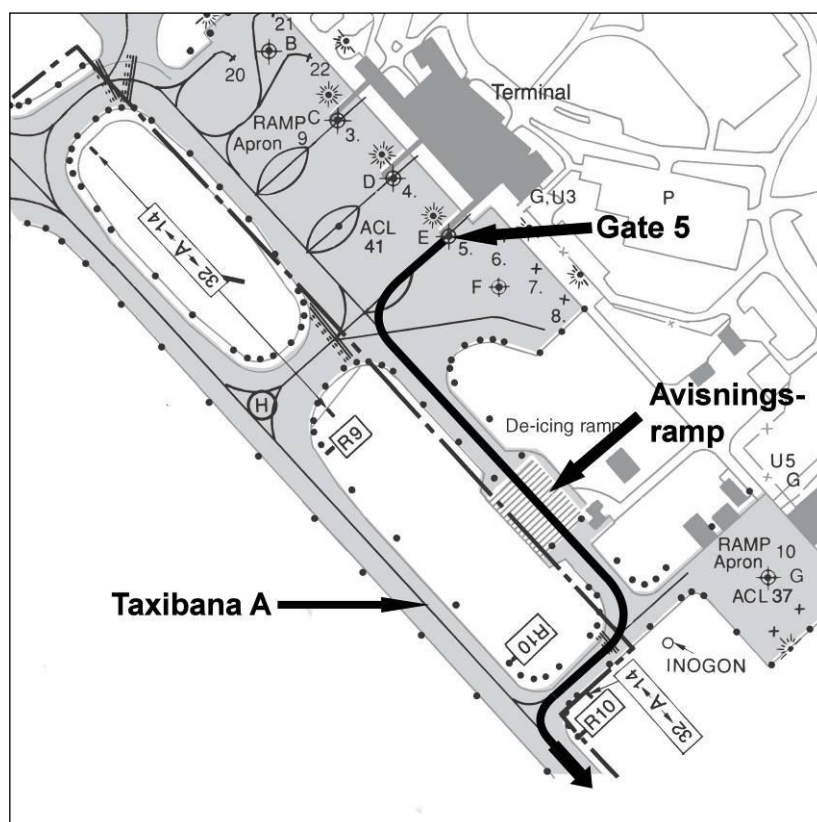
Figure 1. The civil aircraft ramp area at Kallax and the actual taxi route of SK001

At 06:15:49 the aircraft began to taxi from the de-icing ramp. Figure 1. The civil aircraft ramp area at Kallax and the actual taxi route of SK001 illustrates the taxiing route of the aircraft.

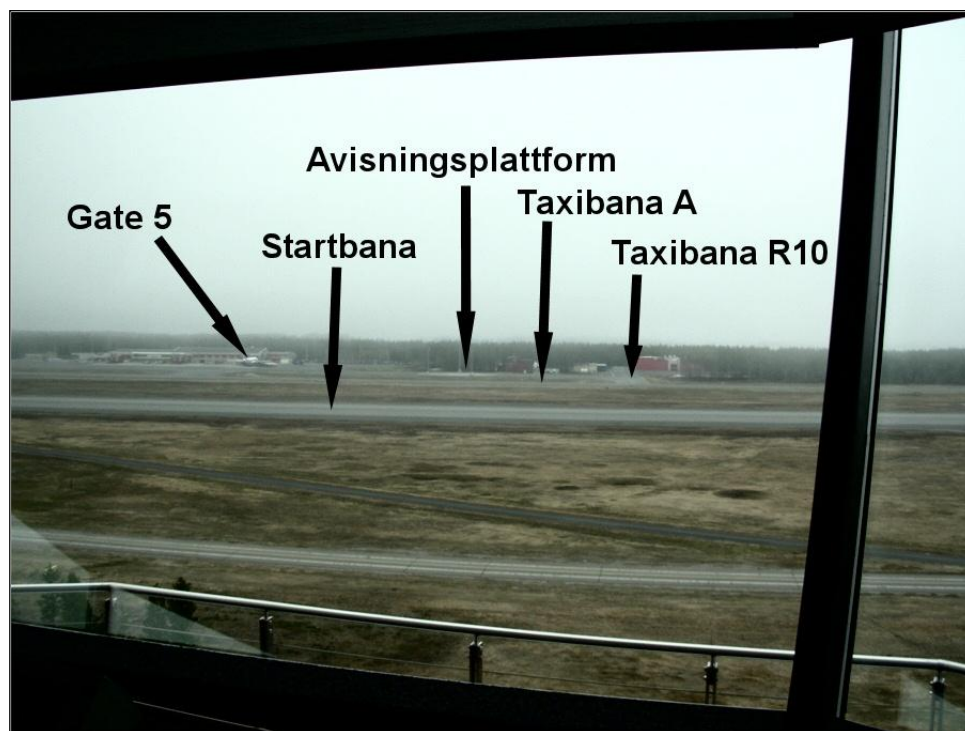
According to the ATCO, visibility reduced severely during the time period 06:00 to 06:20. The visibility became so poor that the ATCO could not see taxiway A, nor the runway. (Fig. 2 below shows the view from the control tower in clear weather.)

Figure 2. The view from Kallax control tower in clear weather

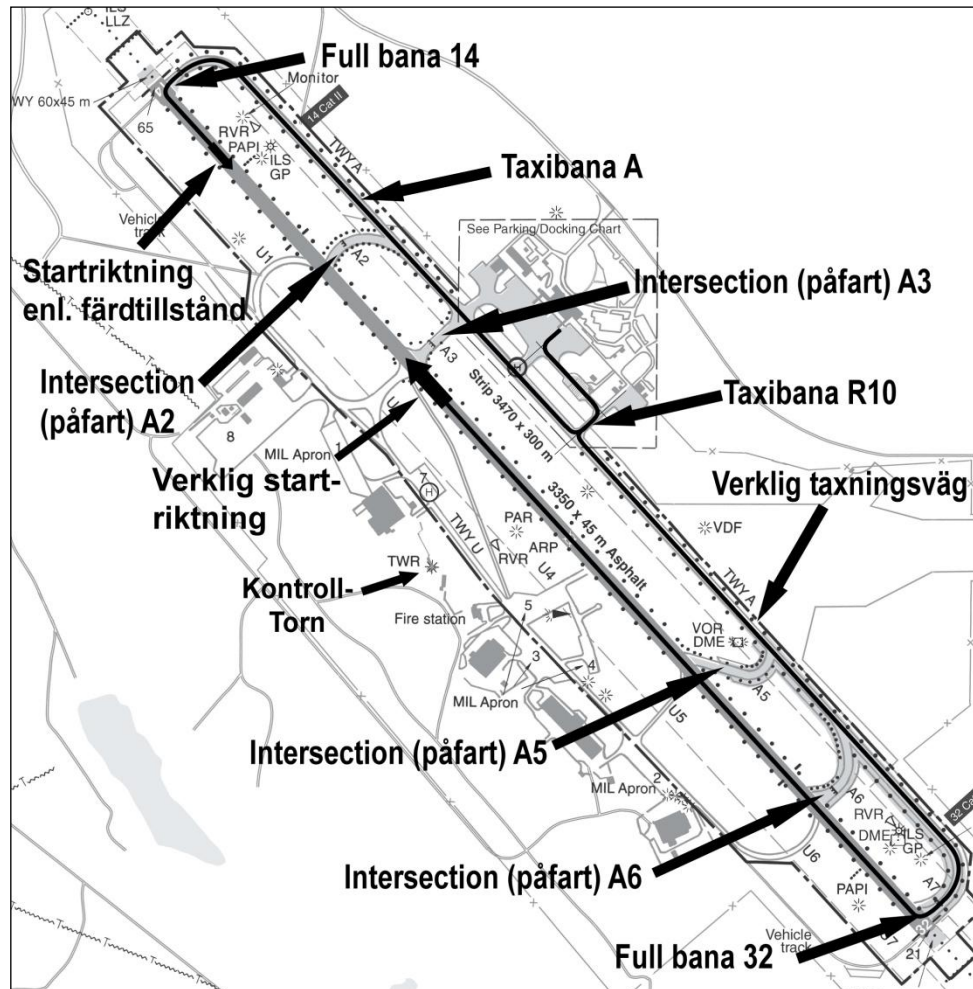
Figure 3. AIP description of the runway layout illustrating the direction of take-off

Fig. 3 above shows an overview of the runway layout and the route along which SK001 actually taxied, and the route it had been cleared to taxi.

During taxiing on Taxiway A, about half way between taxiway R10 and intersection A5 (see fig. 3), a final TODC calculation, i.e. the fourth and final, was performed at time 06:17:35. This was in respect of runway 14 with 2 mm of snow and a friction coefficient of 0.26. The only difference between the two last calculations was the friction coefficient. None of the parameters, except for the friction coefficient, needed to be entered actively at this stage, since the other data was already present since the previous calculation.
